GROUP	MODEL
CLI	2016-2020MY Optima (JFa)
NUMBER	DATE
057	October 2024

TECHNICAL SERVICE BULLETIN

BLOWER MOTOR FUSE RELOCATION

This bulletin provides the procedure to relocate the Heating, Ventilation, and Air Conditioning (HVAC) blower motor 40-ampere fuse on some 2016-2020MY Optima (JFa) vehicles produced from August 28, 2015 through June 23, 2020 which may experience an inoperative blower motor due to a blown multi-fuse at position #3. The HVAC system provides cooling and heating to help maintain a comfortable environment inside the vehicle cabin. The blower motor provides primary airflow for the HVAC system. Extended use of the HVAC system at high fan speeds may cause damage to the multi-fuse terminals for the HVAC blower motor circuit, which can cause the blower motor to become inoperative, resulting in reduced heat and air conditioning. Follow the procedure outlined in this publication to relocate the Heating, Ventilation, and Air Conditioning (HVAC) blower motor 40-ampere fuse to another circuit within the multi-fuse which has an increased terminal width on the applicable vehicle.

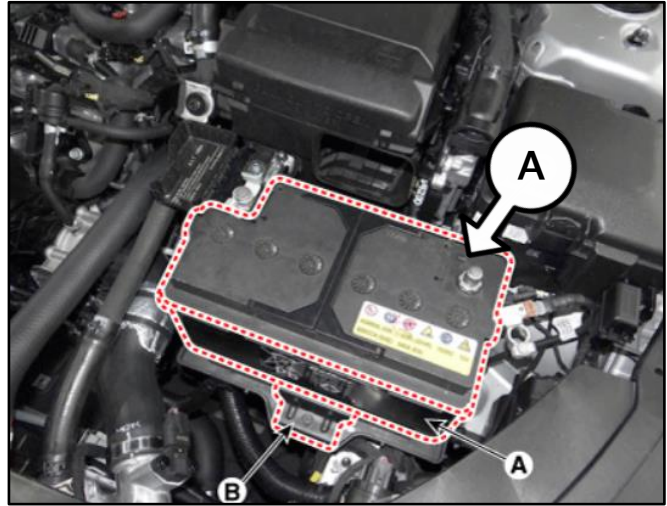
1. Remove the 12V battery (A) by referring to "Engine Electrical System → Charging System → Battery → Repair procedures" in the applicable Shop Manual on KGIS.

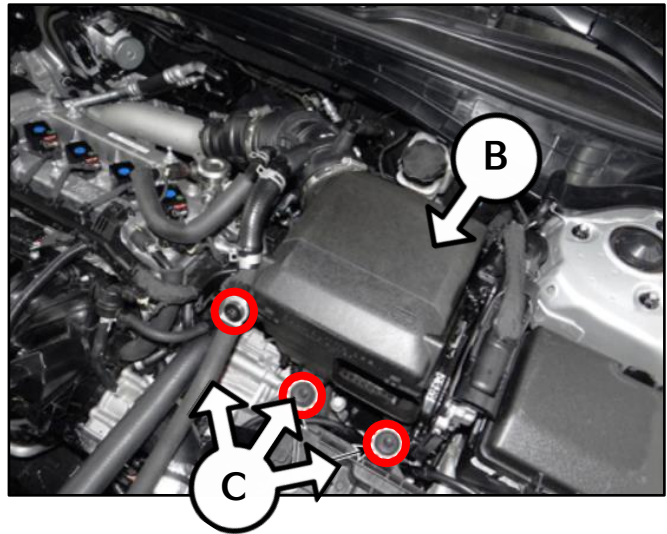
2. Remove the air cleaner assembly (B) by loosening the three (3) retaining bolts (C).

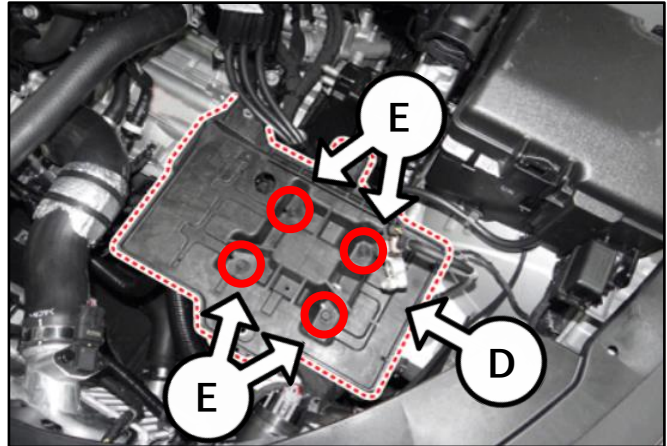
3. Remove the battery tray (D) by loosening the four (4) retaining bolts (E).

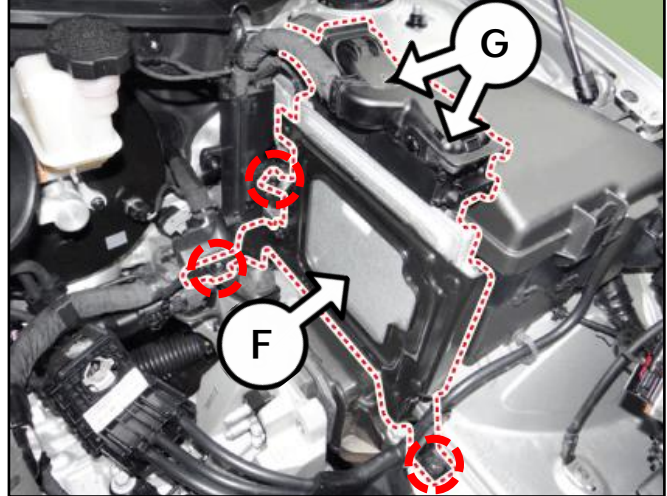
- Loosen the nut and two (2) bolts to remove the Electronic Control Module (ECM) bracket assembly (F).

Note: It is **NOT** necessary to disconnect the ECM connector (G).

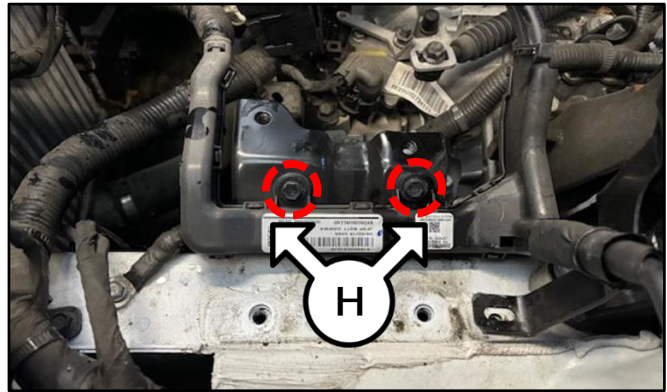
- Loosen the two (2) ECM wiring bracket retaining bolts (H).

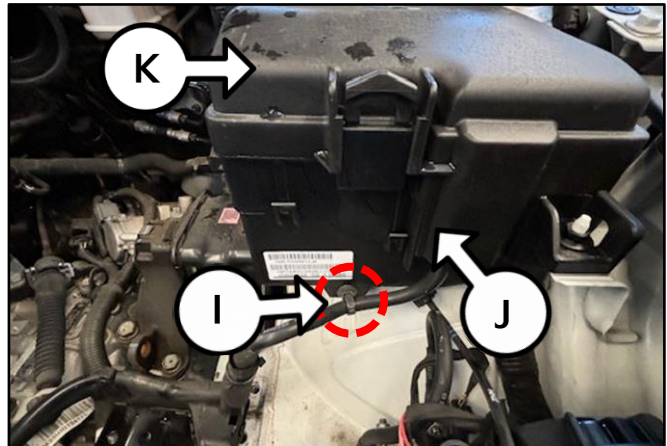
- Detach the wire harness clip (I) from the junction box assembly (J).

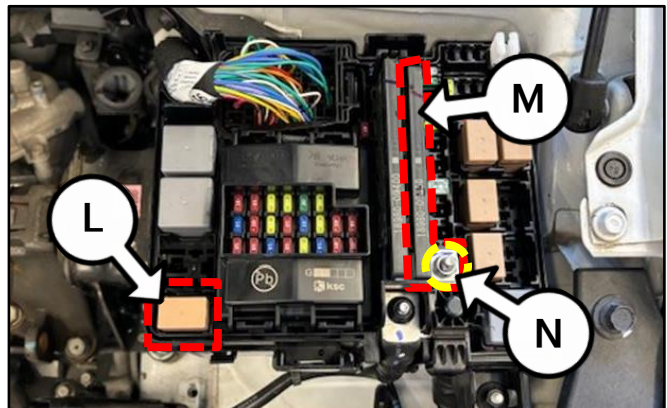
- Remove the junction box cover (K).

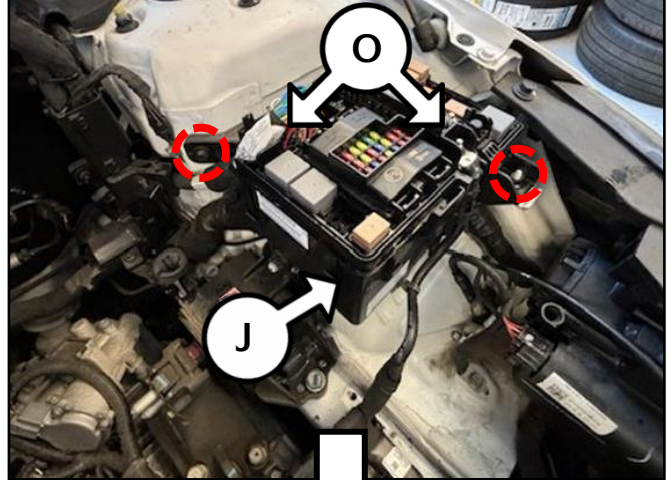
- 9a. Remove the junction box (J) by loosening the retaining nut and bolt (O).

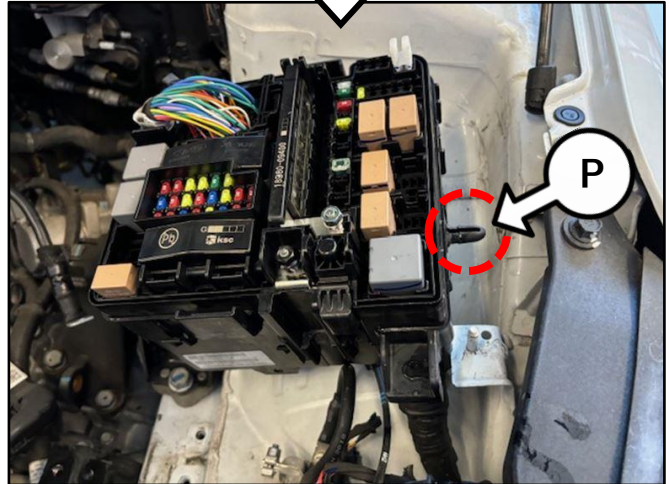
- 9b. Using a clip removal tool, disengage/detach the junction box assembly (P) clip.

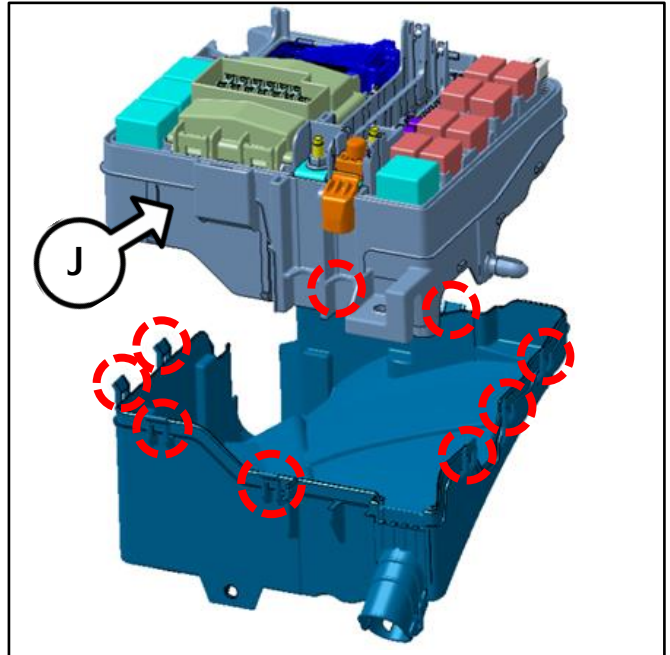
10. Carefully unlock the nine (9) clips to separate the top and bottom of the junction box (J).

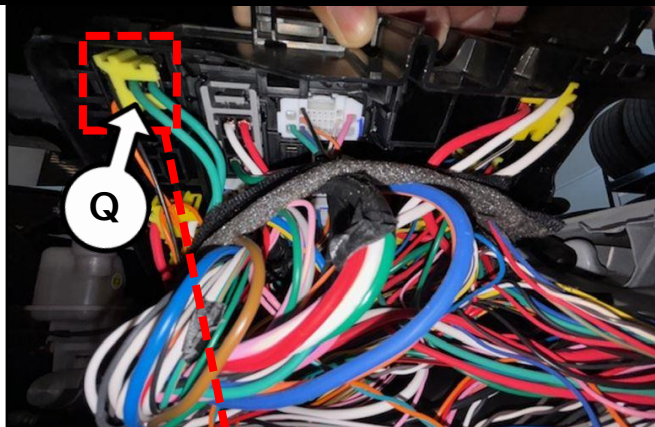
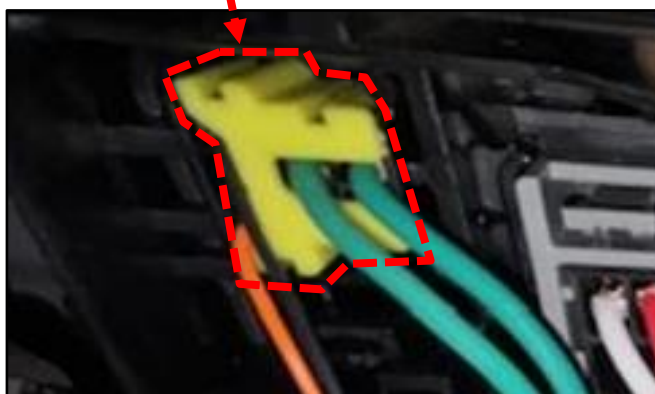
11. Detach the yellow blower motor connector lock (Q) using a pick/awl .

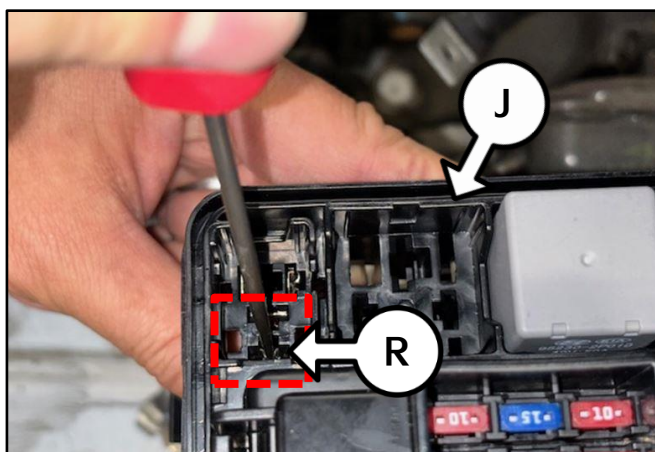
12. Using a pick/awl, release the pin (R) locking tab and pull the wiring pin (R) downward to release it from the existing blower motor relay position on the junction box (J).

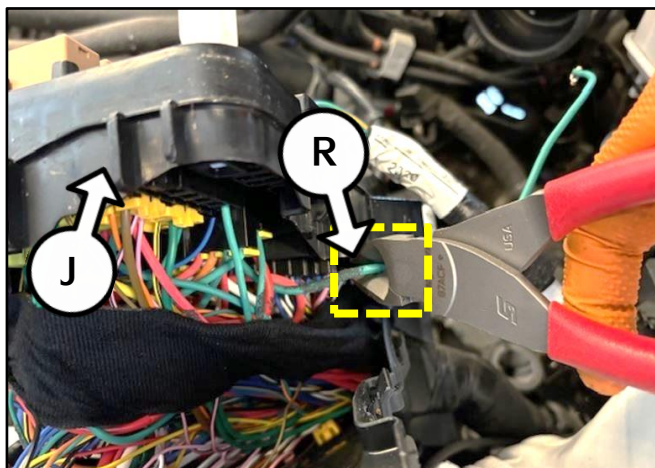
14. Using a wire cutter, cut off the wiring pin (R) end where shown, and discard the wire/pin end.

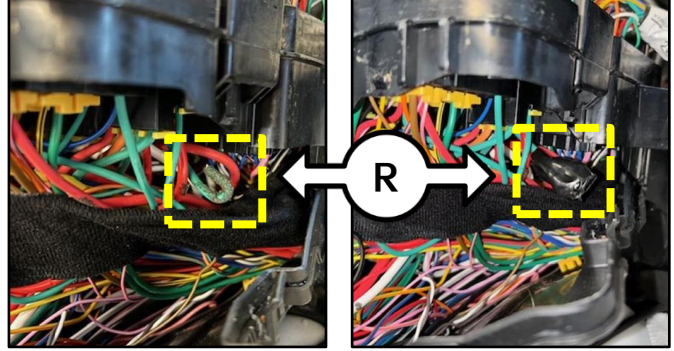
- 15. Bend the remaining end of the cut wire (R) on the junction box (J) and wrap with electrical tape as shown.

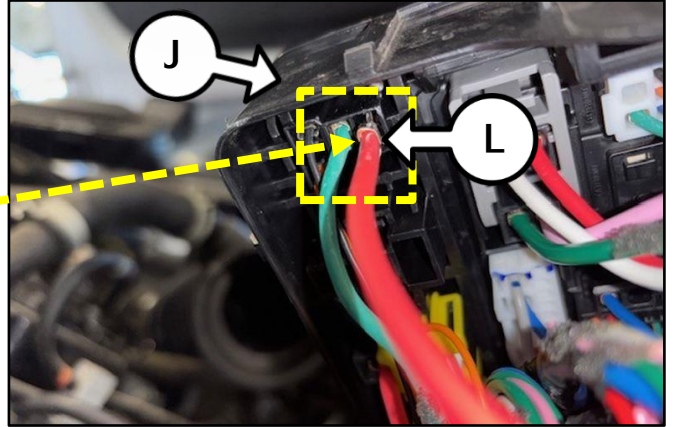
- 16a. Install one of the ends of the new wire into the blower motor relay (L) position on the junction box (J), as shown.

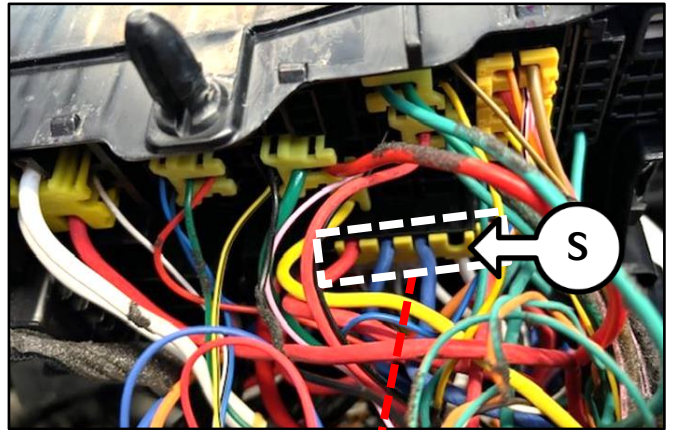
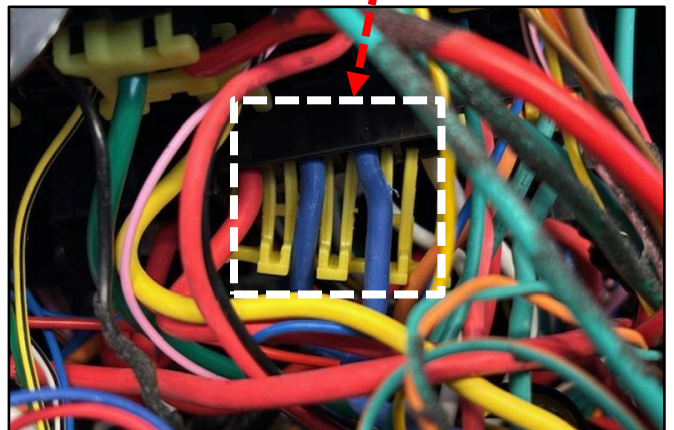
- 17. Using a pick/awl, detach the four (4) clips to remove the yellow multi-fuse connector lock (S).

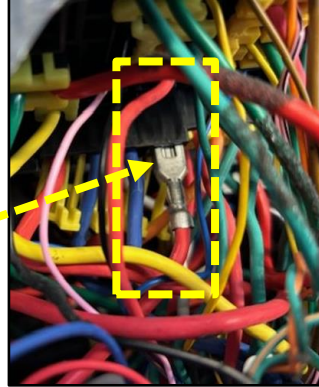
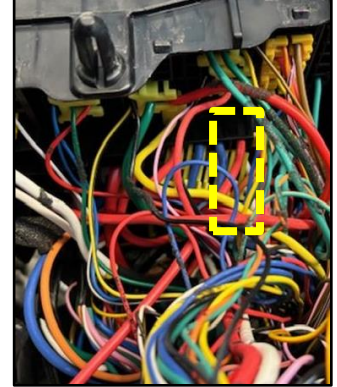
18a. Insert the other end of the new wire into the multi-fuse (M) #5 position on the junction box, as shown.

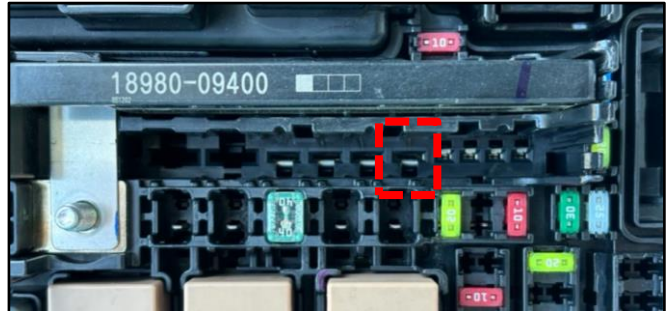
18b. Install the multi-fuse connector lock (S).

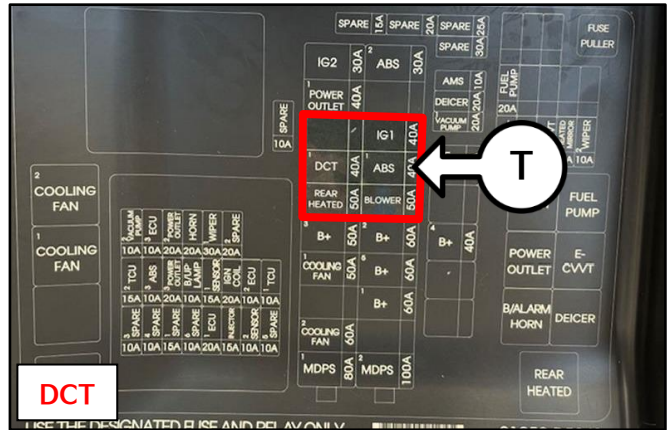
20a. Install new junction box fuse cover label (T) on the inside of the junction box fuse cover (K), as shown.

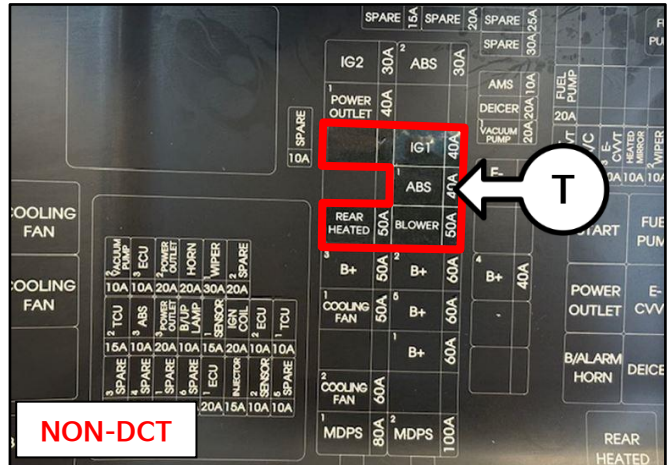
20b. For vehicles with **NON-DCT** transmissions, cut out the 'DCT 40A' section of the new junction box fuse cover inner label (T), as shown.
