| Technical Journal Title<br>Charge Lid Hard to open/close | | Ref. No.<br>TJ 36757.2.0 | |

TJ Instruction VCC-528944-1

| <b>Title</b> | Charge Connector Door | <b>Page</b> | 1 ( 3 ) |

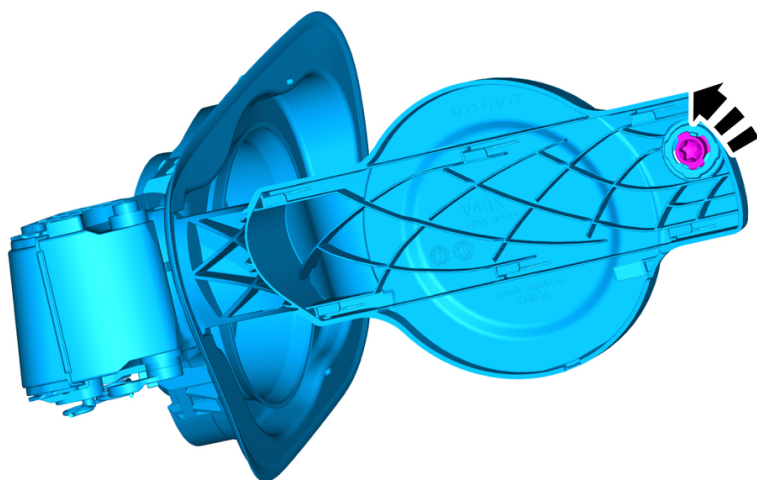
Remove the marked part.

If the charge lid is hard to open/close, begin with replacing the actuator in the lock mechanism. Follow replacement instruction, see attachment TJI-528944-1\_1\_1\_en-US.pdf.

\*The actuator comes as a spare part kit, part number 32399263.

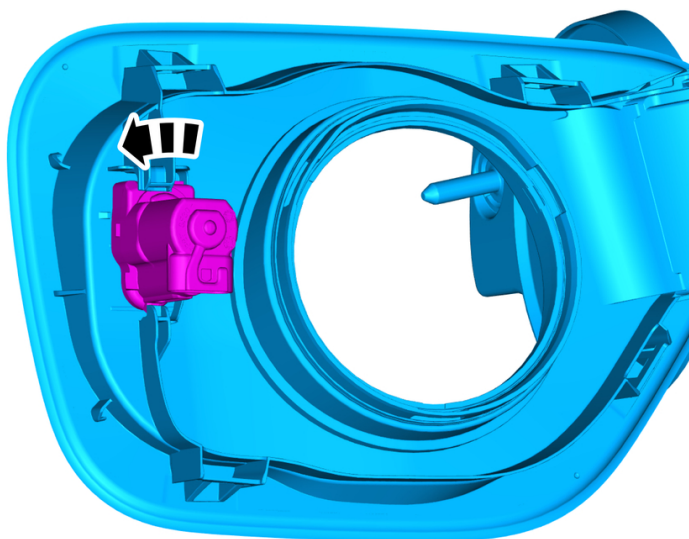
Remove the marked part.

To install, reverse the removal procedure.
