MAS004392 RU 24-36

Rapid Update 753 Granturismo – Rear window water infiltration check

DATE: October 30, 2024

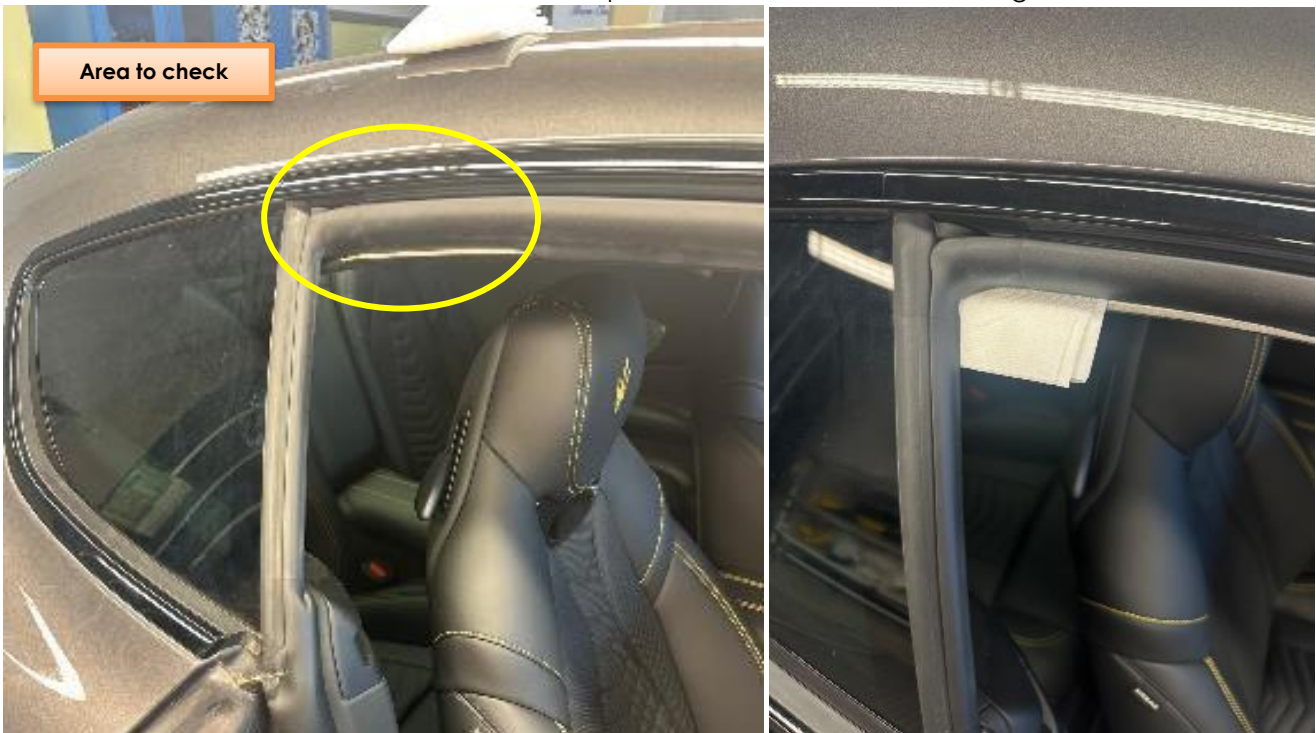
Due to potential issue of the internal seal of the glass molding, water ingress may occur in the roof area. The procedure therefore consists of a check of both sides of the car and the possible replacement of the defective component in the event of a knockout during the check.

1. Always check ModisCS+ to see if the vehicle is involved in this action and if it has not been previously performed.
2. With care, lower the headliner slightly and place sheets of paper towel BETWEEN THE HEADLINER AND THE DOOR GASKET, as shown in the pictures. On both the left and right sides of the vehicle.

- **OK ►** No leak found (Paper towel is completely dry); the procedure is finished. No further action is needed. Reinstall the headliner and door seal back to its original position and release the vehicle.
- **NOT OK ►** Water leak found (Moisture found on paper towel). Open a BOL as "Support request" and attach pictures/videos of how the test was performed and evidence of the leak. Once approved, **Continue to Step 5** and Replace the quarter panel glass including the side moulding. **NOTE: Replace ONLY the components on the side that failed the test.** (Example: no leak on the left side but right side, moisture was found. Therefore, the right side components should be replaced)

5. To replace the component, refer to the workshop procedure in the manual:
 - a. **9.34.011 RIGHT REAR SIDE GLASS** **Detach-Reattach or Replace**
 - b. **9.34.012 LEFT REAR SIDE GLASS. Detach-Reattach or Replace**
6. Also, replace the corresponding mouldings of the non-conforming side:
 - a. **9.34.063 MOULDING AROUND THE RIGHT SIDE. Detach-Reattach or Replace**
 - b. **9.34.064 MOULDING AROUND THE LEFT SIDE. Detach-Reattach or Replace**
7. Reassemble all removed parts following the removal procedure in reverse order.
8. Procedure complete.
