Service Bulletin

Bulletin No.: PIE0804

Date: September, 2024

Subject: Engineering Information - Chirp, Squeal, and/or Whine Type Noise Heard from the Front of Vehicle During a Cold Start and/or While in Operation

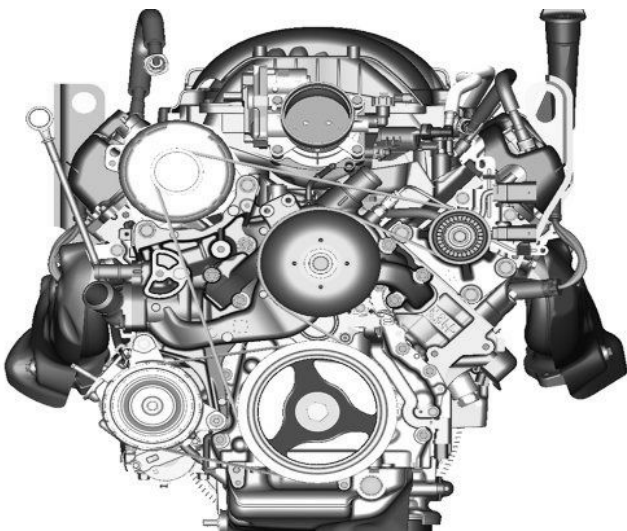
The picture above shows the areas (circled) to look for belt dust.
