GENERAL MOTORS
DCS7066
URGENT - DISTRIBUTE IMMEDIATELY

Subject: N242470162 - Service Update
Reprogramming of Hybrid/EV Battery System Modules

Models: 2020 – 2021 Chevrolet Bolt EV

N242470162 Reprogramming of Hybrid/EV Battery System Modules

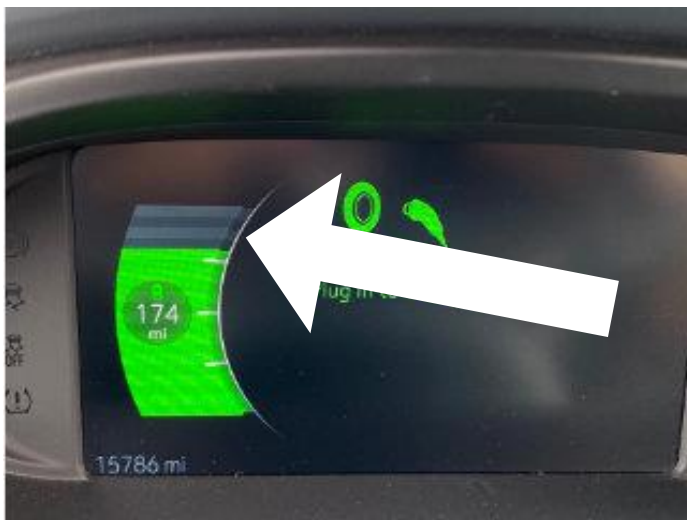
5924268

Important: Verify the vehicle SOC is less than 80%. This can be determined by looking at the bars on the power level indicator. If four or more empty bars (not showing green) are displayed, the SOC is at an acceptable level. If the power level indicator shows an SOC of greater than 80% The SOC must be adjusted before proceeding with the recalibration.

If required, reduce the SOC as follows:

- Vehicle in PARK, Vehicle ON.
- Headlamps Low Beam: ON.
- Temp Control: Hi (Max Heat High) (note: windows should be down).
- Distribution: MAX Defrost (Engages AC Compressor).
- Fan Speed: High (8).
- Select: Fresh Air (Not recirc).
- Select: Heat & A/C.
- If equipped, turn heated seats to hi position.
- Verify SOC after 60 minutes. If the SOC is still greater than 80%, allow additional time for the loads listed above to reduce the SOC to less than 80%.
- When the SOC adjustment is completed return the HVAC controls to 72 Deg. AUTO, Set the headlamp control to AUTO.

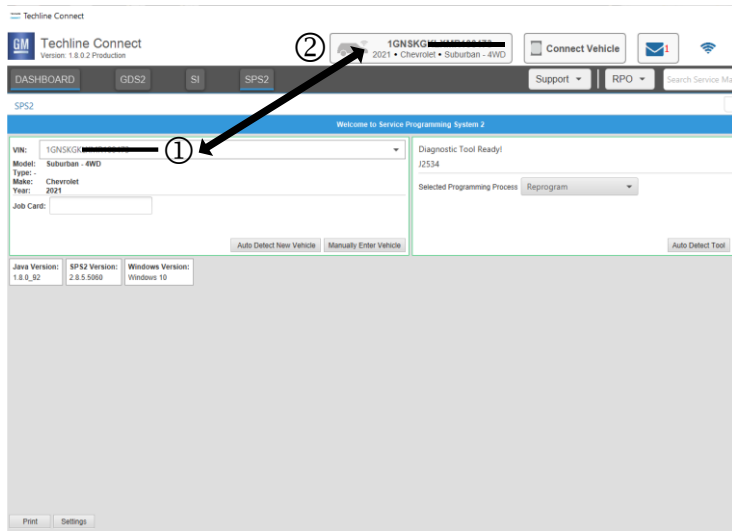
5743643

Caution: Be sure the VIN selected in the drop down menu (1) is the same as the vehicle connected (2) before beginning programming.

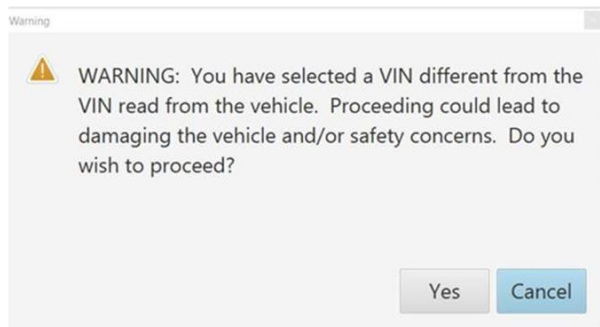
5877000

Important: If the vehicle VIN DOES NOT match, the message below will be shown.

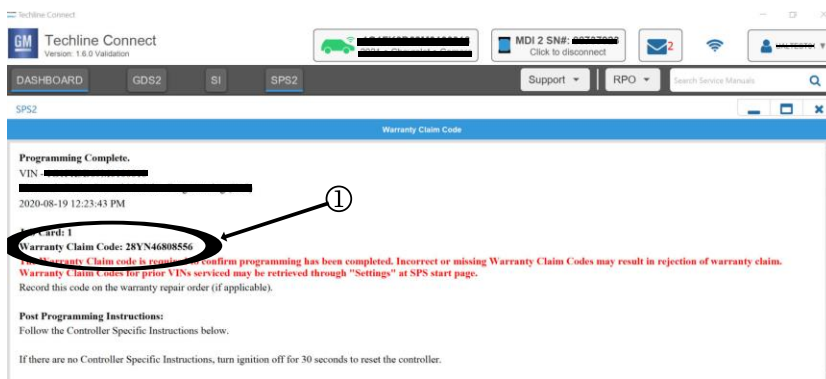
5644478

Important: To avoid warranty transaction rejections, you **MUST** record the warranty claim code provided on the Warranty Claim Code (WCC) screen shown above on the job card. Refer to callout 1 above for the location of the WCC on the screen.

4. Record SPS Warranty Claim Code on job card for warranty transaction submission.
