Anti-theft alarm system triggers without obvious cause

| Topic number | LI80.50-P-077350 |
| Function group | 80.50 - Anti-theft alarm system (ATA), Interior motion sensor/Tow sensor |
| Validity | MODEL 118,177,243,247,167 |

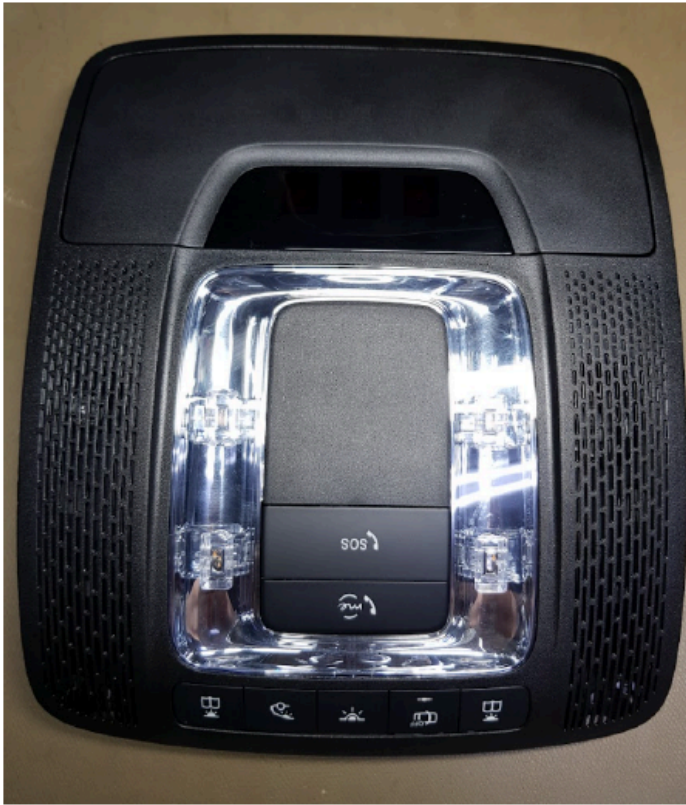
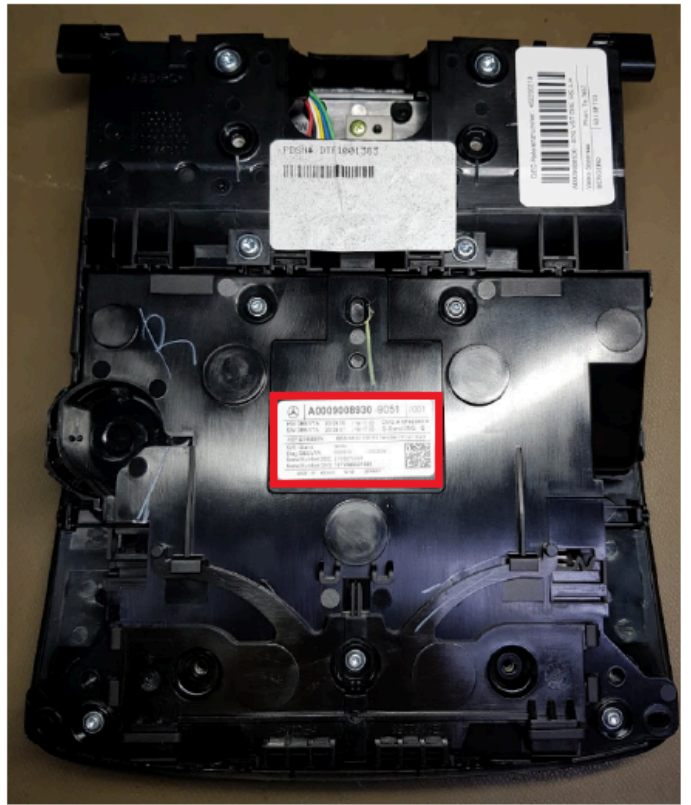
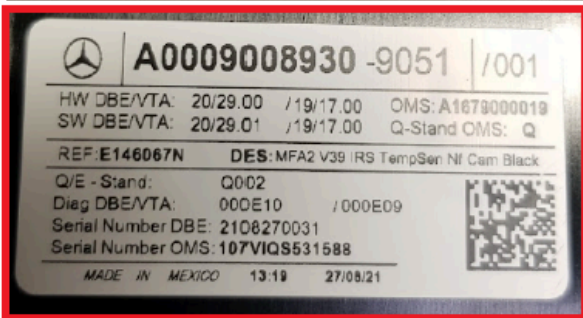
- Attach photo of overhead control panel label (see example images)
- Add control unit log of anti-theft alarm system [N26/6]
- Add alarm history of anti-theft alarm system [N26/6], alarm siren [H3/1] and front signal acquisition and actuation module [N10/6]
