## TECHNICAL SERVICE BULLETIN

### Soft Top - Difficult To Remove Rear Quarter Windows

**24-2330**28 October  
2024**Model:**

<b>Ford</b> 2024 Bronco
----------------------------

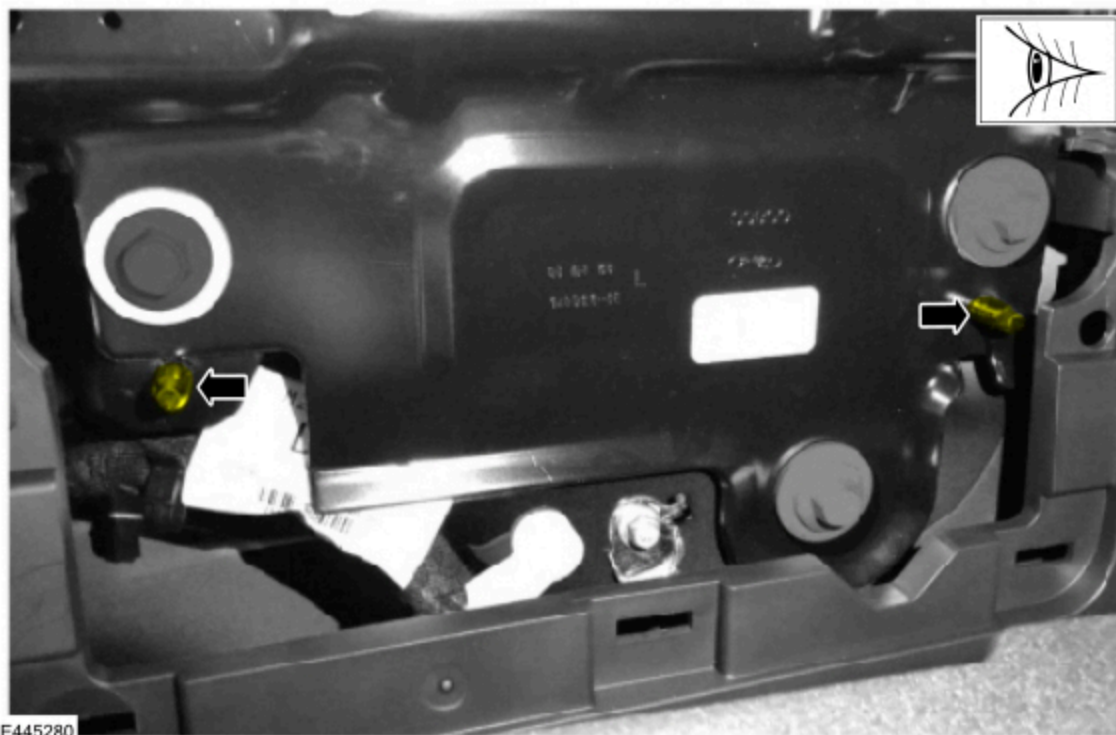
Figure 2

2. Are the soft top mounting brackets fully seated on the guide pins? (Figure 2 - Left side shown, right side similar)

- (1). Yes - proceed to Step 5.
- (2). No - proceed to Step 3.

3. Loosen the bolts to adjust the mounting bracket so that it is fully seated on the guide pins and tighten the bolts to specification. Refer to WSM, Section 501-18.

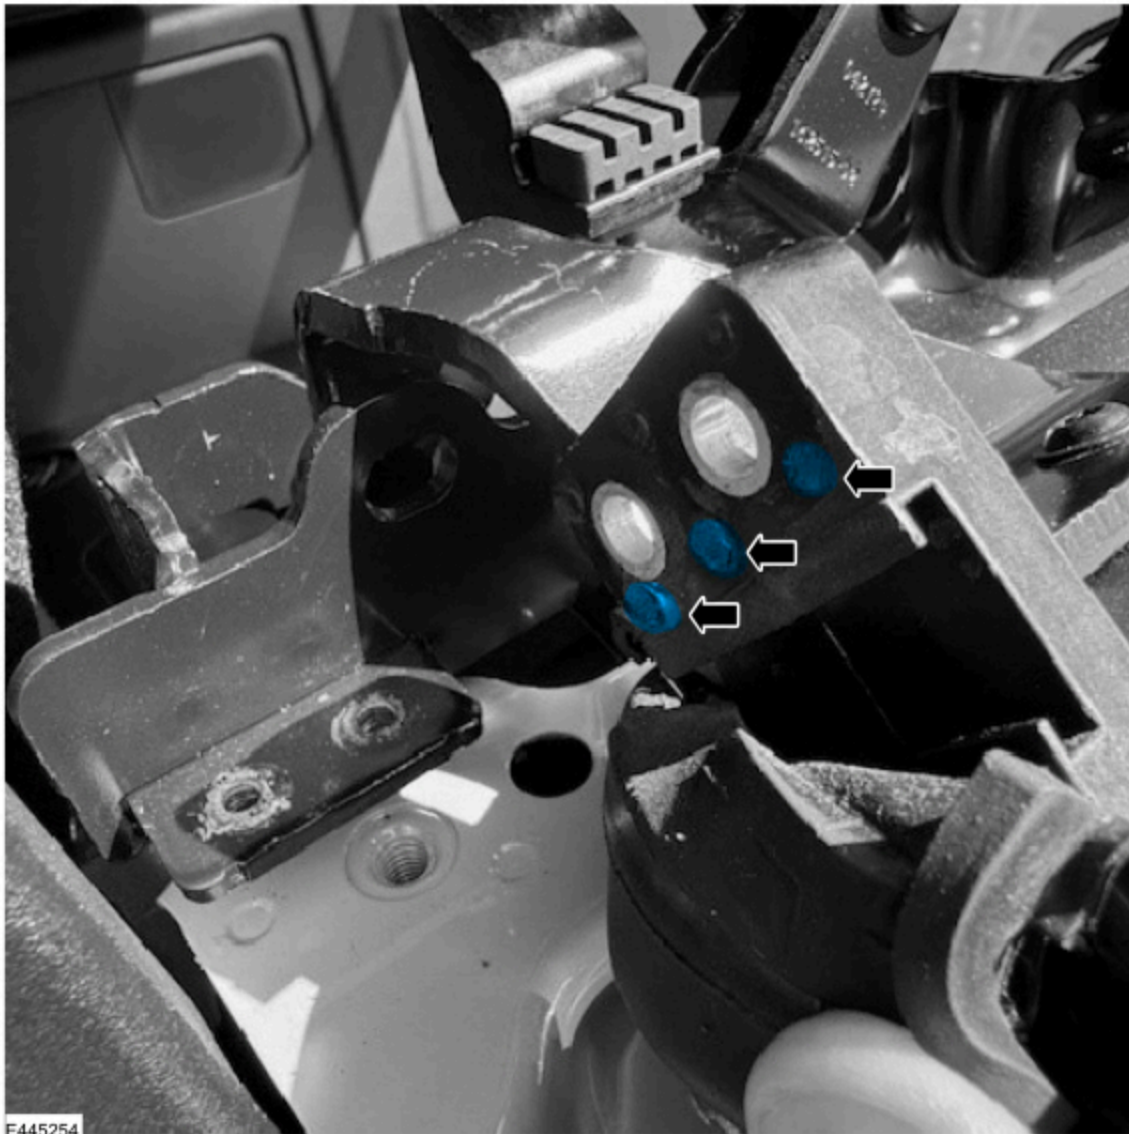
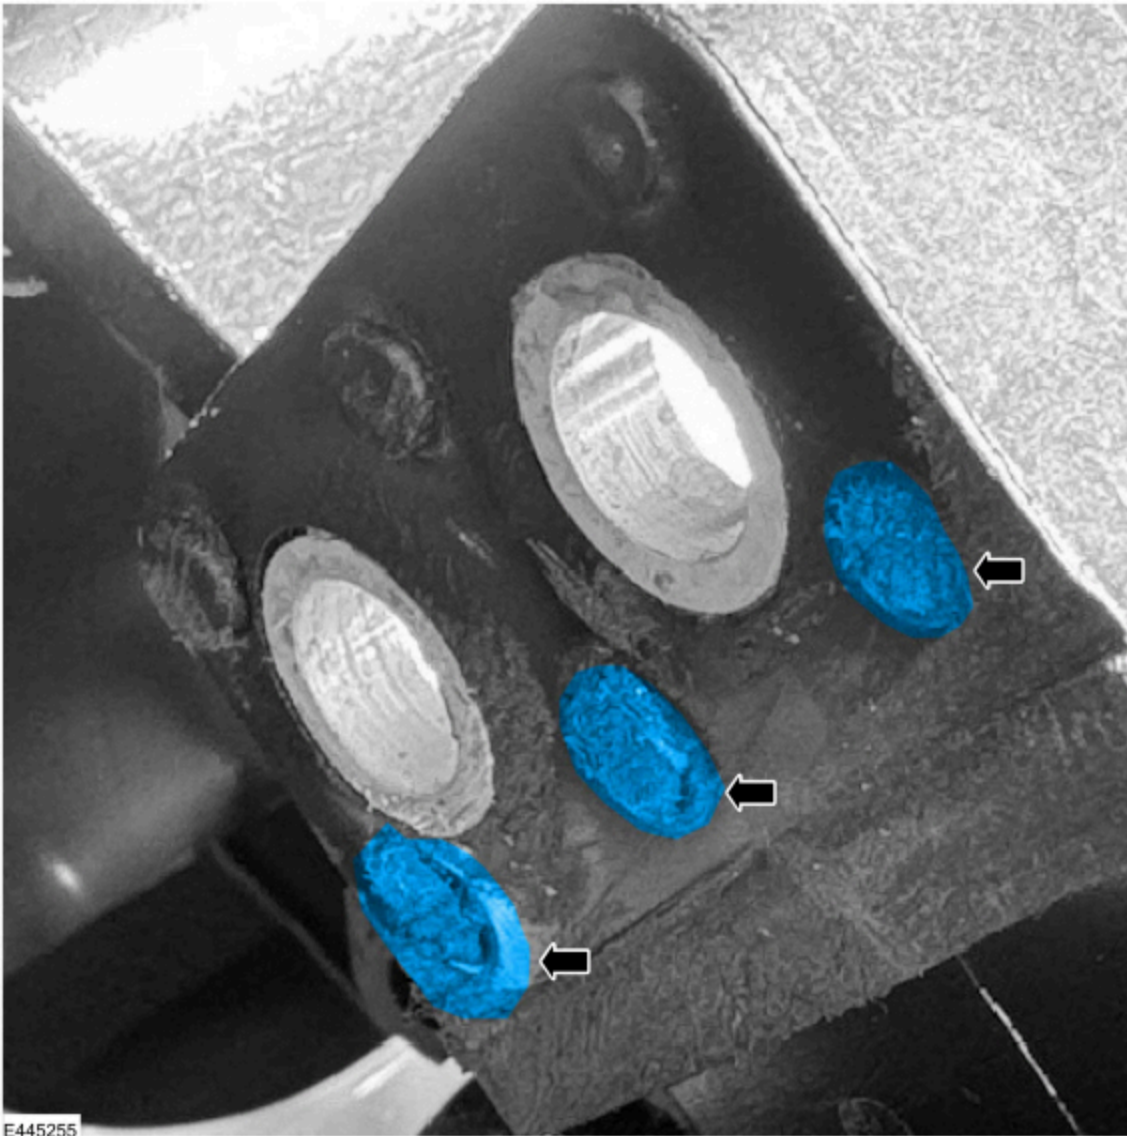
**Issue:** Some 2024 Bronco vehicles equipped with a factory soft top may experience a rear quarter window that is difficult to remove. This may be due to a misalignment between the window retaining channel. To correct the condition, follow the Service Procedure steps to file the bumps down on the window retaining channel.

6. Once the window retaining channel is loose, flip it upside down to expose the underside. Use a file to remove the 3 bumps shown in Figure 4 until the surface is smooth. Do not file the remaining 3 bumps at this time. (Figures 4-5)
