# Field campaign

| Topic | Bentley Bentayga - Replacement of front radars (SC24/17) |
| Campaign number | ED10 |

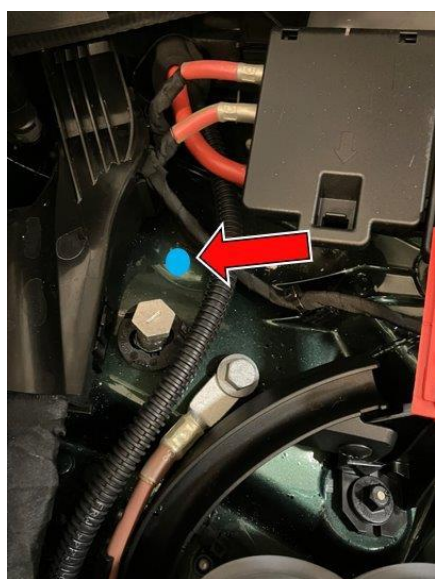
A blue paint mark by the negative jump start post confirms completion as shown in figure 1
