Technical product information

Topic	EPB Warning light in DIP - Front door/s power latch system intermittent - DTC U112300 within Address 03 and Address 46
Market area	Bentley: worldwide (2WBE),China 796 VW Import Comp. Ltd (Vico), Beijing (6796)
Brand	Bentley
Transaction No.	2075034/2
Level	EH
Status	Approval
Release date

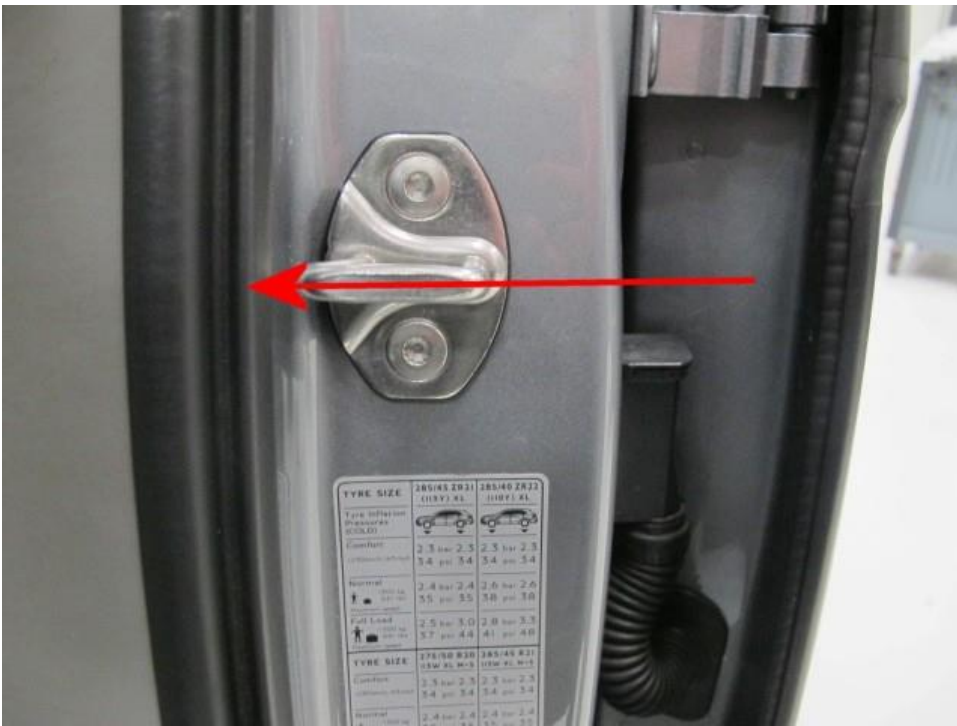
Figure 2

The micro switch signal of the door lock is not recognised or is recognised briefly, a counter press of the door by the operative is required to clearly recognise the signal

Insufficient back pressure of door (door closing loads / seal load) results in the pawl microswitch signal becoming too short. This short signal is then calculated as an error state by address 0003 -Brake electronics

In addition, adjust the striker as far as possible (at least 0.5 mm) further inwards (Figure 2)
