Aftersales Bulletin

A 10 2024 06 – 00 64 36 02 00 - Spectre RR25 – Service Action Air Conditioning Drain Replacement

This Technical Campaign Service Action affects Rolls-Royce Spectre (RR25) vehicles built from March 31, 2023, and August 21, 2024.

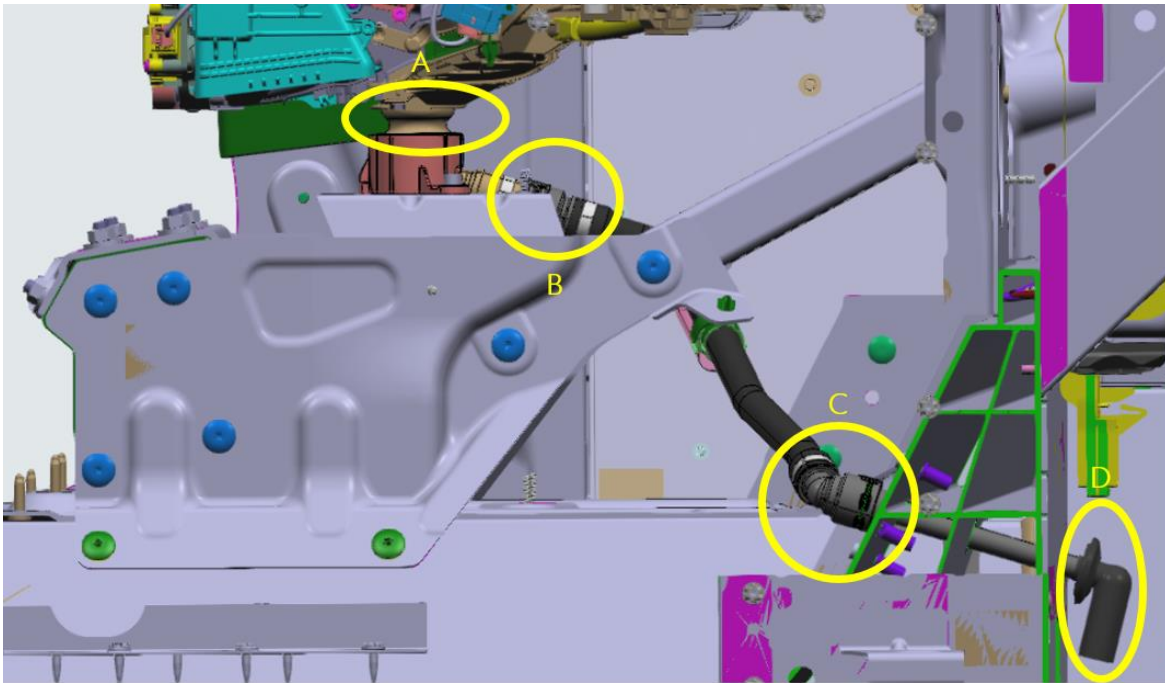
The affected Rolls-Royce Spectre (RR25) vehicles which have been identified as having a potential issue concerning the Air Conditioning (A/C) drain system, leading to the possibility of water condensation leaking into the cabin.

The technical campaign involves checking the A/C connections (see below diagram) and replacing a connection pipe with an improved part. To prevent any mold forming, it is very important all areas in the cabin are completely dry.

1. Replace the condensate pipe P/N 5B67EC6 “Connections B & C” reference the picture above, following Repair Instruction – 64 11 295 | REP-REP-P-6411295-RR25E up to Action 44. Continue with the other checks before rebuilding the vehicle.
2. Check A/C drain connection “A” is fitted correctly. See the below photos for “OK” and “NOK” conditions. Adjust if required.
