Technical product information

Topic	Continental GT / C and New Flying Spur - Outer dashboard speaker grille lifted / Incorrect flushness
Market area	Australia E04 Bentley rest Asia and Australia (6E04),China 796 VW Import Comp. Ltd (Vico), Beijing (6796),Germany E02 Bentley rest Europe (6E02),Japan E03 Bentley Japan (6E03),Korea, (South) E08 Bentley South Korea (6E08),United Arab Emirates E06 Bentley Middle East and Africa (6E06),United Kingdom E01 Bentley UK (6E01),United States E05 Bentley USA and rest America (6E05)
Brand	Bentley
Transaction No.	2073973/2
Level	EH
Status	Approval
Release date

Continental GT - GTC and New Flying Spur

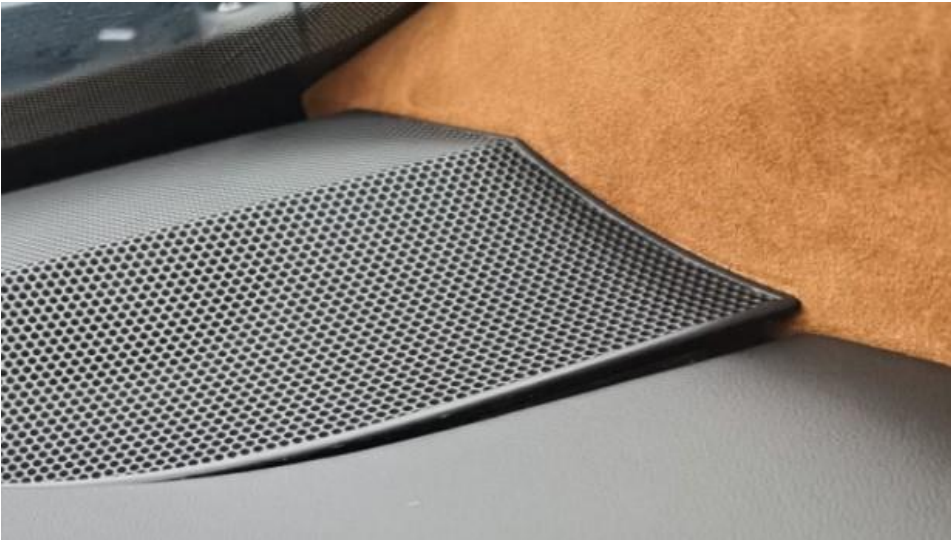
Figure 1

Outer demister panel (speaker grille) lifted / Incorrect flushness (Figure 1)

- In the event the issue is as described please refer to the Measure section
