Technical product information

Topic	Engine overheating - Warning in the DIP (V8 Kovomo)
Market area	Bentley: worldwide (2WBE),China 723 Volkswagen (Anhui) Automotive CO (6723),China 796 VW Import Comp. Ltd (Vico), Beijing (6796)
Brand	Bentley
Transaction No.	2061369/8
Level	EH
Status	Approval
Release date

Bentayga Series - New Continental GT/C - New Flying Spur

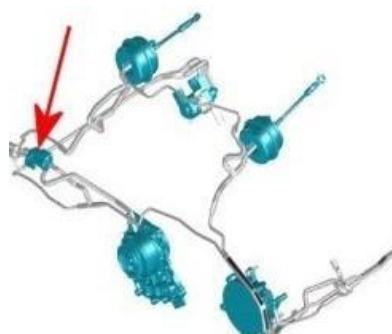
Figure 1

To allow the engine coolant to heat as quickly as possible (from cold start) coolant delivery from the mechanical coolant pump is interrupted by switch valve N649

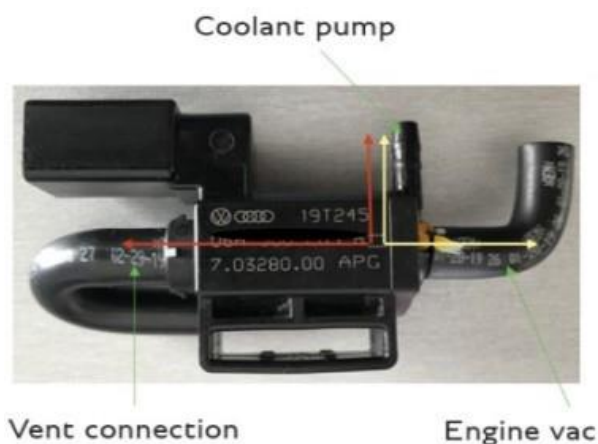
Figure 3

The correct operation of N649 (Figure 3) is as follows

Un-energised state (Ignition off) - Coolant pump connected to vent connection (red arrows)

Energised state (Ignition on) - Engine vacuum connection to coolant pump (yellow arrows)
