# Technical Service Bulletin

<b>Subject:</b>  <b>POWER LIFTGATE MAY OPEN UNINTENTIONALLY WHILE VEHICLE IS PARKED/STOPPED</b>	<b>Bulletin No.: 09-022/24</b>
	<b>Last Issued : 10/11/2024</b>

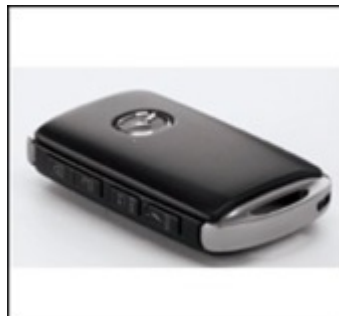
7th Generation Transmitter

Due to the shape of the 7th generation remote transmitter, the power liftgate button may be long pressed unintentionally in a pocket or a bag. To eliminate this concern, the keyless control specification has been modified. The button press time has been increased from 0.5 seconds to 1 second.

1. Verify the concern.
2. Replace the start stop unit according to the instructions on MGSS:
  - CX-5: START STOP UNIT REMOVAL/INSTALLATION
  - CX-9: START STOP UNIT REMOVAL/INSTALLATION
3. Verify the repair.

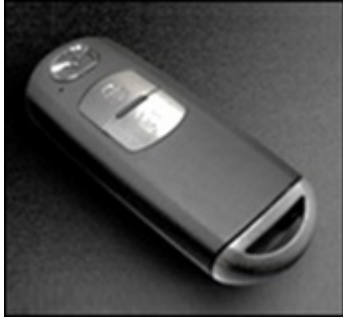
6th Generation Transmitter

**CAUTION:** Vehicles with 6th generation remote transmitter do NOT apply to this Service Information.
