Technical Service Bulletin

Subject: REAR CONSOLE LID STICKING AND SQUEAKING WHEN OPENING AND/OR CLOSING	Bulletin No.: 09-043/24
	Last Issued : 10/02/2024

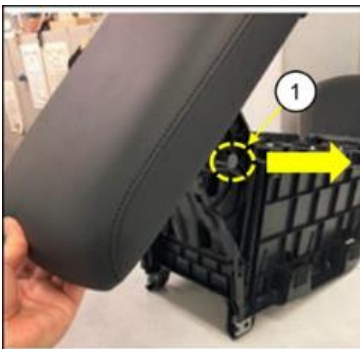
Some vehicles may exhibit a rear console lid with a sticking feeling or a squeaking noise when opening and/or closing. This is caused by an inappropriate shape of the console lid hinge pin where the position of the hinge pin (1) becomes misaligned when the rear console lid is repeatedly opened and closed. When parts around the hinge pin thermally expand, the result creates a gap in the hinge of the rear console lid.

7. Remove the hinge pin (1) by pulling the pin in the direction of the arrow.

- Push the pin from the left side of the console lid toward the console lid with a screwdriver so that the head of the pin sticks out. Use the screwdriver to keep the spring in place while removing the old pin and installing the new pin.
- By opening the console lid about halfway, the tension of the spring is reduced and the hinge pin can be easily pulled out.
- Wiggling the spring a little will help the pin move in and out easier.
