Subject: RATTLE NOISE FROM REAR END OF PANORAMA SUNROOF WHILE DRIVING	Bulletin No.: 09-045/24
	Last Issued : 10/15/2024

APPLICABLE MODEL(S)/VINS

2024 CX-90 (with Panorama Sunroof) with VINS lower than JM3KK*****176818 (produced before May 18, 2024)

2025 CX-70 (with Panorama Sunroof) with VINS lower than JM3KJ*****110175 (produced before May 18, 2024)

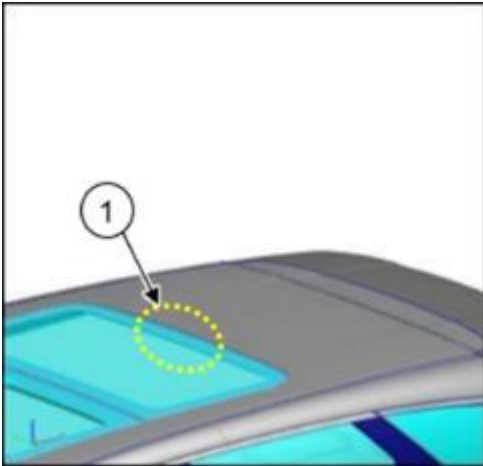
Some vehicles may exhibit a rattle noise from the rear end of the rear glass panel on the panorama sunroof. This may be caused by body vibration while driving and slight gaps (1) between the fastener mounting to the headliner and the sunroof frame. To eliminate this concern, the fastener has been modified to restrain the rattling.
