# Technical Service Bulletin

Mazda North American Operations  
Irvine, CA 92618-2922

<b>Subject:</b>  STAINS FOUND ON PAINT DURING PDI	<b>Bulletin No.:</b> 09-046/24
	<b>Last Issued :</b> 10/24/2024

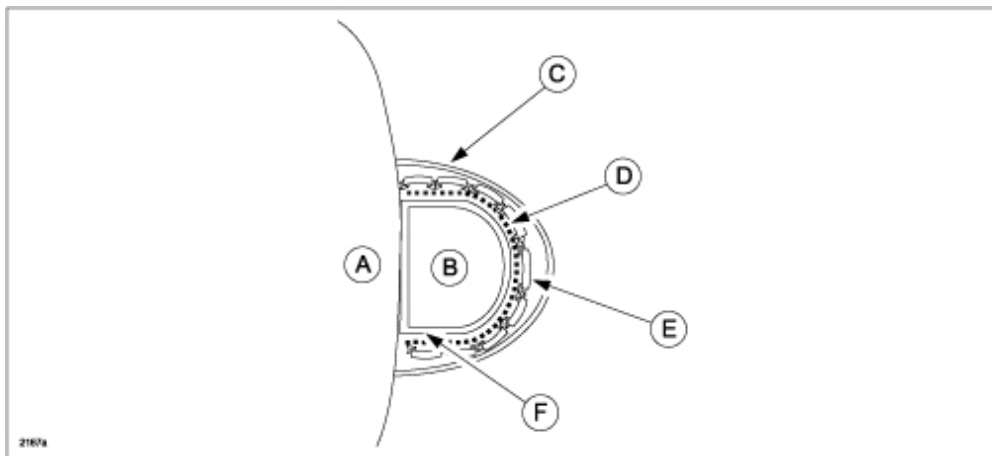
A - Body Panel

B - Molding

C - Aluminum foil covering all area

D - Wet towel

E - Folded aluminum foil

F - Aluminum foil tape

2. Insulate all plastic and rubber parts (as shown below) using heat insulation materials (C ~ F) prior to beginning the application of heat.

- Since this repair procedure requires the use of heat from a heat gun or infrared drier, be sure to insulate all rubber or plastic parts which are easily affected by heat from near the affected stain area.
- Use extreme care to ensure the top coat surface temperature stays below 284°F (140°C).
- To protect materials inside the cabin area (i.e. carpet, seats, etc.), also place insulation over the glass as necessary.
