Subject: MULTIPLE WARNING LIGHTS ON, VEHICLE ONLY STARTS WITH KEY TRANSMITTER NEAR START BUTTON DUE TO POOR CONTACT AT FUSE F1	Service Alert No.: SA-040/24
	Last Issued : 10/16/2024

2024-2025 CX-90
2025 CX-70

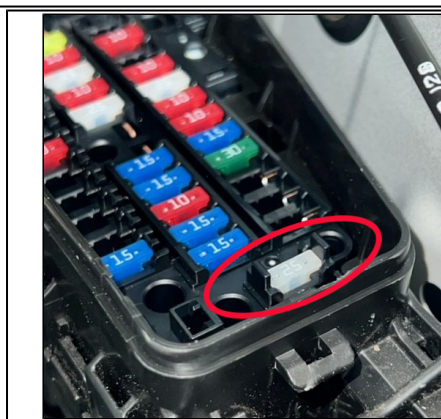
Good

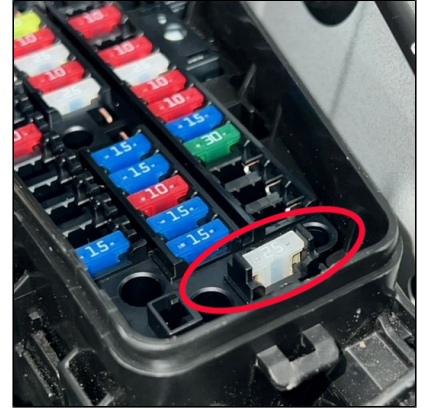
This may be caused by Fuse F1 not fully seated (poor terminal tension) or a poor ground connection at the front harness connector G03.

No Good (not secured)

NOTE: The F1 25A fuse is removed during transportation. The F1 25A fuse must be inserted completely before the vehicles are delivered to customers.

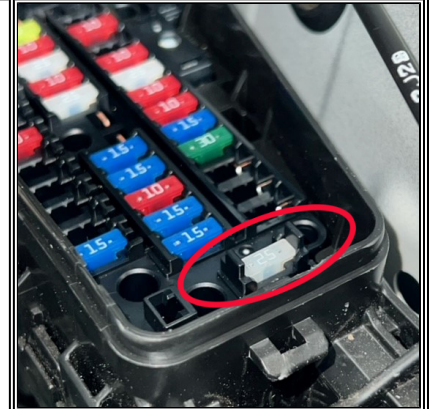
Good

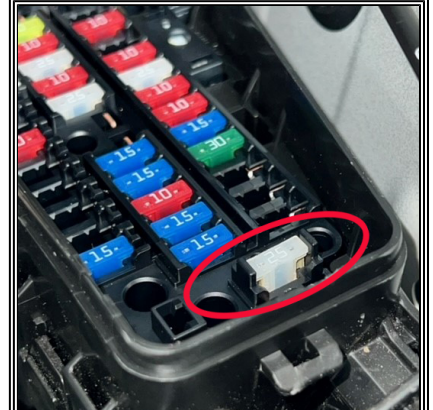
Is fuse F1 not fully seated or have poor terminal tension?

NOTE: The positioning rib may cause insufficient insertion.

No Good (not secured)

- **Yes** - Secure fuse F1
- **No** - This service information does not apply. Proceed to normal MGSS troubleshooting.

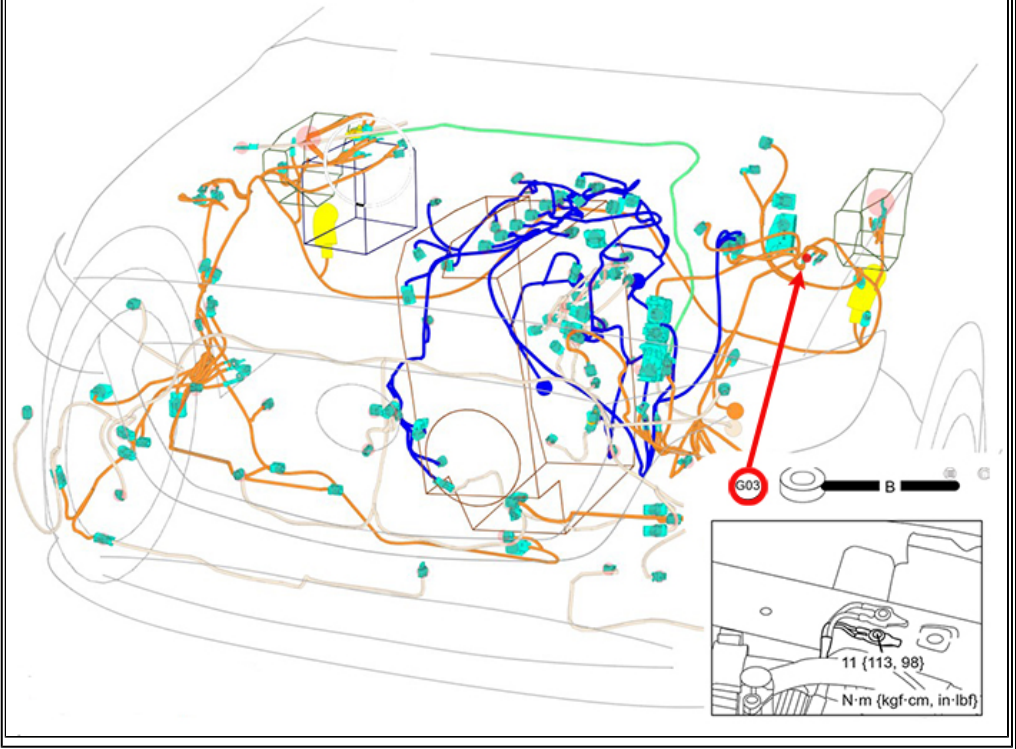
Is G03 ground connection loose?

- **Yes** - Secure G03 ground connection.
- **No** - This service information does not apply. Proceed to normal MGSS troubleshooting.
