Subject: HANDS-FREE LIFTGATE POOR PERFORMANCE AFTER TRAILER HITCH INSTALLATION	Service Alert No.: SA-069/24
	Last Issued : 10/15/2024

2025 CX-70 equipped with hands-free liftgate function and Mazda genuine trailer tow hitch

2024-2025 CX-90 equipped with hands-free liftgate function and Mazda genuine trailer tow hitch

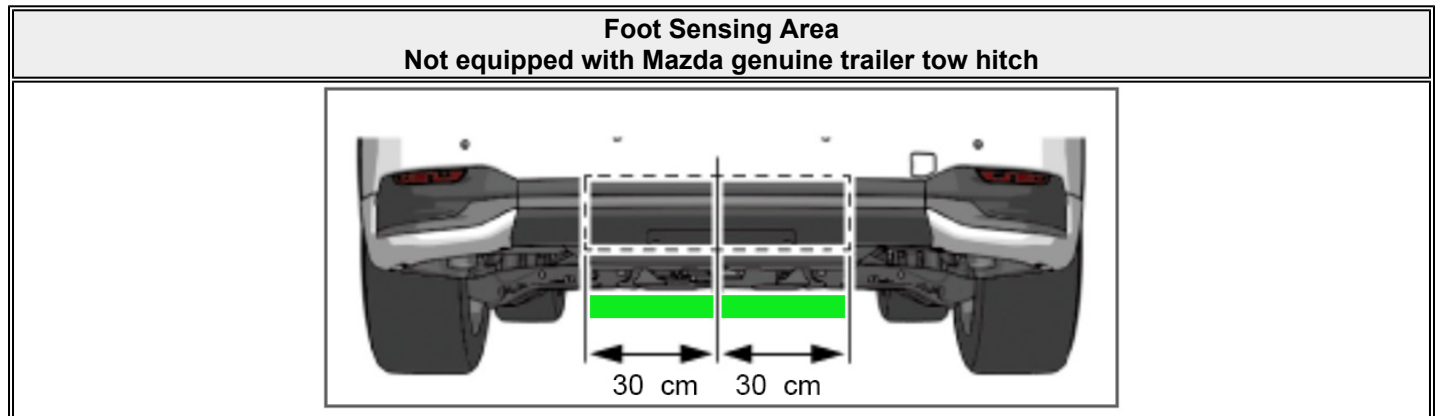
IMPORTANT: When a Mazda genuine trailer tow hitch is installed on a CX-90 equipped with hands-free liftgate function, the sensing area is reduced due to the mechanical structure of the hitch. The hands-free liftgate's optimal sensing area below the rear bumper is shown in green boxes in the image below. Since the left side of the hitch has a 7-pin connector socket, the right side is the most ideal for hands-free operation. For safety, be extra careful performing the kicking motion around the hitch.

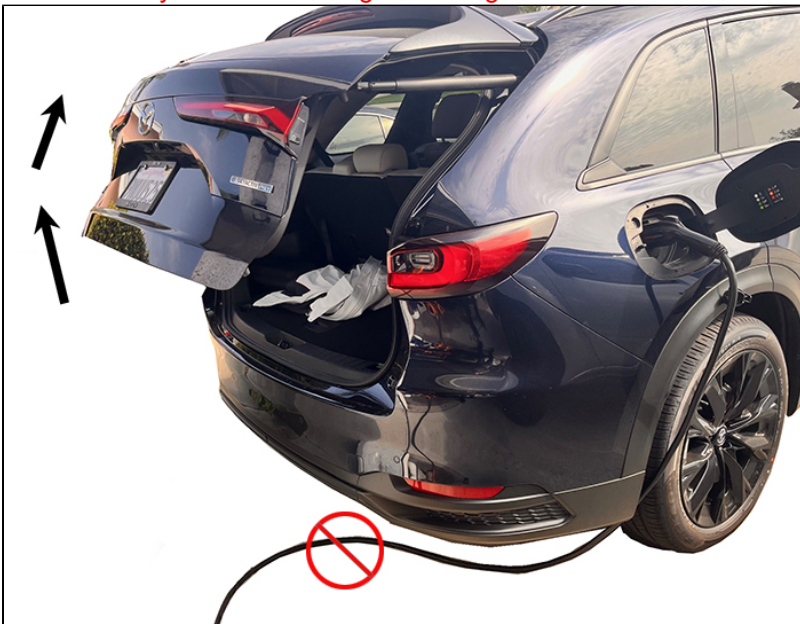
The PLG Hands-free sensor may detect the movement of the charging cord when charging, causing the liftgate to open unintentionally and a risk of liftgate damage.

NOTE: This is a normal operation of the PLG sensor, not a system malfunction

CAUTION (PHEV Model Charging): DO NOT place the charging cord at the bottom of the rear of the vehicle and DO NOT let the cable hang around at the rear of the vehicle.
