Subject: DOOR BELTLINE MOLDING LOOSE OR FELL OFF	Service Alert No.: SA-075/24
	Last Issued : 10/16/2024

2023- 2025 CX-50

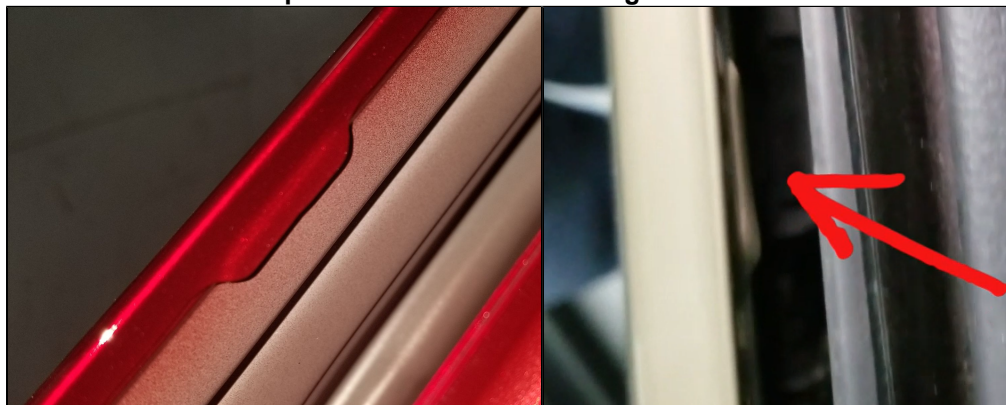
- If the tab is bent inward, the belt molding will not hold in place. When removed, the belt molding's internal clips can be damaged where it was properly held in place. DO NOT try to reuse it.
- If the tab is bent outward, the belt molding's internal clips can be damaged during the installation and it will not

hold in place. It must be replaced.

3. Use a hooked tool (e.g. a crochet hook) to straighten the bent tabs. The tabs may be bent in or out.

4. Replace all loose beltline moldings.
