<b>Subject:</b> <b>TRANSMISSION INITIAL LEARNING PROCEDURE / WARNING LIGHT ON OR FLASHING AFTER TRANSMISSION REPLACEMENT</b>	<b>Service Alert No.: SA-078/24</b>
	<b>Last Issued : 10/23/2024</b>

2025 CX-70 PHEV and H3T

2024-2025 CX-90 PHEV and H3T

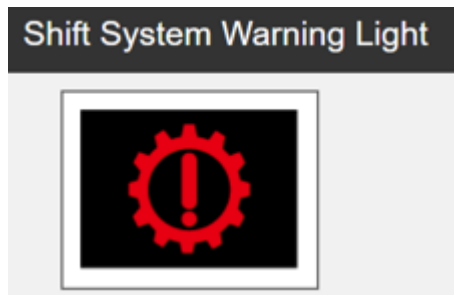
Some vehicles may experience a transmission warning light on or flashing in the instrument cluster with no DTCs after a full transmission replacement. This will affect the configuration or learning with MDARS.

Vehicles having this concern should be repaired using the following repair procedure.
