# McLaren 750s, McLaren GTS - Displacement Sensor Ball Stud Check

<b>Bulletin type:</b>	Service Campaign
<b>Reference number:</b>	N/A
<b>Campaign reference:</b>	SCB 00 B 002
<b>Attention:</b>	Retailer Aftersales Managers, Retailer Service Managers, Retailer Service Advisors, Retailer Technicians, Retailer Parts Managers
<b>Affected vehicles:</b>	McLaren 750S, McLaren GTS
<b>Situation:</b>	Check for correct position of the ball stud of the rear displacement sensor
<b>Procedure:</b>	Action affected vehicles during PDI or immediately available at the Retailer premises (including stock, demo and showroom vehicles). Please refer to the information outlined in this document to complete the required work
<b>Date:</b>	18 October 2024

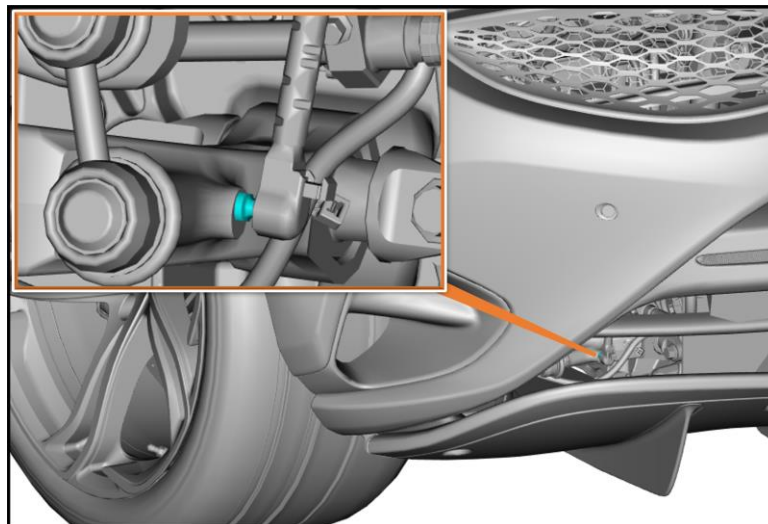
Through continuous product quality monitoring, McLaren Automotive has identified an inconsistency in fitment of the ball studs of the rear displacement sensors.

Image 1 Overview of the checking location of the ball stud

McLaren Automotive is instructing Retailers to check the fitment of the ball stud, re-torque if needed and report the results of all the vehicles within the supplied VIN range.

Torque the displacement sensor bull-stud. (6 Nm)
