# Side Markers Showing Signs of Condensation Misting

**Topic:** Repair method for vehicles showing signs of condensation or misting on the rear side markers

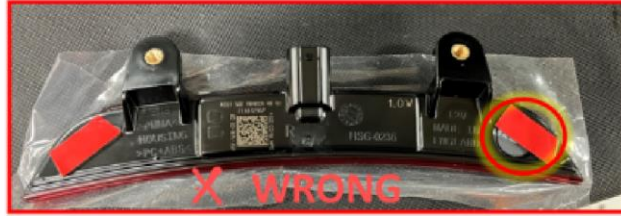
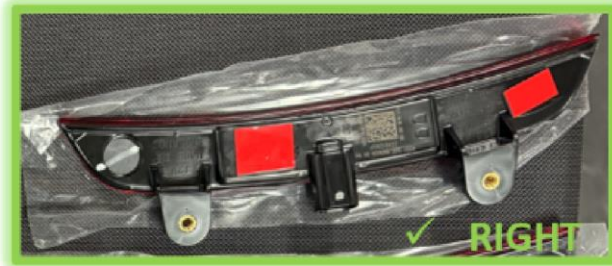
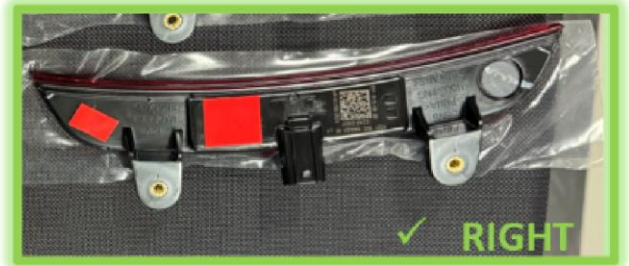
Current P16, P22 and P28 rear side markers have 2 pieces of tape on the back side, where one of them is covering a breather hole. If required, the work intent is to reposition one of the pieces of the tape to stop side markers from becoming foggy under any circumstances.

**Observation:** Do not proceed with side marker installation if breather hole (circled at the top image) is covered by the tape

Confirm if side-markers have 3M tape installed as per image below, correct the position of the tape if needed. Check that the
