S-Series™

2.0 Over The Air Programming (OTAP)

Bulletin Name: FDM-IB-006

Model: Oshkosh S-Series 2.0

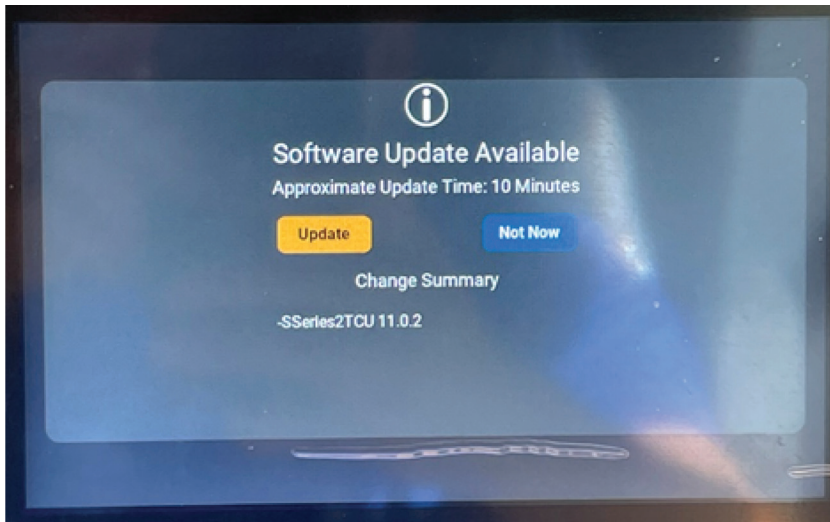
Figure 1 - Overhead Display

The overhead display will prompt operator when the update has successfully been downloaded to the truck. See Figure 1. Selecting Not Now button delays the installation of the update and returns the overhead display to the home screen. If delayed, the Software Update Available screen will prompt operator again at next ignition key cycle.

1. Select Update button when ready to install software update. See Figure 1.

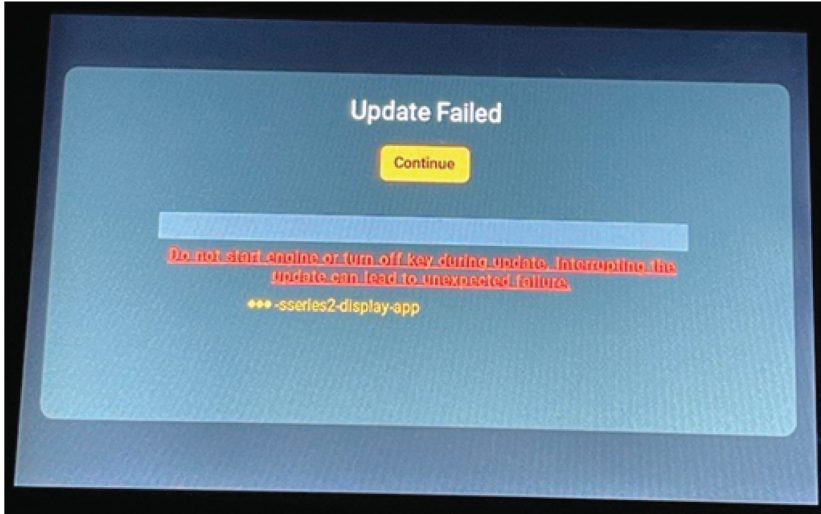
Figure 5 - Overhead Display

If installation of the update fails perform the following steps.

6. Turn vehicle battery disconnect switch OFF and let truck sit for 2 hours or until Telematics Control Unit (TCU) powers OFF.
7. Turn battery disconnect switch ON.
8. Turn vehicle ignition switch to ON position. The overhead display will prompt for the software update. If update screen does not appear contact service for more information.
9. Repeat Step 1 - 4 to install software update.
