**SERVICE BULLETIN**

**APPLICABILITY:** 2020-22MY Legacy and Outback Models      **NUMBER:** 15-261-20R  
**SUBJECT:** Reprogramming File Availability for Optimization of Gen 4 Denso CP1 Infotainment Systems      **DATE:** 03/10/20  
**REVISED:** 10/01/24

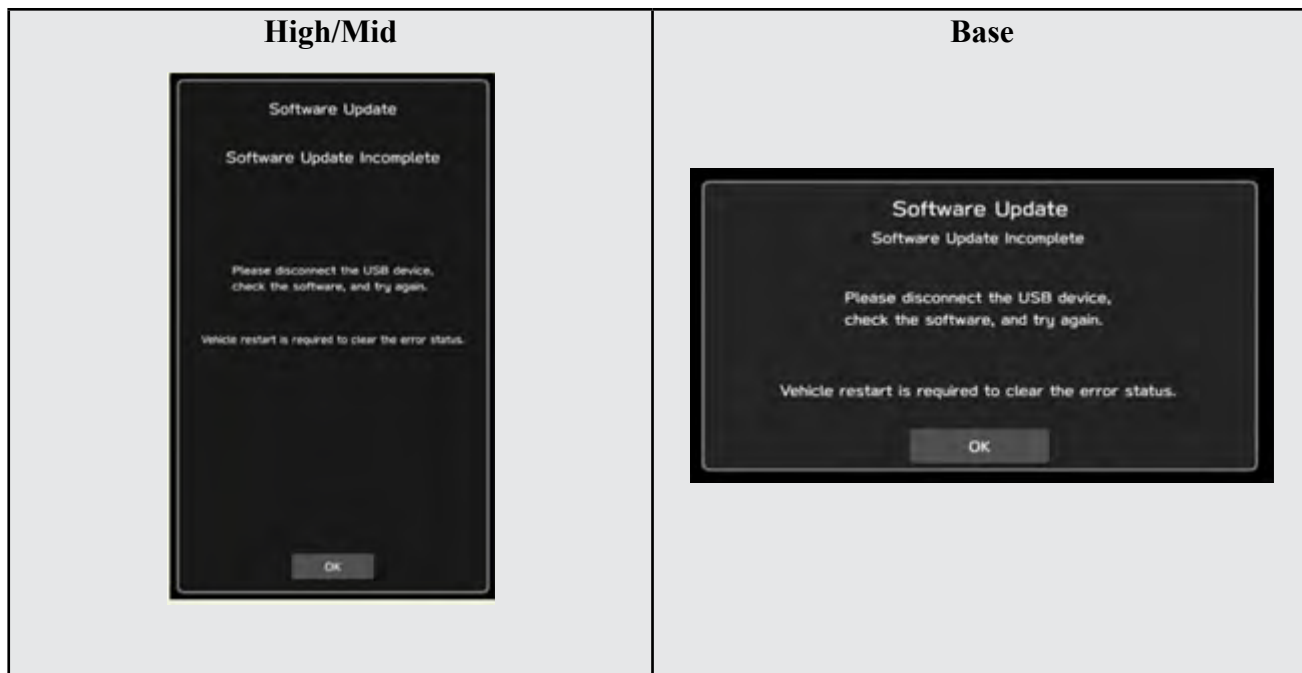
If you get the message Software Update Incomplete as shown below, please don't replace the hardware but retry updating the software according to the instructions in "Appendix B" on pg. 21.

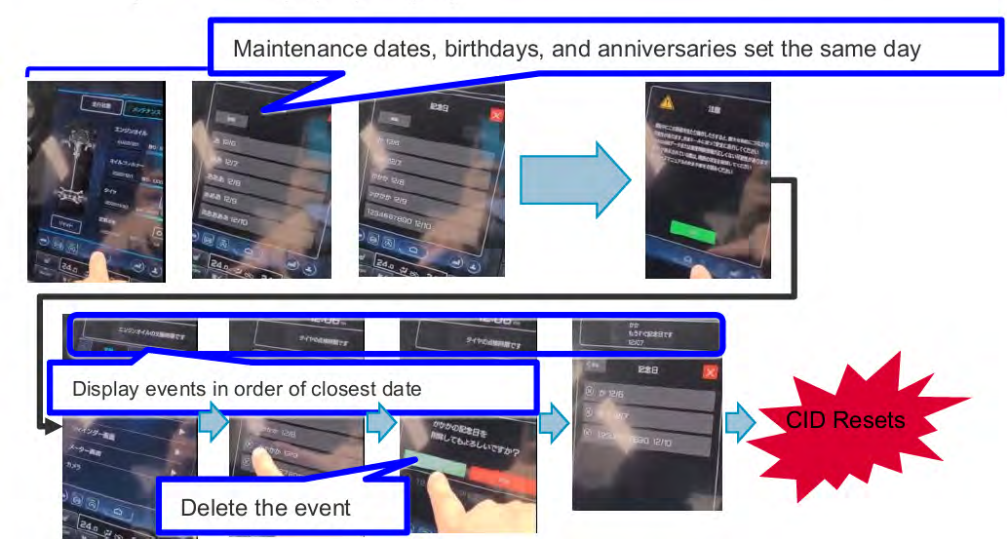
11	When the ignition is repeatedly turned ON/OFF in quick succession, CID screen resets right after startup.
12	After turning the ignition ON, the CID screen resets approximately after 6 minutes due to a communication issue within the CCU causing the radio tuner to become unresponsive.
13	Repeated and consecutive operation of voice recognition activation, CarPlay activation, and the HOME button operation cause the CarPlay screen to be black screen for several seconds.

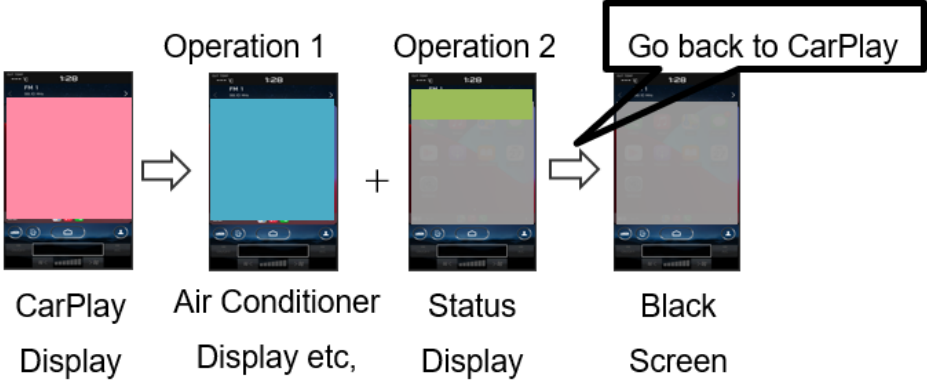
</div>
<p><b>15</b></p>	<p>After performing operations 1 and 2 below from the CarPlay screen, returning to the CarPlay screen causes the CarPlay screen to be black screen.</p> <p><b>Operation 1:</b> Switching to a pop-up screen such as the air conditioner screen</p> <p><b>Operation 2:</b> Interrupt pop-up screen display due to volume operation, etc.</p> <div style="text-align: center; margin-top: 20px;">

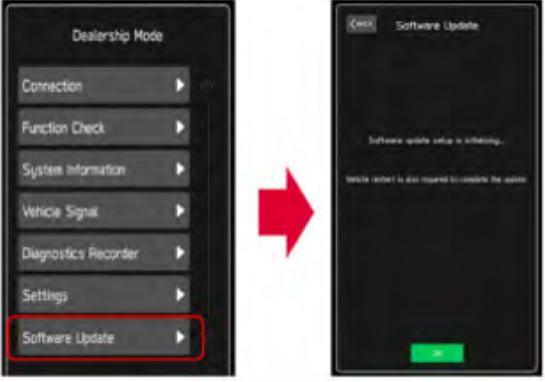
<p>Insert USB</p> <p>Tap OK</p> <p>Confirmation screen</p> <p>Error screen</p>
13	<p>When “Software Update” is selected in the Dealership Mode, the following initialization process does not end more than 20 minutes. *</p>

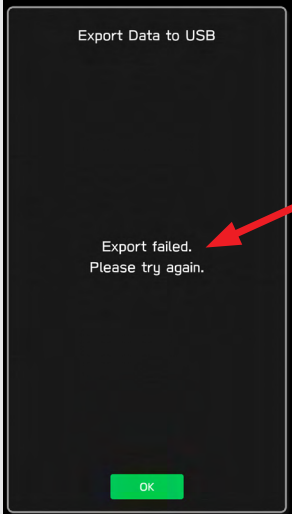
4	<p>Diagnostics Recorder Data cannot be exported to the USB memory device. When the diagnostic log data is being downloaded (by selecting: Dealership Menu &gt; Diagnostics Recorder &gt; Export Data to USB), it fails after the progress bar reaches almost 90% with an error message of Export failed. Please try again.</p>
