SERVICE BULLETIN

APPLICABILITY: 2022-24MY BRZ Models **NUMBER:** 15-297-22R
SUBJECT: Reprogramming File Availability for Optimization of Gen 4 Denso CP1 Infotainment Systems **DATE:** 07/01/22
REVISED: 10/02/24

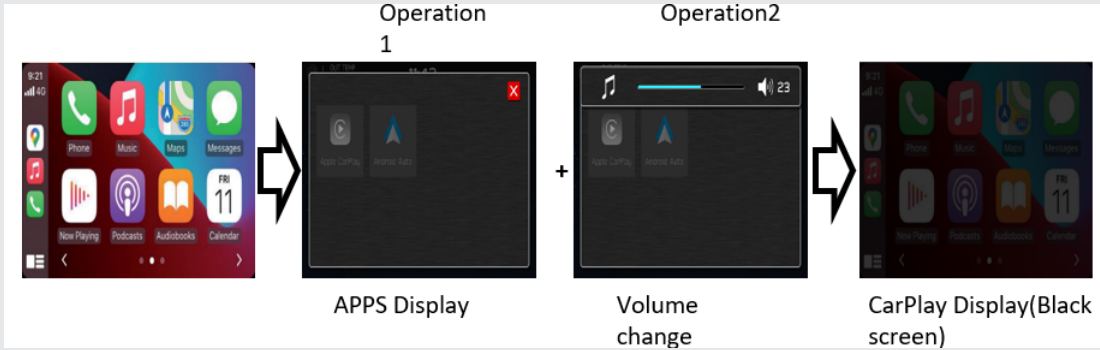
Category	Symptom
Black screen	While welcome animation on CID is displayed and the driver's door is left open, if turning ignition OFF/ON, the CID screen will be black screen.
	After starting the engine, the loading animation remains and the screen does not transition.
Display	Repeated and consecutive operation of voice recognition activation, CarPlay activation, and the HOME button operation may cause the CarPlay screen to be black screen for several seconds.
	After performing operations 1 and 2 below from the CarPlay screen, returning to the CarPlay screen may cause the CarPlay screen to be black screen. Operation 1: Switching to a pop-up screen such as the air conditioner screen Operation 2: Interrupt pop-up screen display by volume operation, etc.

<p style="text-align: center;">Operation 1 Operation 2</p> <p style="text-align: center;">APPS Display Volume change CarPlay Display (Black screen)</p>

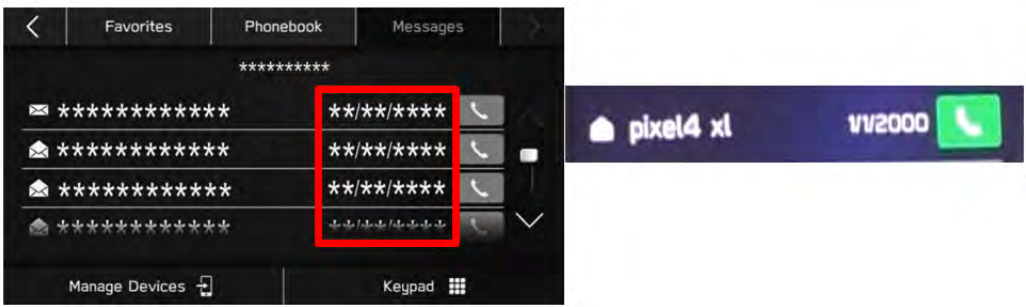
The date of receipt of a received message is displayed as 2000/1/1. This occurs on some models of phones with Android OS 13 or later.

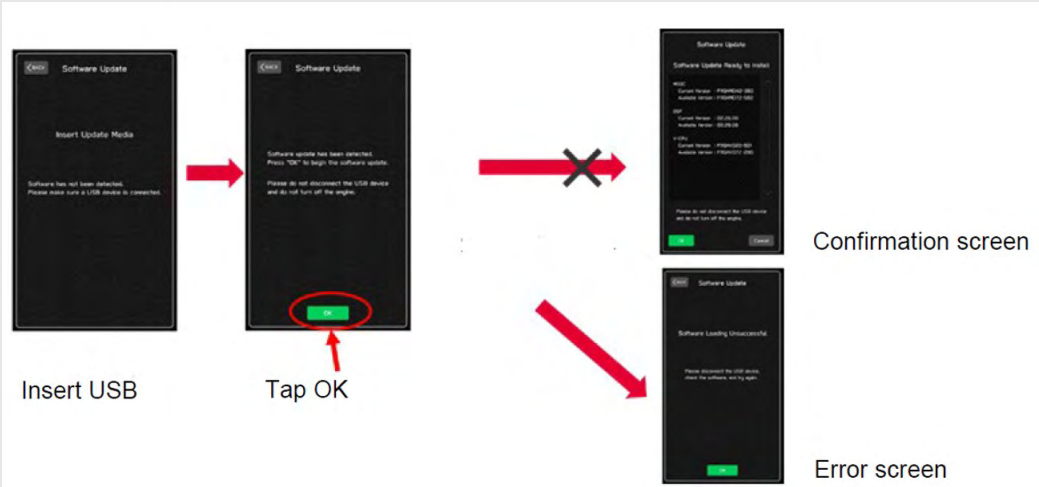
Number	Symptoms to be Improved:
<p>12</p>	<p>When conducting USB reprogramming, the screen transition to error screen instead of confirmation screen.</p>

<p>Insert USB</p> <p>Tap OK</p> <p>Confirmation screen</p> <p>Error screen</p>
<p>13</p>	<p>When “Software Update” is selected in the Dealership Mode, the following initialization process does not end more than 20 minutes. *</p>

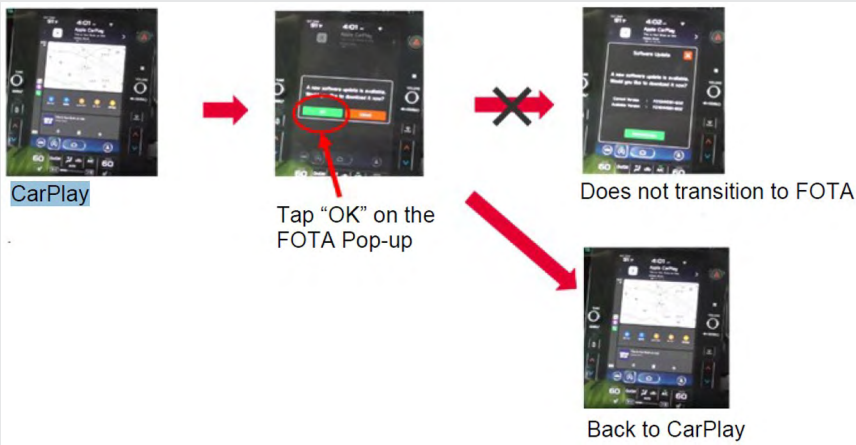
<p>Note* In case this USB update failure occurs, retry updating according to the instructions in “Appendix A ”</p>
<p>14</p>	<p>When the FOTA pop-up (new software availability notification) is displayed while the CarPlay is being used, the display comes back to CarPlay screen even if the customer tries to get into the FOTA screen.</p>

<p>CarPlay</p> <p>Tap “OK” on the FOTA Pop-up</p> <p>Does not transition to FOTA</p> <p>Back to CarPlay</p>

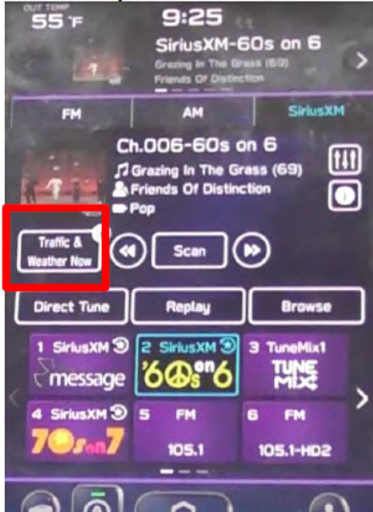
Number	Symptoms to be Improved:
25	<p>No response when touching “Traffic & Weather Now (TWN)” on SMX screen.</p>

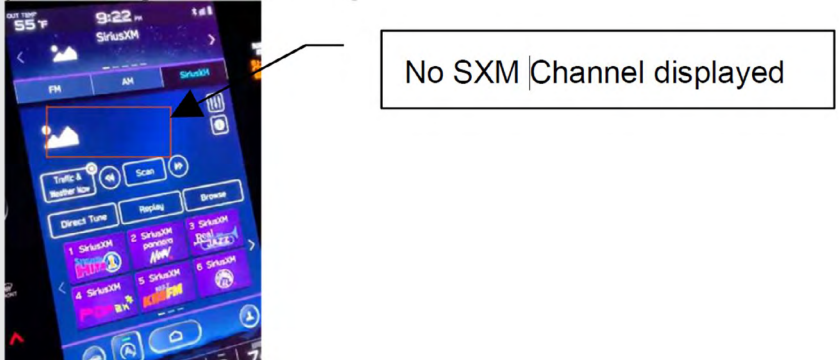
26	<p>SXM has blank screen and no sound when the SXM screen had been selected as audio source at the previous ignition off timing.</p>

<p>No SXM Channel displayed</p>
27	<p>About 30 seconds after starting the SXM the operation is paused with loading screen and resume after another 30 seconds. This symptom occurs when the SXM screen had been selected as audio source at the previous ignition off timing.</p>

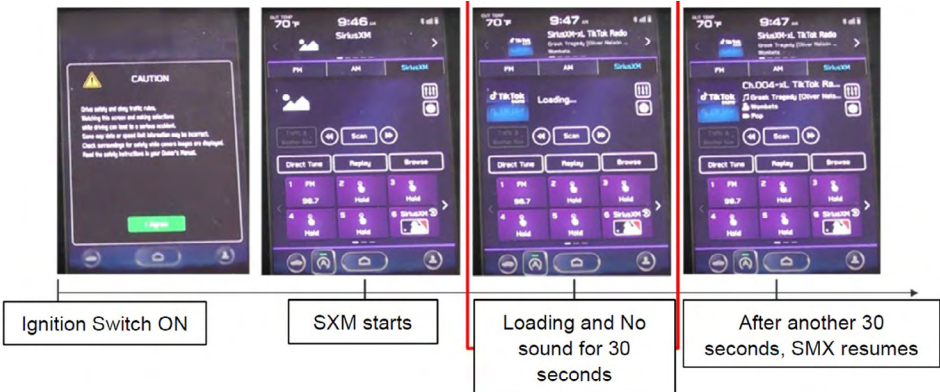
<p>Ignition Switch ON</p> <p>SXM starts</p> <p>Loading and No sound for 30 seconds</p> <p>After another 30 seconds, SXM resumes</p>
28	<p>SXM has blank screen and no sound when the audio source is change to SXM.</p>

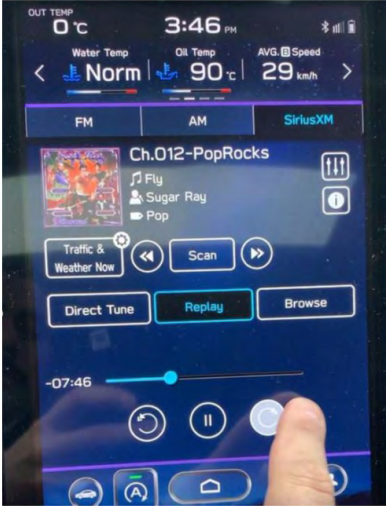
Number	Symptoms to be Improved:
29	<p>“Fast forward” does not work in SXM replay function. (Fast Rewind works.)</p>

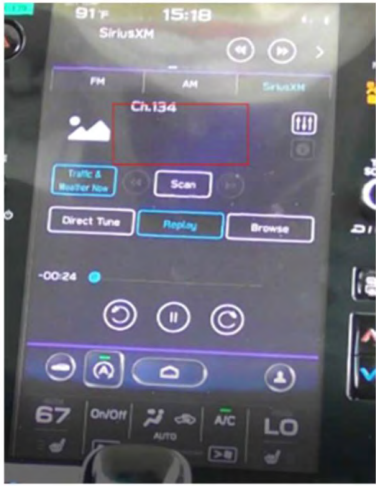
30	<p>The channel information becomes blank when the seek button (<< / >>) of the steering satellite switches is pressed continuously to control the Traffic & Weather Now (TWN) in SXM.</p>

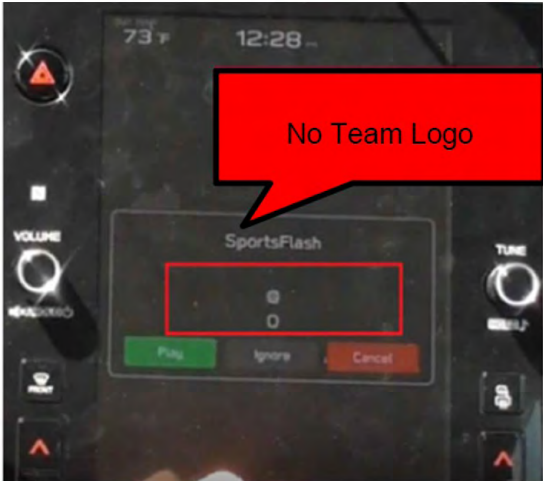
31	<p>The team logo is not displayed on Sports Flash screen when the SXM screen had been selected as audio source at the previous ignition off timing.</p>
