SERVICE BULLETIN

APPLICABILITY: 22-23MY WRX Models **NUMBER:** 15-301-22R
SUBJECT: Reprogramming File Availability for Optimization of Gen 4 Denso CP1 Infotainment Systems **DATE:** 09/09/22
REVISED: 10/02/24

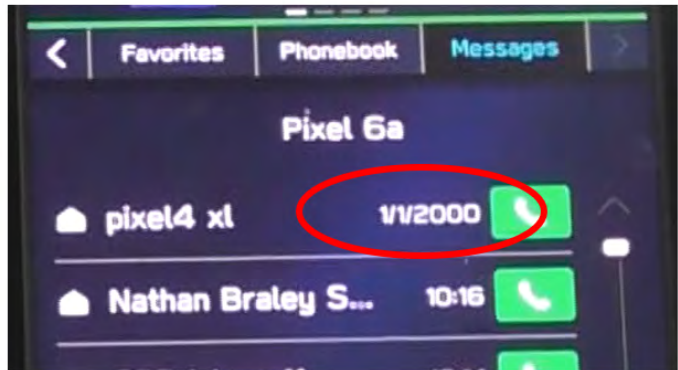
28	<p>The date of receipt of a received message is displayed as "2000/1/1."</p> <p>This occurs on some models of phones with Android OS 13 or later.</p>

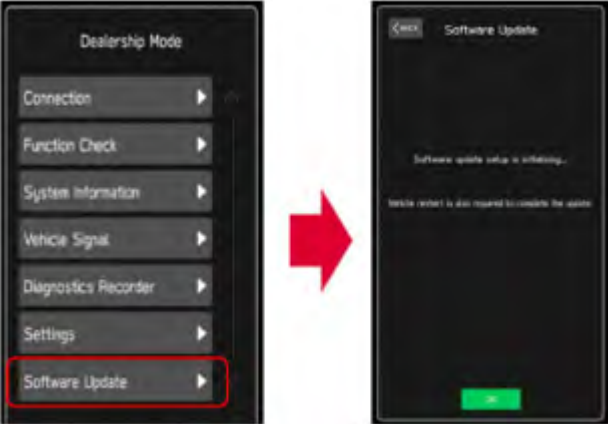
<p>Insert USB Tap OK Confirmation screen Error screen</p>
13	<p>When “Software Update” is selected in the Dealership Mode, the following initialization process does not end more than 20 minutes. *</p>

<p>Note* In case this USB update failure occurs, retry updating according to the instructions in “Appendix A”</p>
14	<p>When the FOTA pop-up (new software availability notification) is displayed while the CarPlay is being used, the display comes back to CarPlay screen even if the customer tries to get into the FOTA screen.</p>

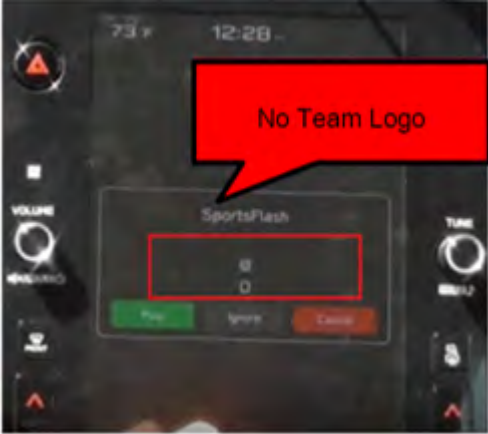
31	<p>The team logo is not displayed on Sports Flash screen when the SXM screen had been selected as audio source at the previous ignition off timing.</p>
