**SERVICE BULLETIN**

**APPLICABILITY:** 23-25MY Outback/Legacy Models (including Wilderness models)  
 23-24MY Ascent Models  
 24MY Impreza  
 24MY Crosstrek (including Wilderness models)  
 24MY WRX  
 25MY Forester

**NUMBER:** 15-305-22R  
**DATE:** 11/15/22  
**REVISED:** 10/02/24

**SUBJECT:** Reprogramming File Availability for Optimization of Gen 4.5 Denso CP1.5 Infotainment Systems

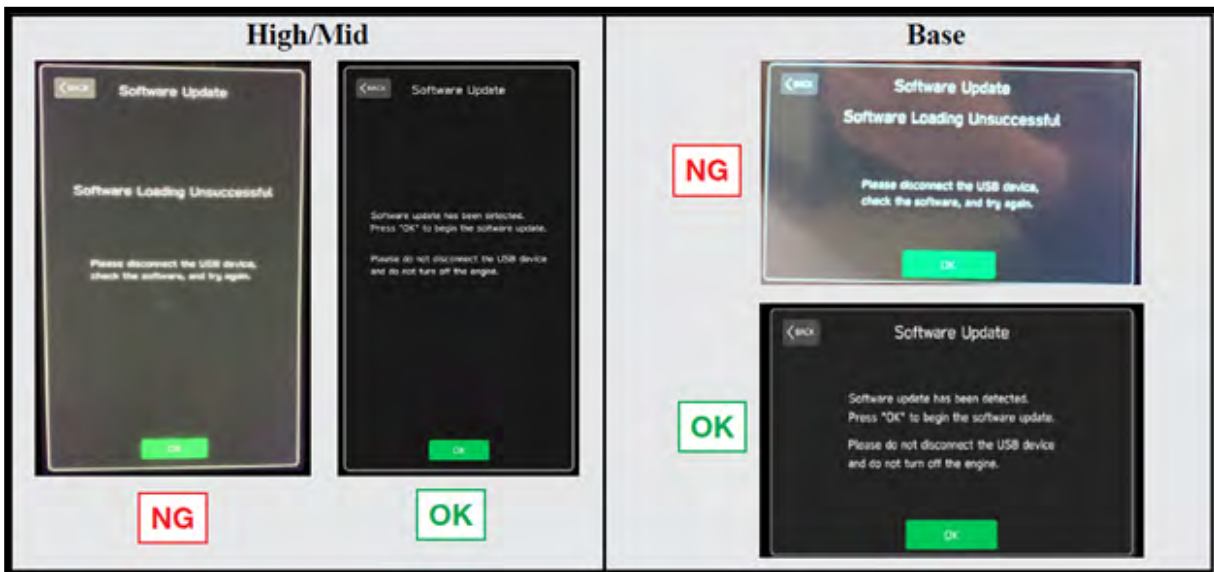
**NOTE:** If after plugging in the USB, the screen displays a **Software Loading Unsuccessful** message, confirm the USB device has been properly formatted and the software on the device matches the system being reprogrammed (example: Base software is being used to update a Base system) and retry.

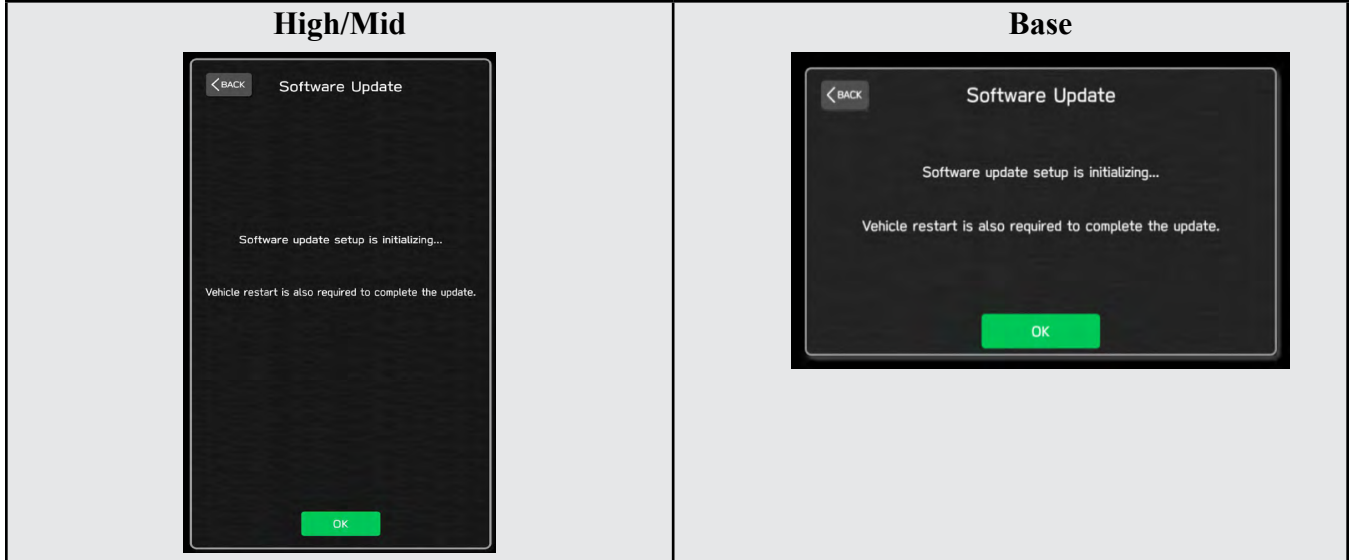
- If the screen shown below appears, **WAIT** for approximately 30 minutes or as long as necessary (waiting for longer than 60 minutes might indicate system malfunction). In that case please perform recovery according to the instructions in [Appendix 6 \(page 29\)](#) to allow the Software update setup initialization process to complete.
