SERVICE BULLETIN

APPLICABILITY: 2022-24MY BRZ

NUMBER: 09-128-24

SUBJECT: DTCs P2404, P0016-19, P0021, & U0100 Diagnostic Procedures

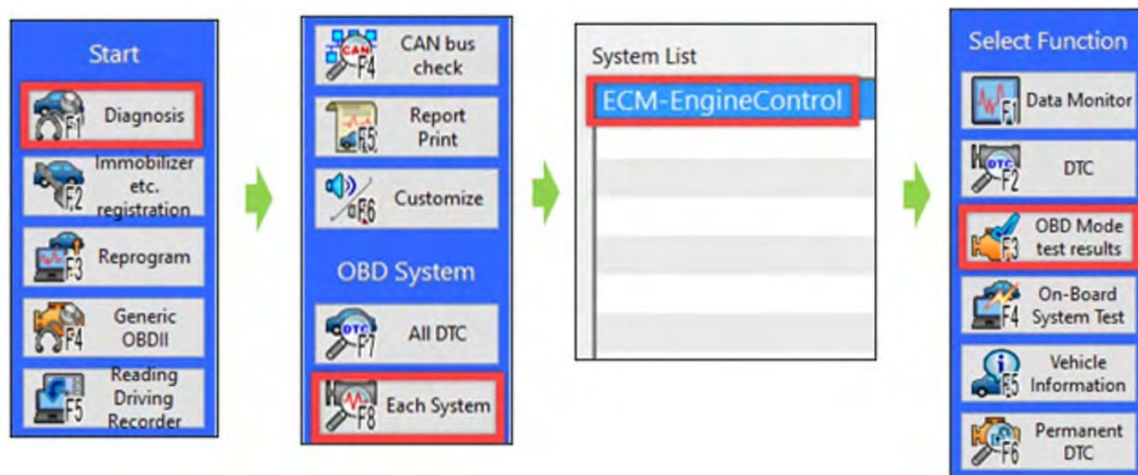
(*1) **IMPORTANT:** Use the following instructions to perform and read the OBD MODE test results. This procedure will be required when performing the diagnostic steps outlined below.

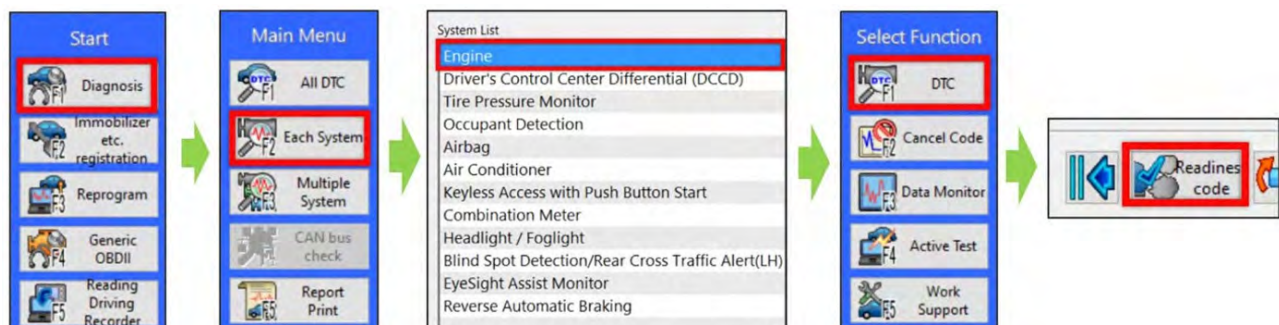
N. Using SSM, select Diagnosis > Each System > Engine > DTC > Readiness Code

- O. Read the readiness codes for P0016, P0017, P0018, P0019, P000A, P000B, P000C, and P000D. Confirm the self-diagnosis is complete and that the codes are not pending.

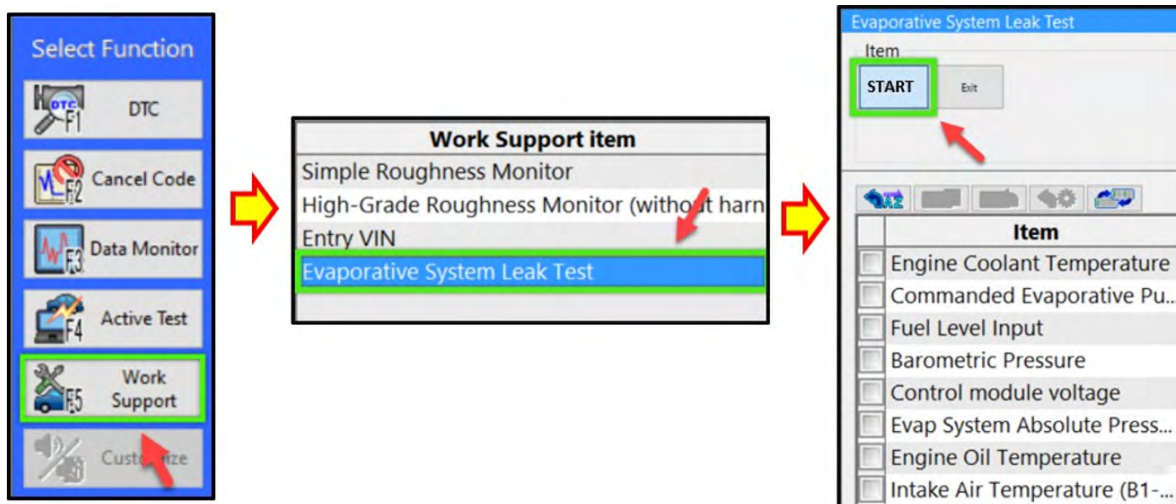
STEP 6: Connect the vehicle to a recommended power supply. See **APPENDIX A** for additional information regarding power supply. Using SSM, perform the Evaporative System Leak Test. Collect and save all data.

Once the evaporative system leak test is complete, check the DTCs and examine the vacuum value results. Record the value shown in the row labeled MID: \$3C, TID: \$C4, and Scaling ID: \$FE. This value should be lower than -0.26 PSI.

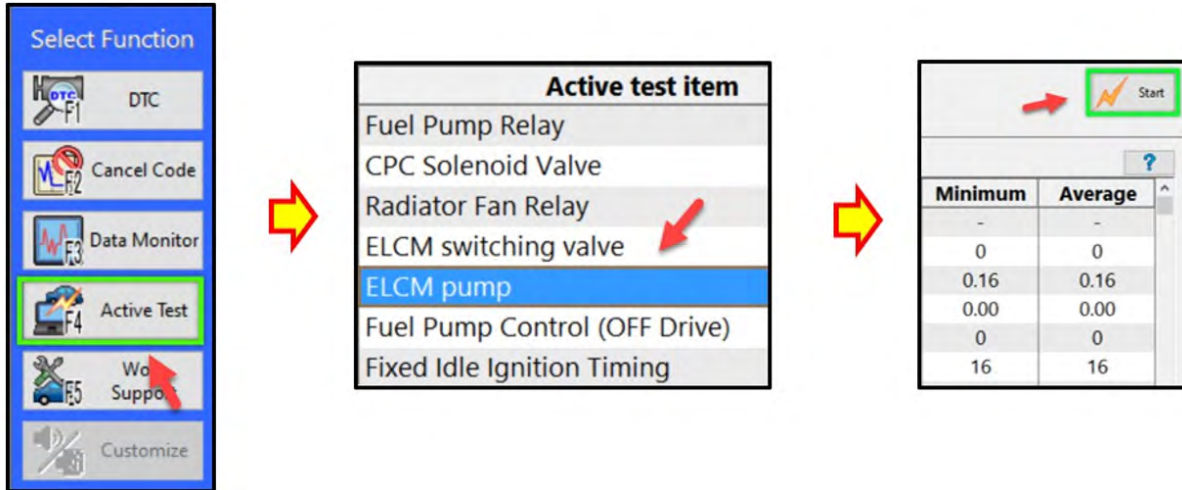
STEP 8: Using SSM, perform the ELCM Pump Active Test for a period of 35 minutes or more. See **APPENDIX A** for additional information regarding power supply.

Once the ELCM Pump Active Test has been performed for a period of 35 minutes or more, repeat the Evaporative System Leak Test outlined in STEP 6. Check the DTCs and the vacuum value results.

STEP 10: Replace the Evaporate Leak Check Module and repeat the Evaporative System Leak Test outlined in STEP 6. Check the DTCs and the vacuum value results.
