SERVICE BULLETIN

APPLICABILITY: 2020-2022MY Outback & Legacy
 2022-2023MY BRZ
 2022-2023MY WRX

NUMBER: 15-270-20R

SUBJECT: FOTA (Firmware Over-The-Air) Reprogramming for DENSO Gen 4 Audio / Navigation Infotainment Systems

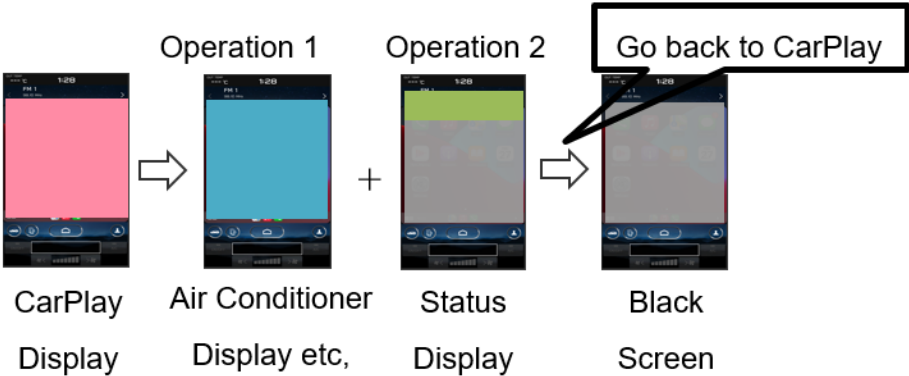
No.	Conditions/Symptoms to be improved
13	<p>After performing operations 1 and 2 below from the CarPlay screen, returning to the CarPlay screen causes the CarPlay screen to be black screen.</p> <p>Operation 1: Switching to a pop-up screen such as the air conditioner screen</p> <p>Operation 2: Interrupt pop-up screen display due to volume operation, etc.</p>

<p style="text-align: center;"> CarPlay Display Air Conditioner Display etc, Status Display Black Screen </p>
14	CarPlay does not activate if the cable is disconnected or inserted while using CarPlay and/or temporary contact failure occurs on the cable.
15	When an iPhone/iPod is connected via USB cable and connected as an iPod audio device instead of CarPlay, the CID screen resets when the music information is received. (This occurs when some of the music information data sent by the iPhone/iPod is missing.)
16	When using CarPlay, it suddenly disconnects and not reconnect even after unplugging and plugging the USB cable.

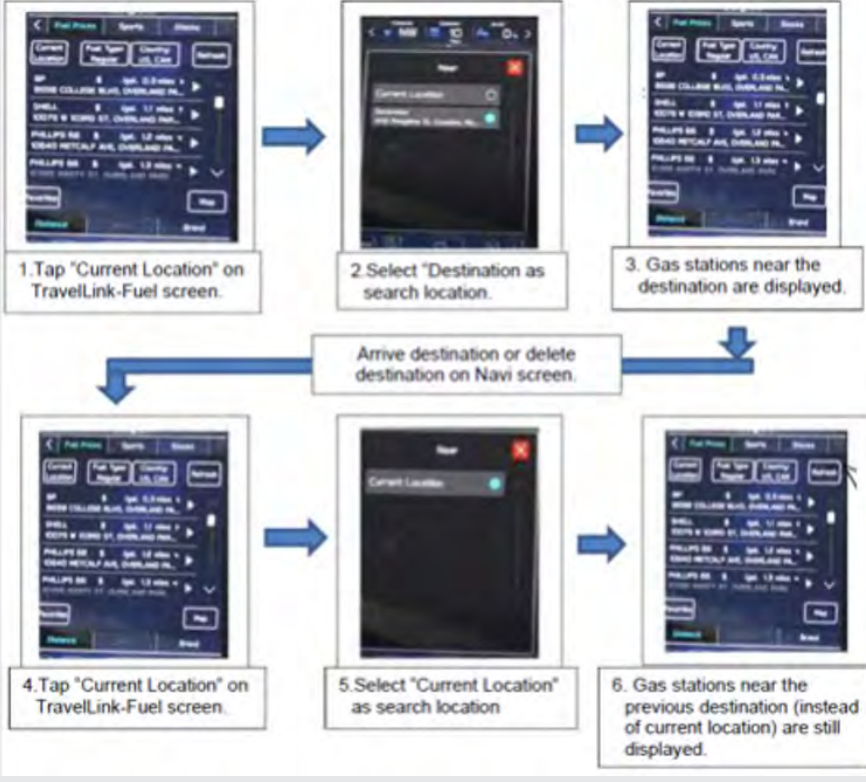
No.	Conditions/Symptoms to be improved
30	<p>A wrong search location is used on TravelLink function. Example of the symptom</p>

<p>1. Tap "Current Location" on TravelLink-Fuel screen.</p> <p>2. Select "Destination" as search location.</p> <p>3. Gas stations near the destination are displayed.</p> <p>Arrive destination or delete destination on Navi screen.</p> <p>4. Tap "Current Location" on TravelLink-Fuel screen.</p> <p>5. Select "Current Location" as search location</p> <p>6. Gas stations near the previous destination (instead of current location) are still displayed.</p>

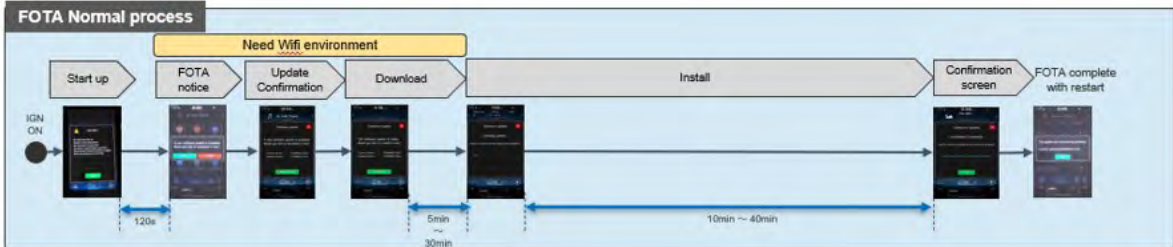
No.	Conditions/Symptoms to be improved
1	<p>System restarts itself during FOTA (Firmware Over The Air) update. FOTA operation is conducted in two processes: downloading (from the server to the Cockpit Control Unit via Wi-Fi) and installation (inside the Cockpit Control Unit). During the FOTA operation, after the new software has been downloaded to the Cockpit Control Unit (CCU) customer is to push “Install Now” on the Center Information Display (CID) to start installation of the software.</p>

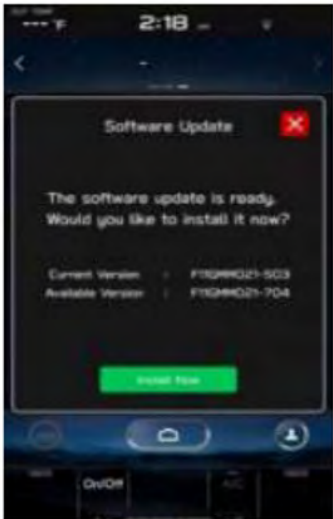
<p>Note*) Even if this symptom occurs, after approximately 2 minutes, the system resumes, and the CID comes back to the below screen. Customer can then push the “Install Now” to proceed with the installation.</p>

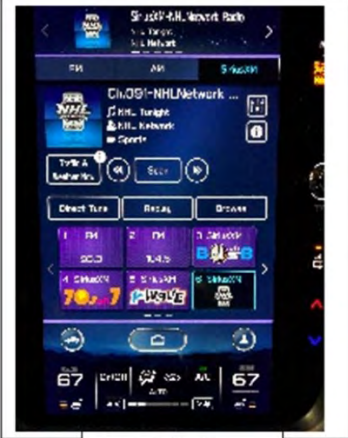
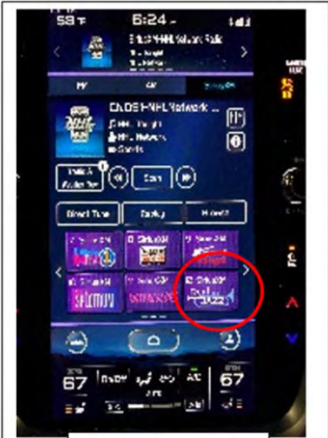
No.	Conditions/Symptoms to be improved
36	<Home> cannot be selected
37	Radio station moves unexpectedly due to momentary flick or brush of the touch screen
38	Temperature setting cannot be controlled by Voice Recognition in Canadian (C*) specification
39	Preset outline is not shown following station selection using steering switch <div style="display: flex; justify-content: space-around; align-items: center;">

</div> <div style="display: flex; justify-content: space-around; margin-top: 5px;"> Correct display Incorrect display </div>
40	When restart Engine, while downloading map data through Wi-Fi, <Major Update>and/or <Up to Date> button is not displayed
41	If destination set by voice recognition, after restart Engine, Navigation screen not displayed
42	Steering switch button doesn't work to select preset station or control music playback
43	Preset station isn't selected on the screen, when using steering switch button

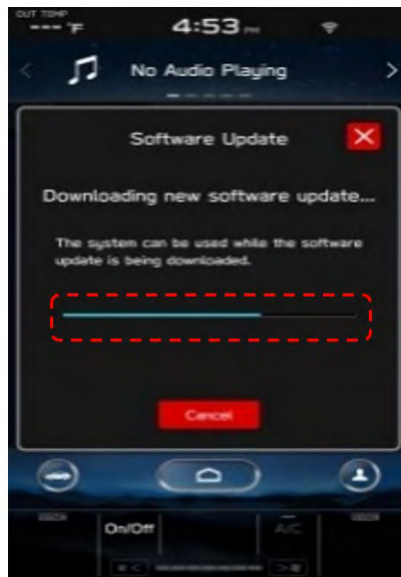
5. If the “progress bar” does not progress after selecting “Download” or, if you receive a “Connect to Wi-Fi” popup while downloading:

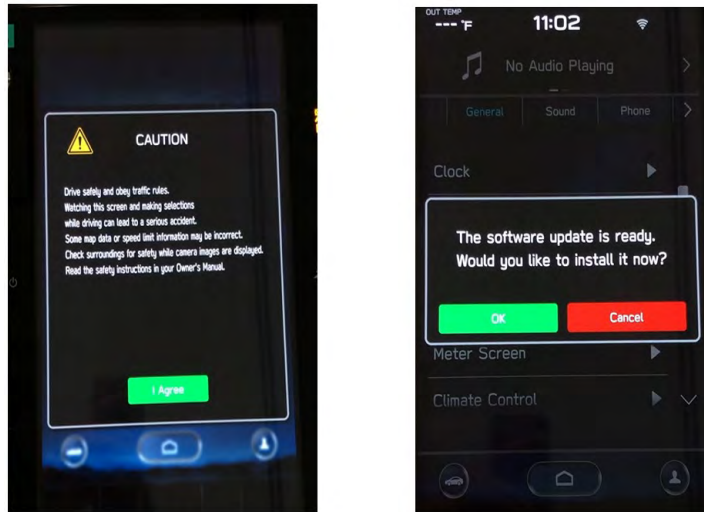
6. If you encounter a blank screen and the update restarts during the installation process:
