SERVICE BULLETIN

APPLICABILITY: 2020-24MY Legacy & Outback
 2022-24MY WRX (A/T Only)
 2019-24MY Ascent

NUMBER: 16-151-24

SUBJECT: TR690 Chain Slip, Judder, Shudder, & Hesitation Concerns

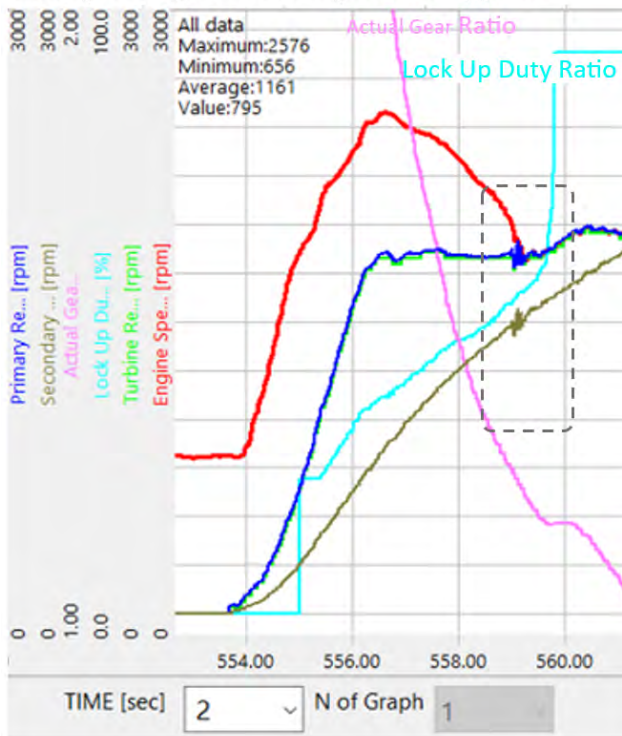
Example Graph for Lockup Judder Type B:

Judgement Criteria

- There are fluctuations in Turbine Revolution and Primary Rev Speed:

Peak to Peak > 50 rpm

Duration < 1 second

Lockup Judder Type A & B: Torque Convertor (p.n. 31100AB460) replacement, CVT Fluid (p.n. 31333AA160) replacement, and TCM software reprogramming (newest software available).

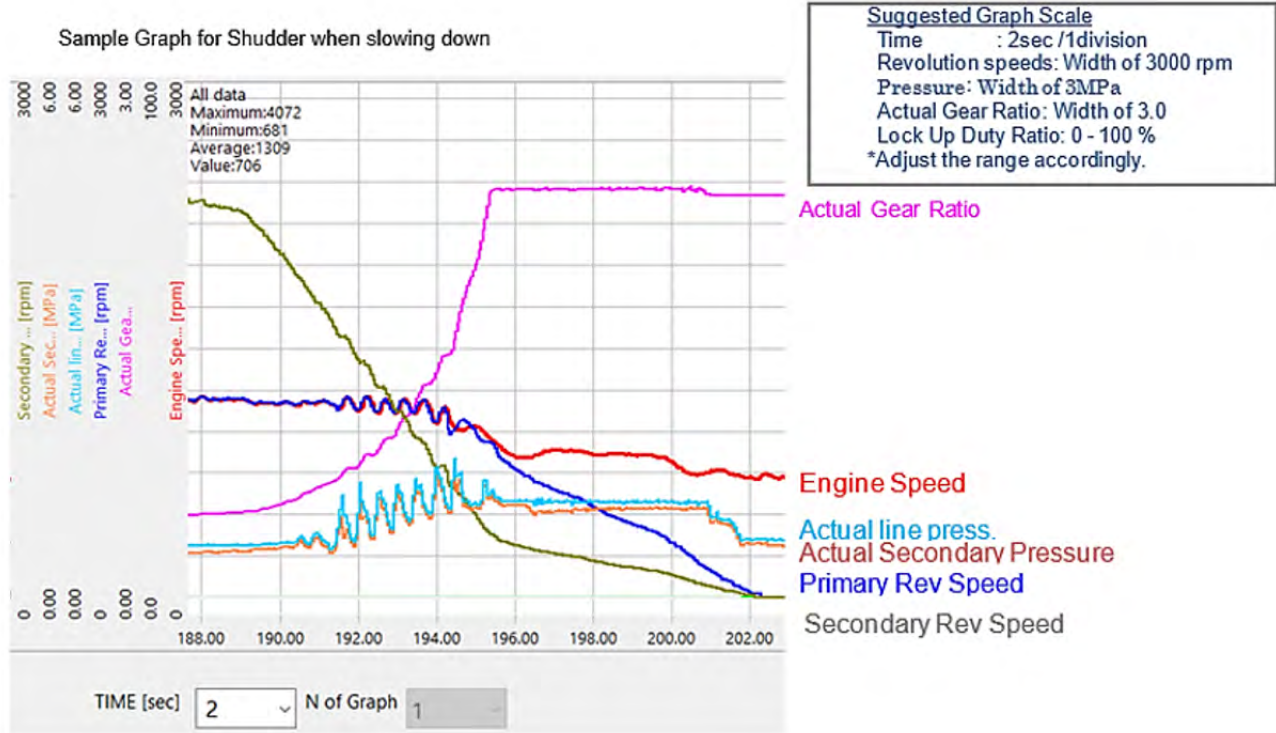
**A jerk or judder sensation felt from the powertrain during braking
with the air conditioning on.**

IMPORTANT: 2023-24MY Legacy & Outback 2.4L, 2023-24MY Ascent, and 2023-24MY WRX vehicles, refer to TSB 16-150-24
