SERVICE BULLETIN

APPLICABILITY: 2025MY Forester

NUMBER: 12-256-24

SUBJECT: Insufficient Seat Heater Output

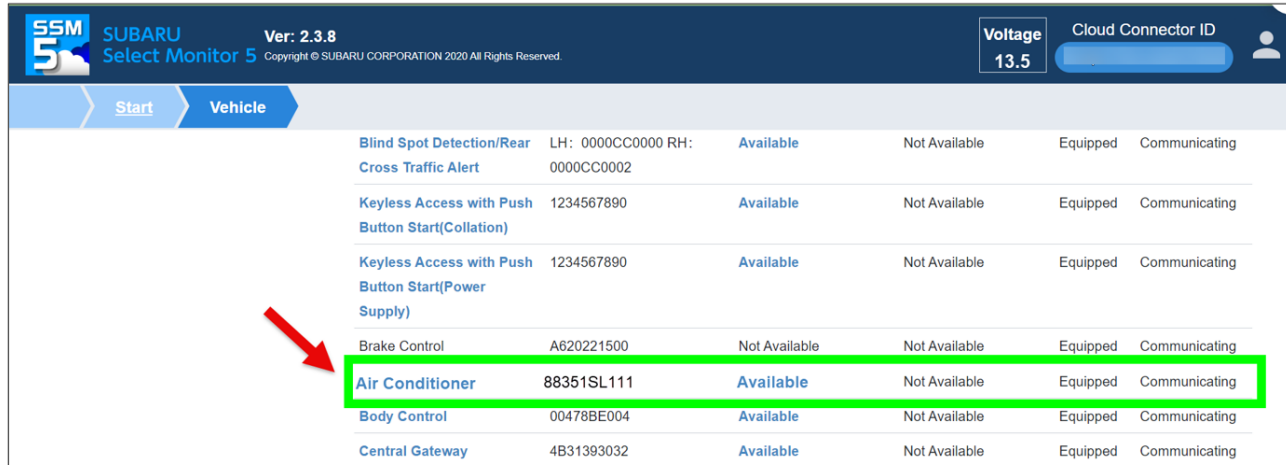
STEP 1: Using SSM5-R, confirm the reprogramming availability of the Air Conditioner Control Module.

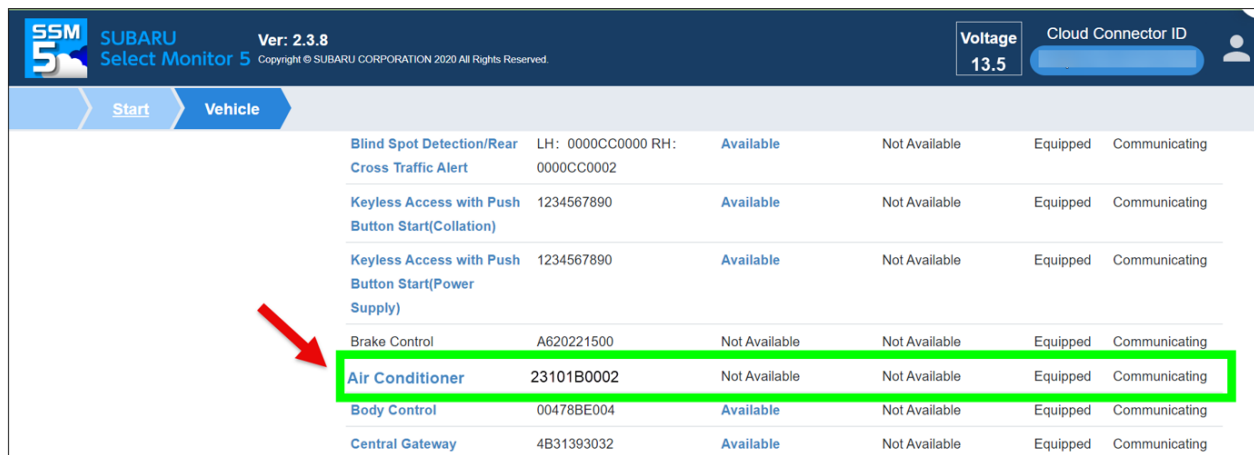
STEP 2: Review the battery charging information provided in the **APPENDIX A** section of this bulletin. Reprogram the Air Conditioning Control Module following the normal SSM5-R procedure.

IMPORTANT: ALWAYS confirm the NEW ROMID after reprogramming is completed.
