## SERVICE BULLETIN

**APPLICABILITY:** 2020-24MY Legacy 2.4L  
 2020-24MY Outback 2.4L  
 2019-24MY Ascent  
 2022-24MY WRX  
 2022-25MY Outback Wilderness

**NUMBER:** 16-150-24R

**SUBJECT:** Transmission Control Module (TCM) / Software Enhancement

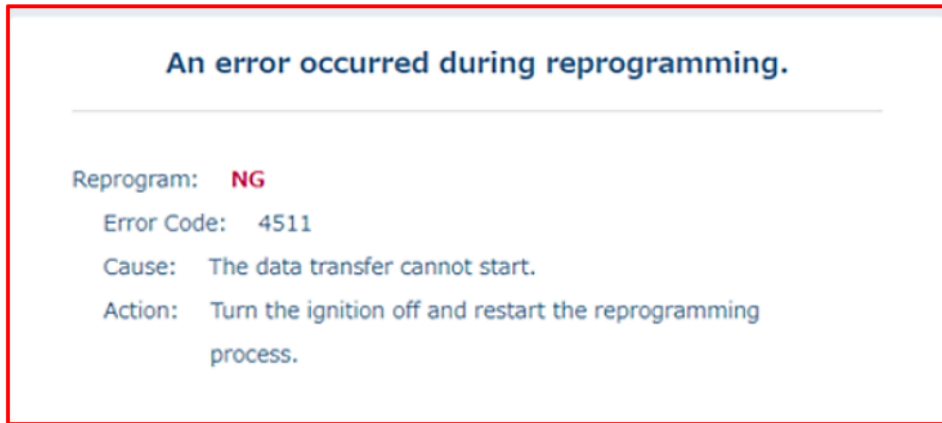
This TCM cannot be reprogrammed, replace TCM with the latest superseded part.

**IMPORTANT:** If reprogramming is attempted on a TCM that has been determined to be not suitable, Error Code 4511 will be displayed.

**STEP 4: Transmission Control Module Replacement is required.**

- Perform TCM replacement as per the applicable Service Manual.
- Perform the SSM5-R reprogramming procedure.
- Refer to the confirmation information supplied in the **APPENDIX A** section of this bulletin.

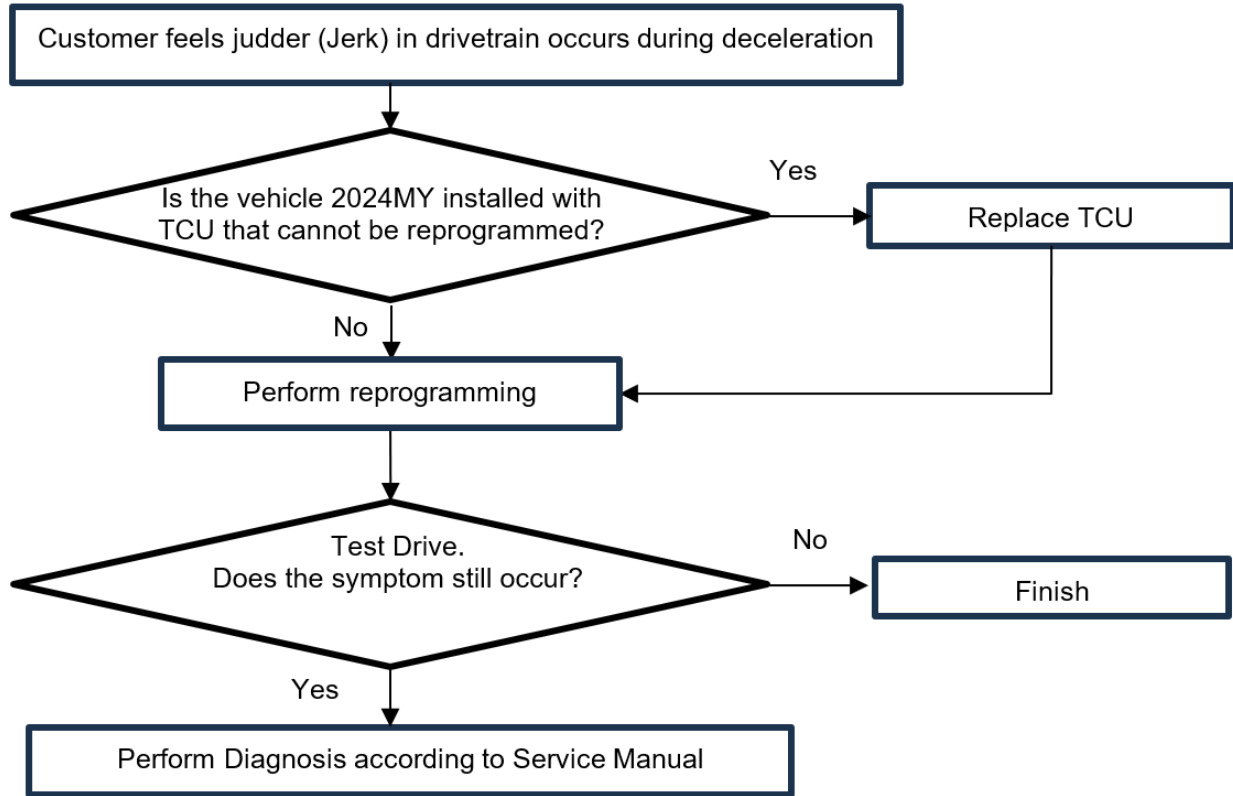
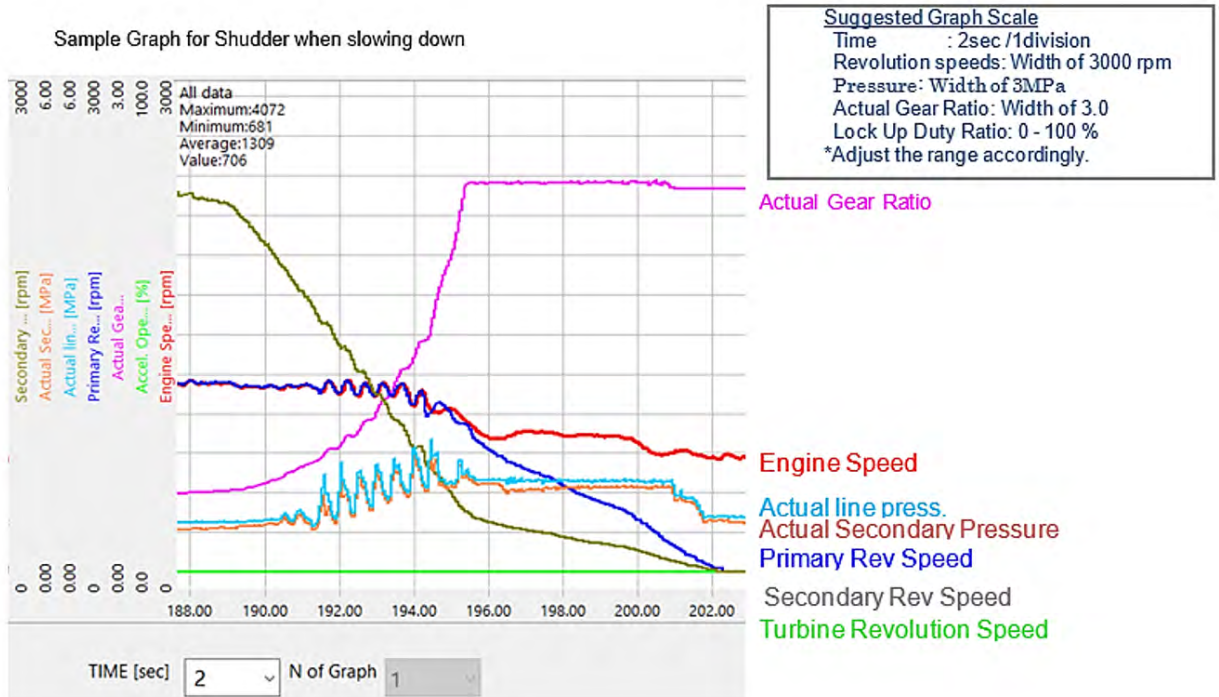
### SYMPTOM 1:

**SYMPTOM 1:** A jerk or judder sensation felt from the powertrain during braking with the air conditioning on.

Actual line press. and Actual Secondary Pressure are fluctuating while feeling shudder when slowing down

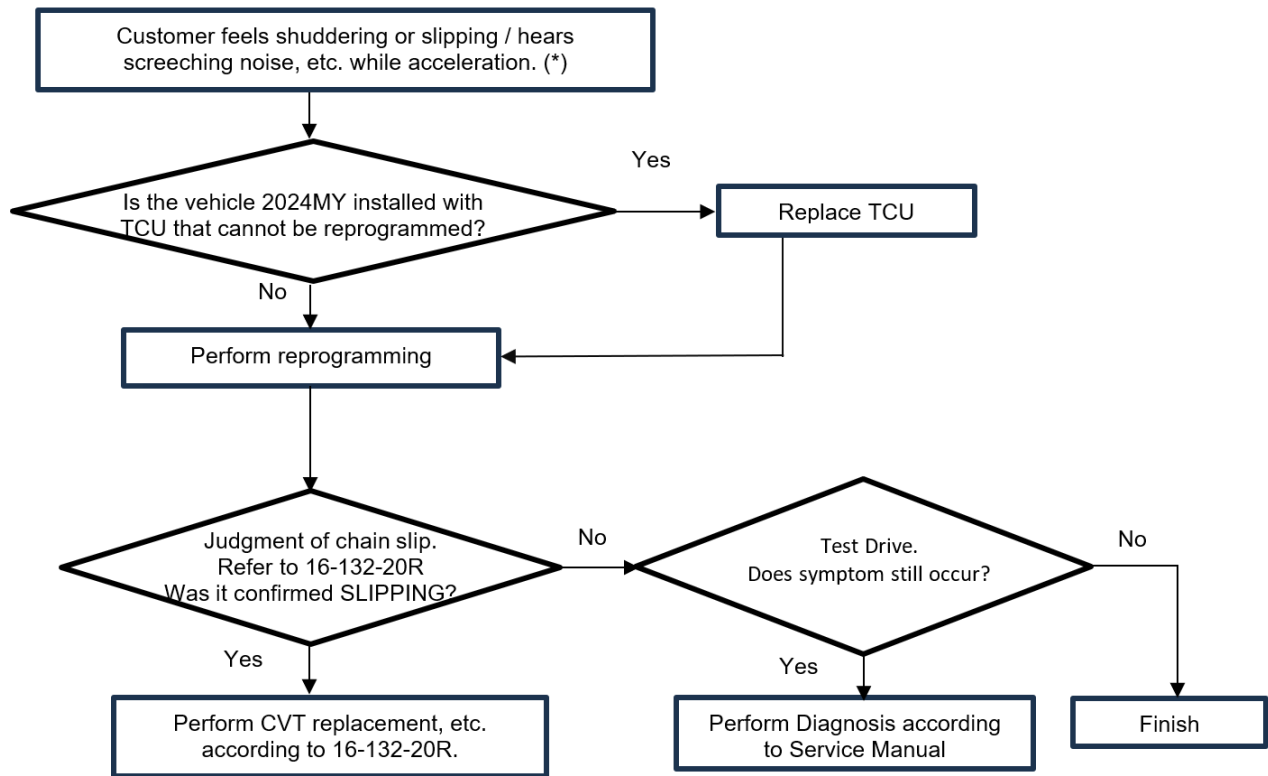
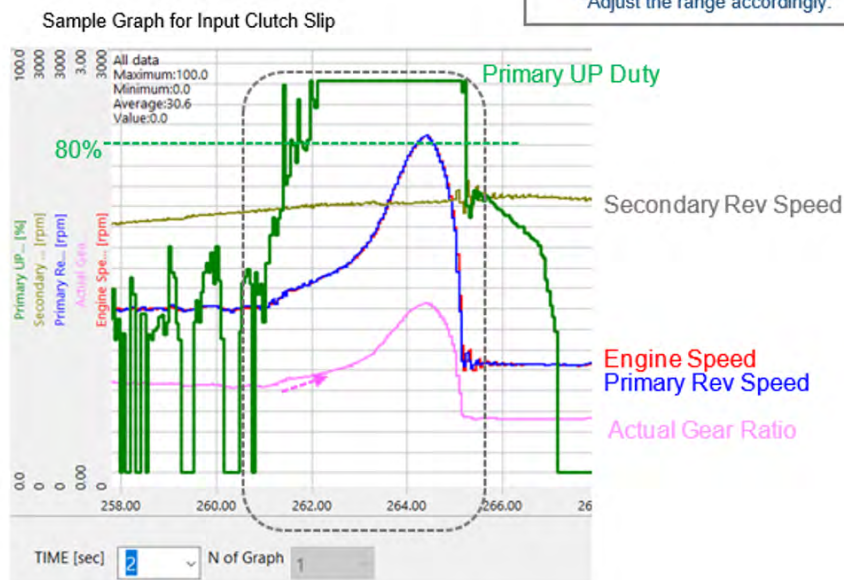
### SYMPTOM 2:

(\*) **NOTE:** In case of chain slip caused by input clutch slip, customers may experience symptoms under the following driving conditions.

- (1) Constant speed driving between 25 and 62 mph.
- (2) Gentle acceleration between 25 and 62 mph.

- All of the following are satisfied.
- Primary UP Duty > 80 %
  - Actual Pulley Ratio changes to Low
  - Above conditions last for 0.5sec or more
