Preview Solution CBR-2409-2

## 13L Engine - Rear Main Oil Seal Leak - Model Year 2025

Published October 2024

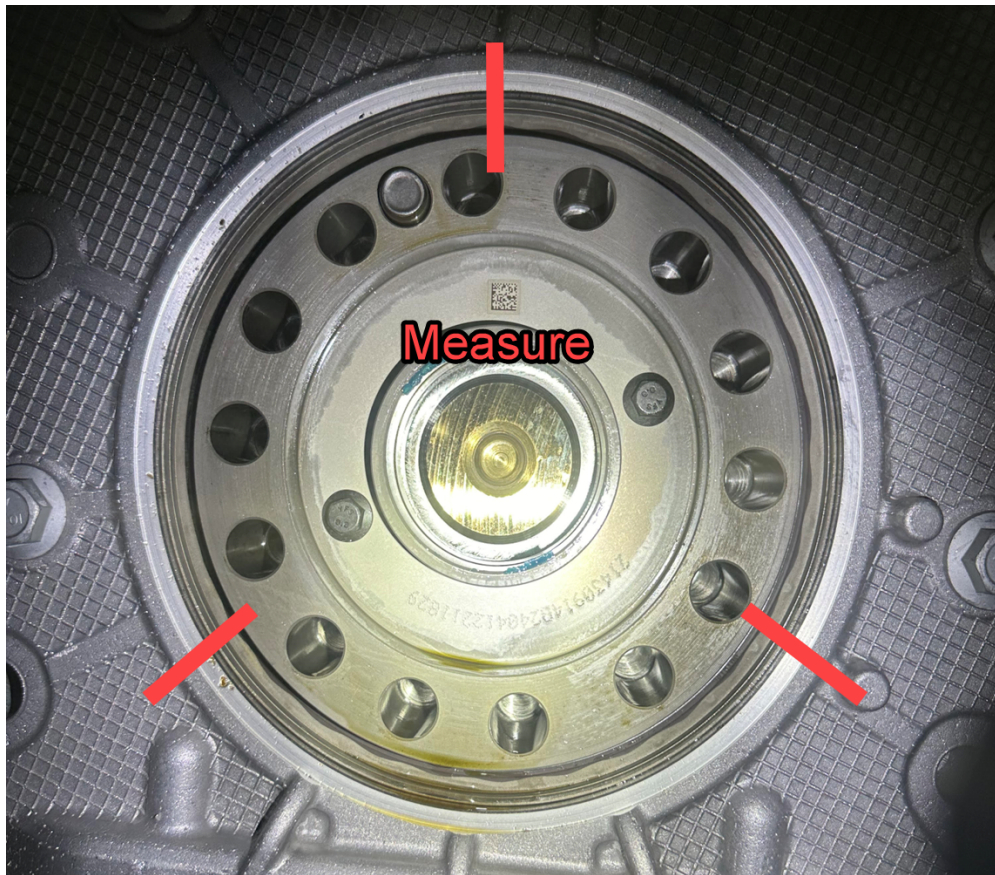
- Any damage or irregularities
  - Full seal view (as shown in the example in Step 4)
4. Measure the depth of the rear main seal in three places as shown below:  
Measurement should be taken from the face of the seal to the outer surface of the crank gear.

- Record the measurements in the eService case
  - Specification for seal depth:  $8.5 \pm 0.4$  mm
  - All three measurements should be within 0.4 mm of each other

- **If the seal depth is within specification and all three measurements are within .4 mm of one another:**
  - Pull the rear main seal.
  - Proceed with the inspection steps below.
- **If the seal depth is NOT within specification and/or the measurements are NOT within .4 mm:**
  - Update the eService case and await further instructions.

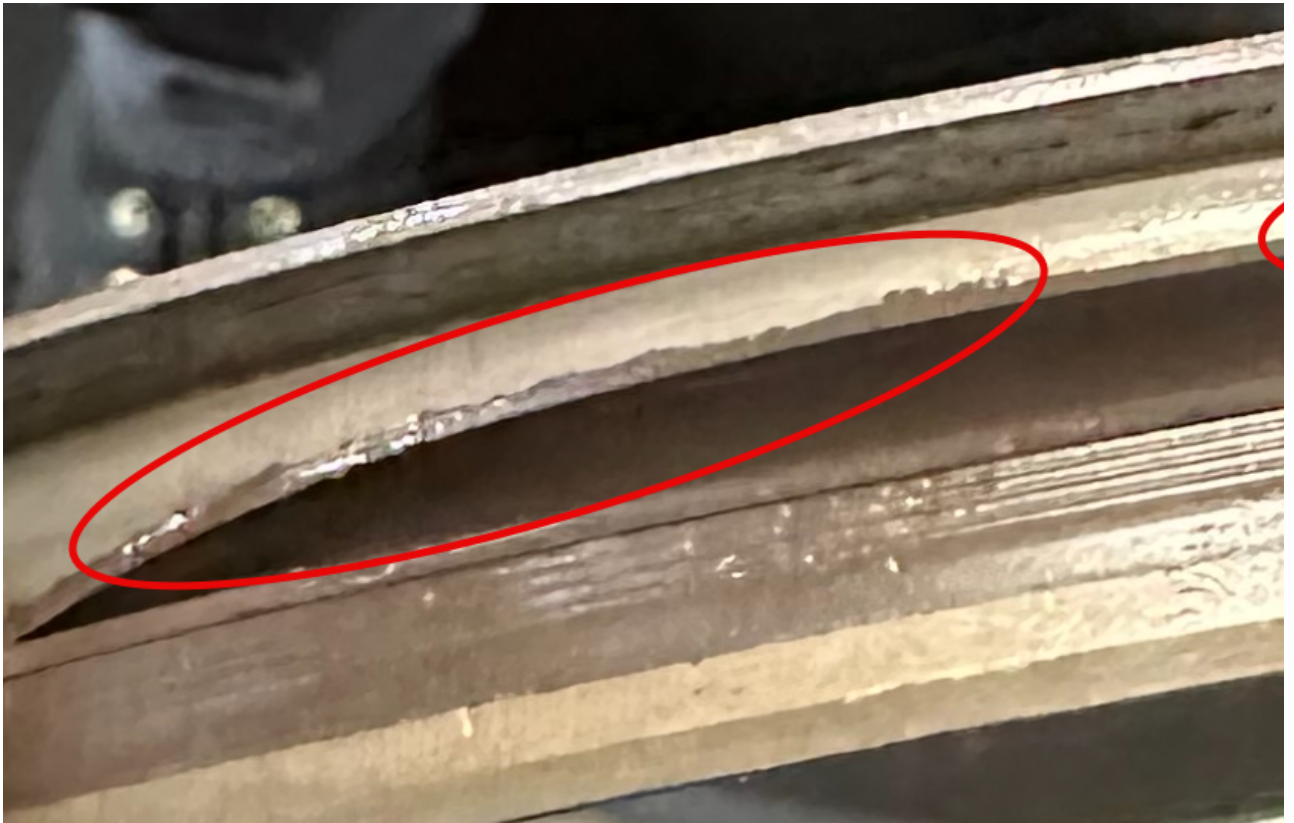
**6.** Inspect the seal for flash from the molding process or damage that was not visible with the seal installed. An example of flash is shown below.

Flash on seal from molding process

- Take clear pictures of any flash and/or damage found.
- Attach the pictures to the eService case.

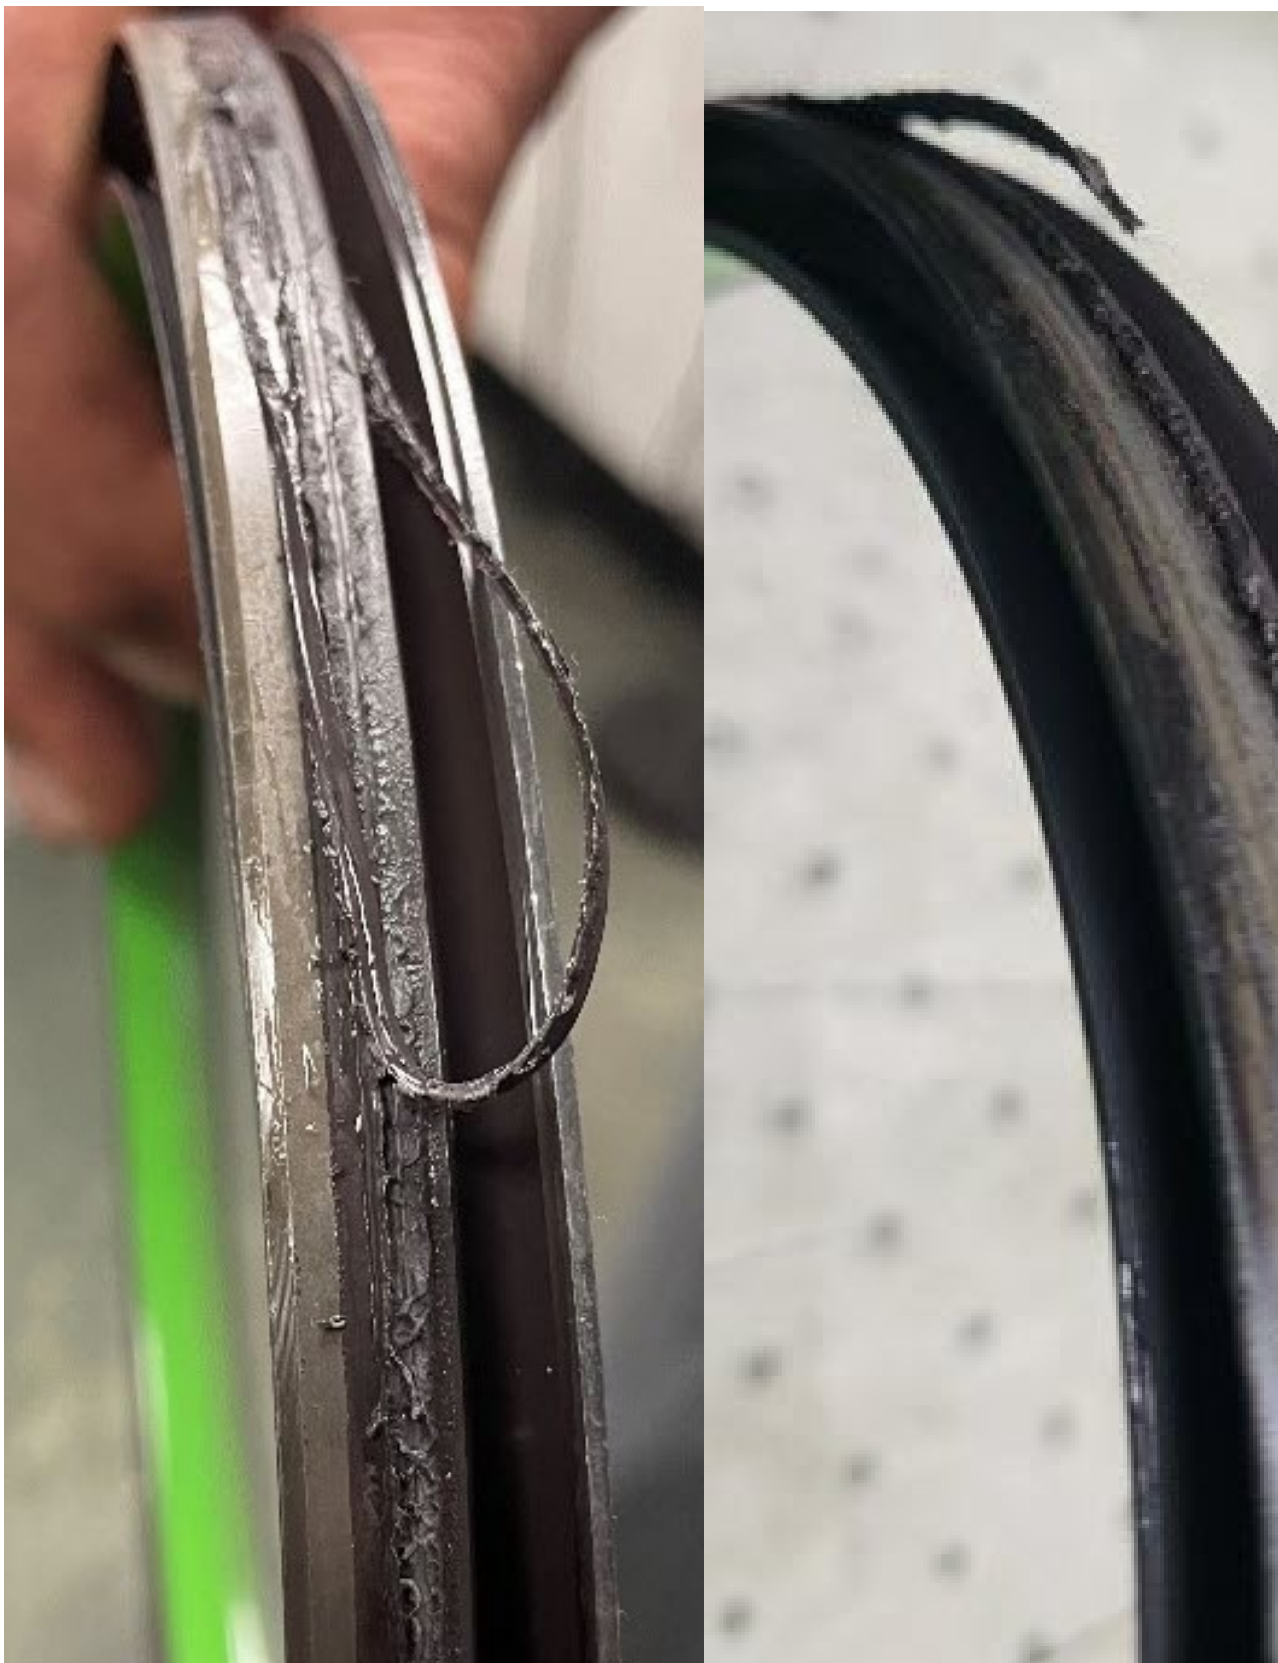
Damage to seal
