Technical product information

Topic	Front windscreen - Water ingress - Left or right hand side Or water ingress from the top of the front windscreen
Market area	Bentley: worldwide (2WBE),China 796 VW Import Comp. Ltd (Vico), Beijing (6796)
Brand	Bentley
Transaction No.	2075729/1
Level	EH
Status	Approval
Release date

Water ingress into the cabin (Front windscreen)

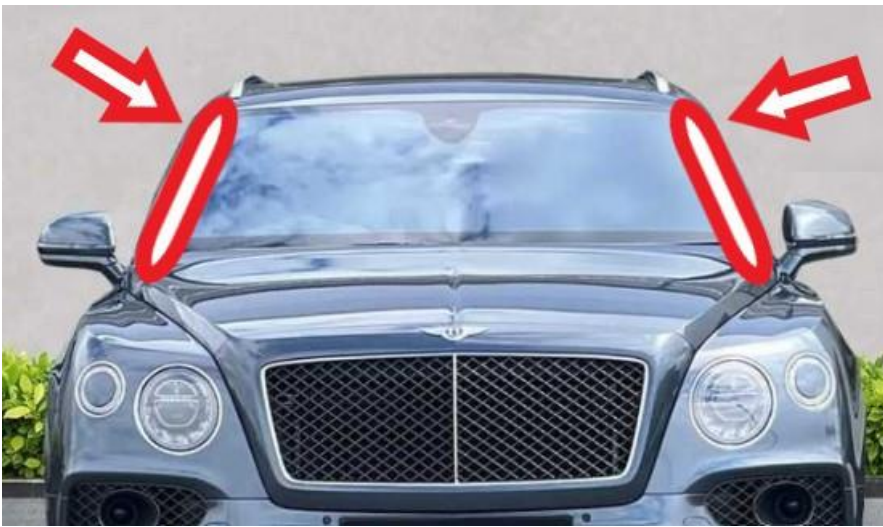
Water ingress into the cabin from the locations shown in Figure 1

Front windscreen water ingress (into cabin) - Left hand side

Front windscreen water ingress (into cabin) - Right hand side

Section 1 - Water ingress from the left and / or right hand side

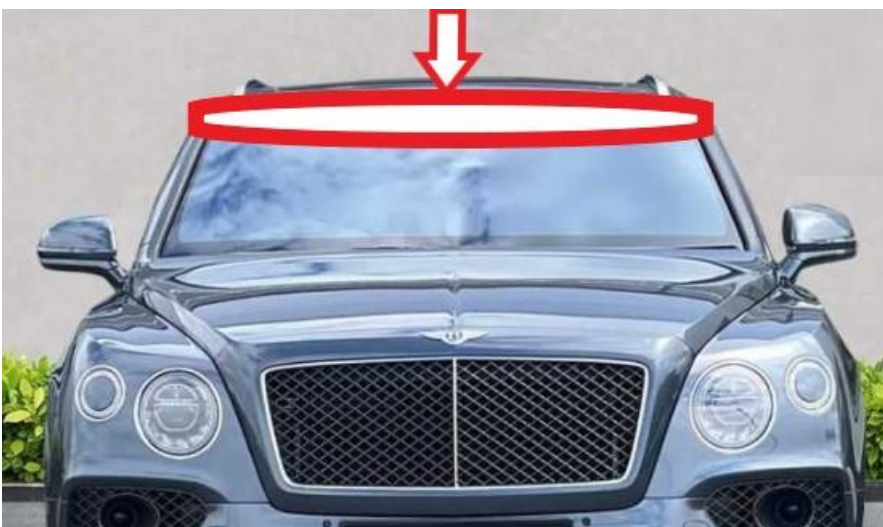
Referring to Figure 2 - Front windscreen water ingress (into cabin) from the top of the windscreen

Section 2 - Water ingress from the top of the front windscreen

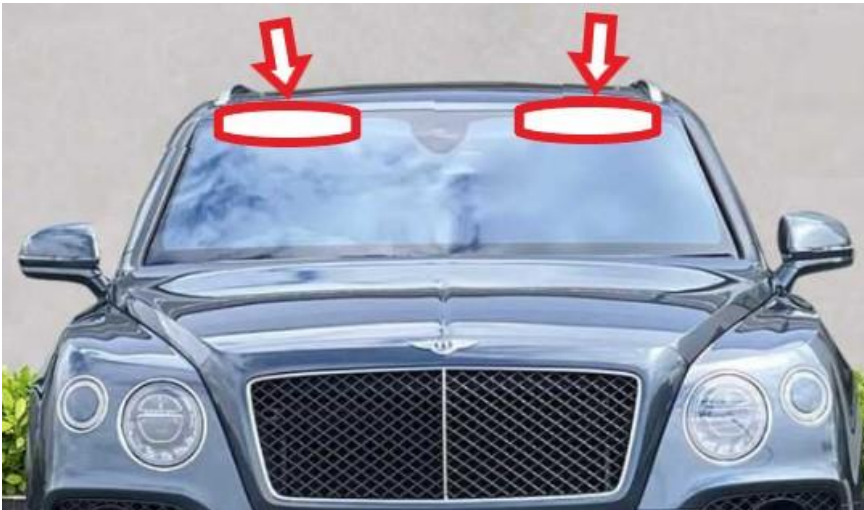
In the event the ingress is as at the location shown in Figure 12 - DO NOT REMOVE THE HEADLINER the operative must only remove the following components as described within the applicable Rep.Gr

- Remove the front roof console
- Remove the interior mirror from the windscreen
- Remove the camera for front assist systems. Refer to "camera for driver assist systems - to remove and fit"
- Remove both sunvisors
- Remove all grab handles
- Remove both upper A-post trim panels
- Pull down on the front of the headlining to release the clipping points and allow to hang

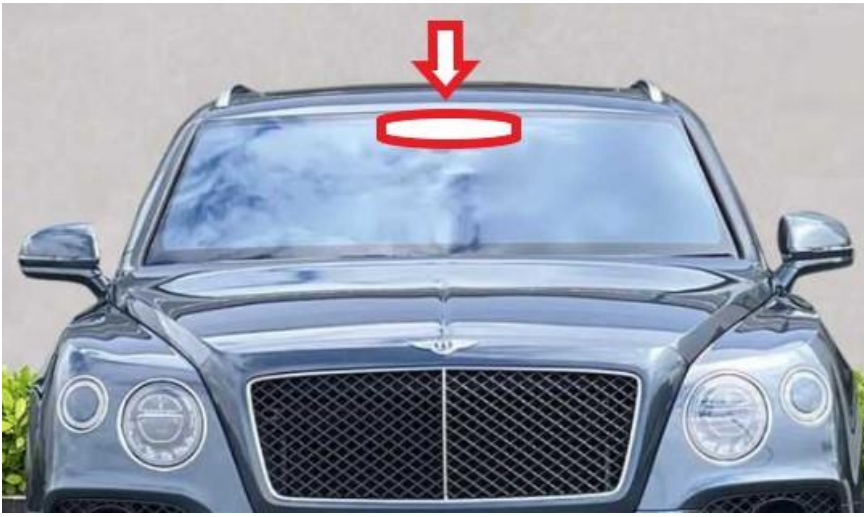
In the event the ingress is at the location shown in Figure 13 - Remove the roof console and interior mirror only to gain access to the area of the ingress
