1210F SPL 170XL Interaxle Driveline

1210F / NHTSA Recall ID: 10V634000 / Transport Canada ID: 2010-441

3/2/2011

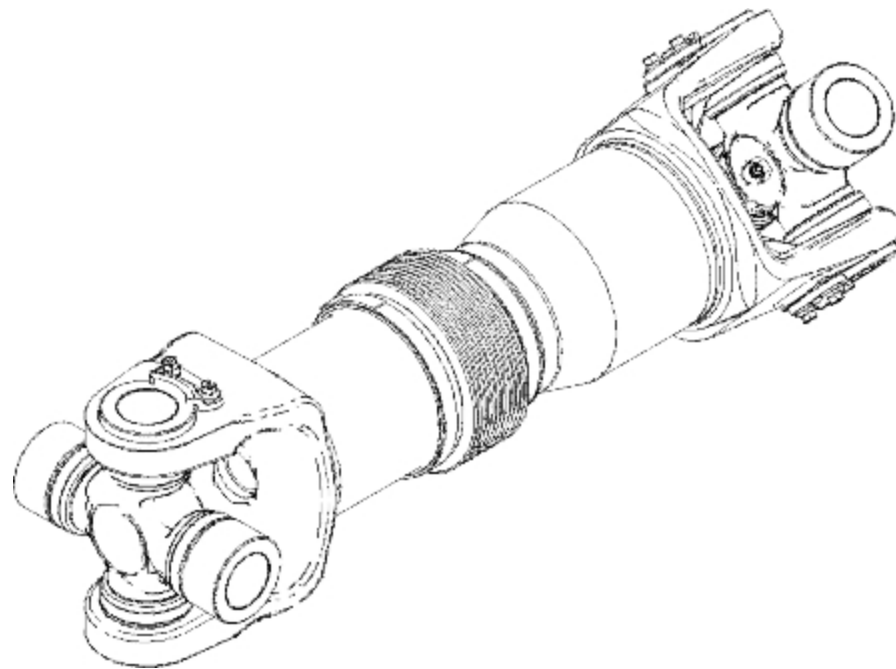
Phased driveline should look similar to this when complete.

6. Raise one of the axles off of the ground so that the axle yoke can be rotated to match the newly phased yoke.
7. Replace the u-joint on the other end of the driveline.
