Technical product information

| Topic | Noises from Panoramic sun roof |
| Brand | Bentley |
| Transaction No. | 2075792/1 |

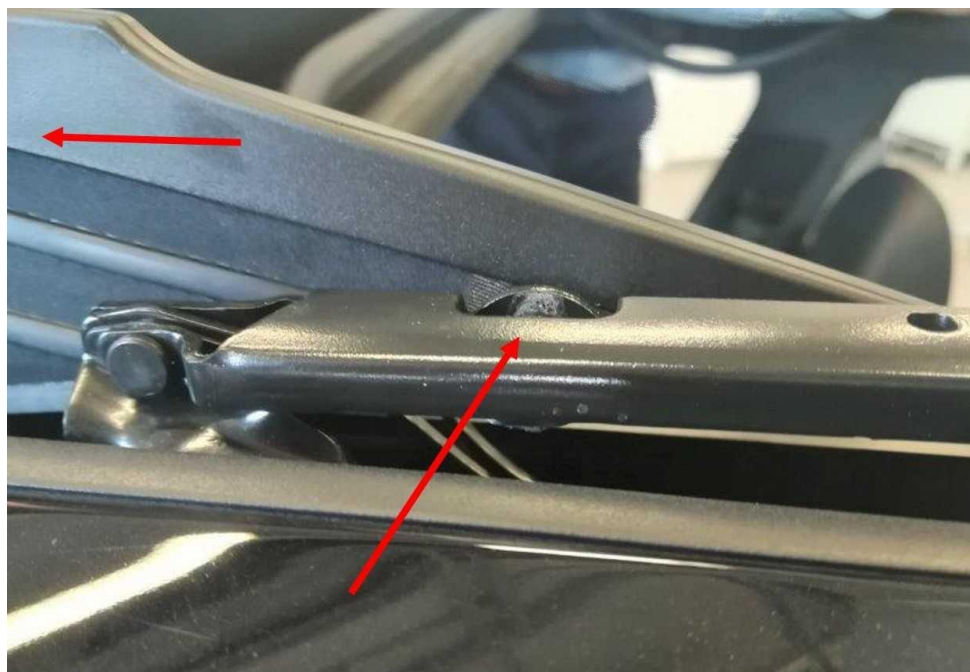
2) The above illustration shows the left mechanical system. The upper left arrow points to the driving direction. The lower arrow points to the first mounting point of the glass panel.

- For a better access to the points to be greased move the mechanical system (slightly) rearwards
- Apply grease spray **G 060 567 A2** to the points shown within the onward instructions
