# Technical product information

<b>Topic</b>	Rear lid or boot - Water ingress diagnosis
<b>Market area</b>	Australia E04 Bentley rest Asia and Australia (6E04),China 723 Volkswagen (Anhui) Automotive CO (6723),China 796 VW Import Comp. Ltd (Vico), Beijing (6796),Germany E02 Bentley rest Europe (6E02),Japan E03 Bentley Japan (6E03),Korea, (South) E08 Bentley South Korea (6E08),Russian Federation 935 Volkswagen Group RUS (6935),United Arab Emirates E06 Bentley Middle East and Africa (6E06),United Kingdom E01 Bentley UK (6E01),United States E05 Bentley USA and rest America (6E05)
<b>Brand</b>	Bentley
<b>Transaction No.</b>	2068829/2
<b>Level</b>	EH
<b>Status</b>	Approval
<b>Release date</b>

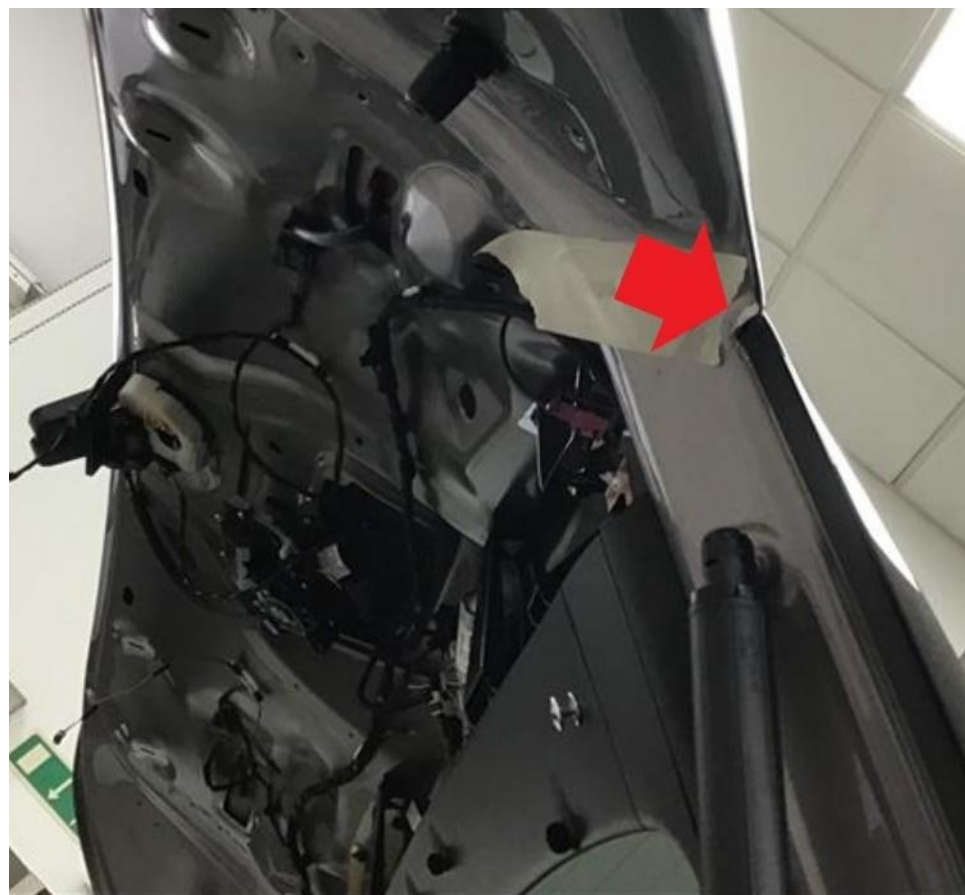
1) Referring to Figures 1 and 2 (below the rear lid strut) check to confirm the sealant is present and in a good condition at the location shown (right hand side)

HINT: Figure 1 shows the rear lid trim removed, however the rear lid trim does not require removal for this operation

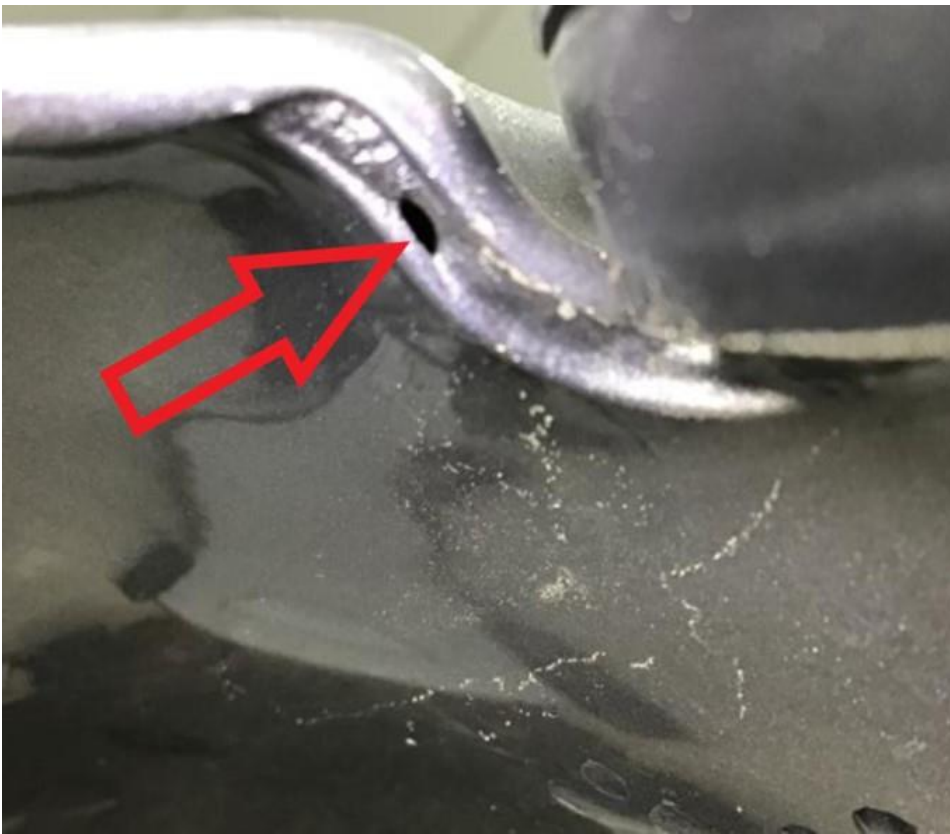
2) In the event that sealant is missing from the locations shown in Figure 2 (left and/or right hand side)

Different locations on the rear lid the operative should clean/prepare the areas concerned and apply sealant (See parts information) to the applicable locations

- Once sealant has been applied conduct a local paint repair in the location in which sealant was missing

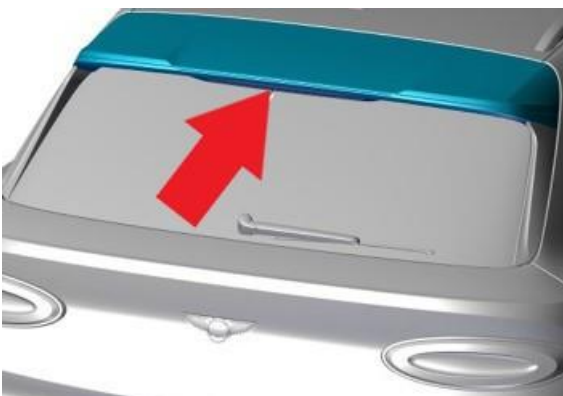
- Figure 3 - Rear spoiler

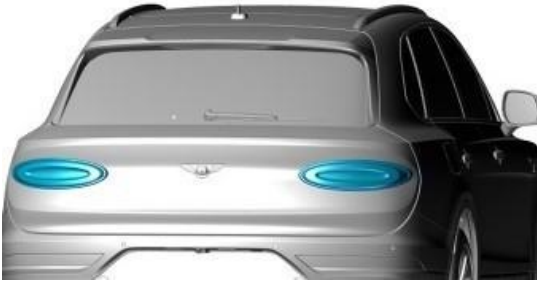
- Figure 4 - Rear lamps

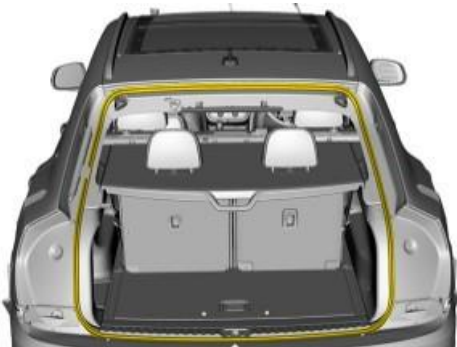
- Figure 6 - Tailgate seal - Refer to Rep.Gr 55 to confirm the seal is fitted correctly and also confirm the seal is not damaged or distorted

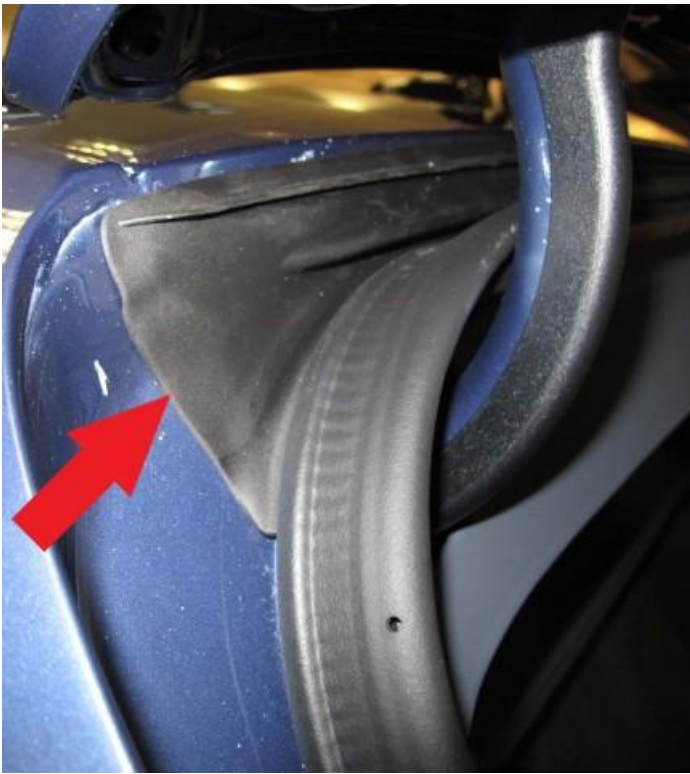
- Figure 7 - Upper water deflector – Check to confirm the upper water deflector is fitted correctly and not damaged/distorted

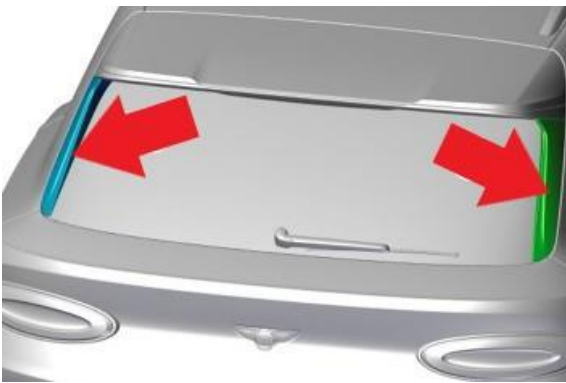
Figure 8

- Rear spoiler side strakes (Figure 8) - Check to confirm the side strakes are secure and water is not leaking past the location tang seals

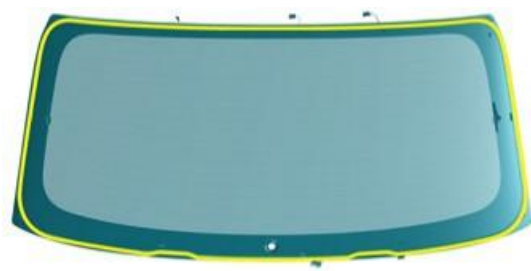
- Rear window glass (Figure 9) - Apply water in the locations shown (yellow line) to confirm the rear window glass is not leaking due to missing sealant

In the event that water ingress is suspected at the location shown in Figure 9 please raise a DISS query and await a response before conducting any further work
