Technical product information

Topic	Front door clash condition with the rear door brightware or clash between the front and rear door brightware
Market area	Bentley: worldwide (2WBE),China 723 Volkswagen (Anhui) Automotive CO (6723),China 796 VW Import Comp. Ltd (Vico), Beijing (6796)
Brand	Bentley
Transaction No.	2068064/3
Level	EH
Status	Approval
Release date

Bentayga and Bentayga EWB

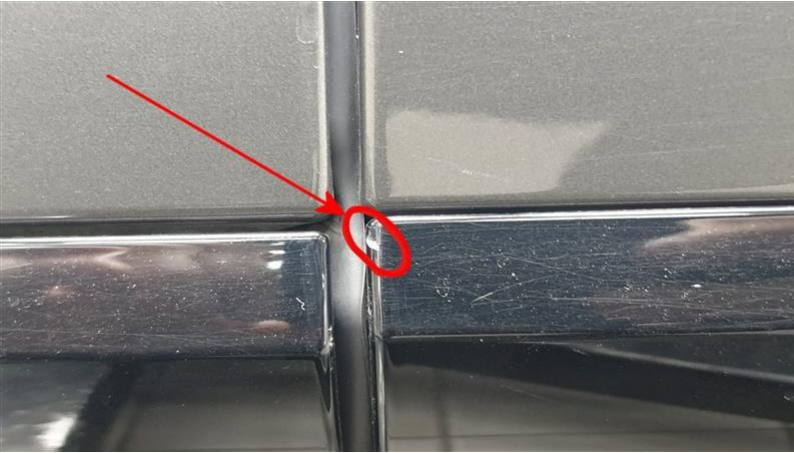
Figure 1

The front door inner panel hem is clashing with the rear door lower brightware (Figure 1) during the closing operation of the front door

1) With extreme care - Use a suitable "smooth cut hand file" to remove the raised inner door panel hem edge, until the hem edge is as shown in Figure 5

2) Once the protruding hem edge has been suitably reduced, close the front door to confirm the issue is resolved (No clash condition evident between the front door inner panel hem and the rear door lower brightware)

3) Conduct a paint repair to the applicable area ensuring all approved paint repair guidelines are strictly followed to eliminate the risk of any paint and/or corrosion related issues

4) Referring to Rep.Gr 66 - Replace the rear door lower brightware

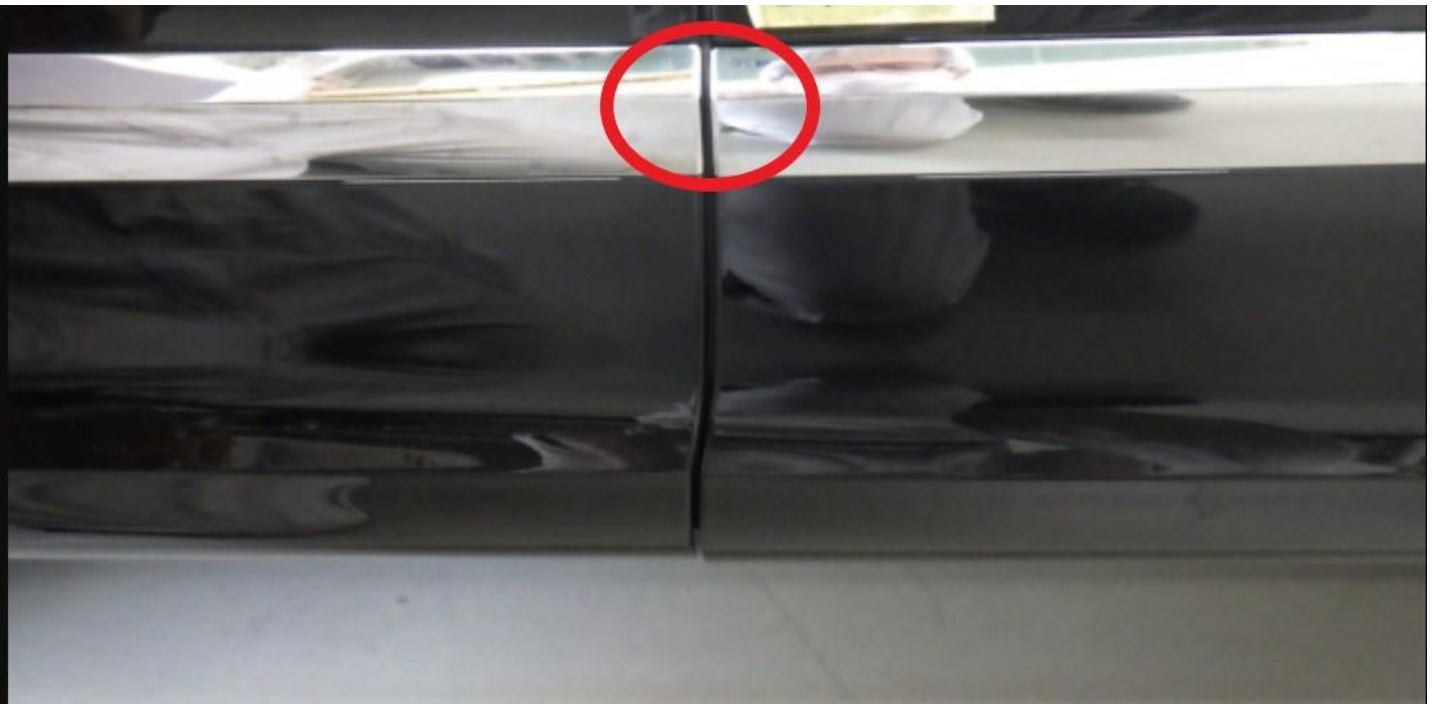
The rear door lower brightware is clashing with the front door brightware (Figure 2)

In the event the rear door lower brightware is clashing with the front door lower brightware as shown in Figure 2 the operative should conduct the instructions within the Measure section for (Scenario 2)

In the event the issue is as described and the clash condition is between the rear door lower brightware and the front door lower brightware the operative must refer to the instructions within Rep.Gr 66 - Door lower brightware – To remove and fit ensuring the following before refitting:

-
- If you are re-using the old part, replace the adhesive strips with "3M automotive acrylic tape" or similar, locally sourced
 - Clean the bonding surface of the door with Cleaning solution 3M VHB before refitting the lower brightware

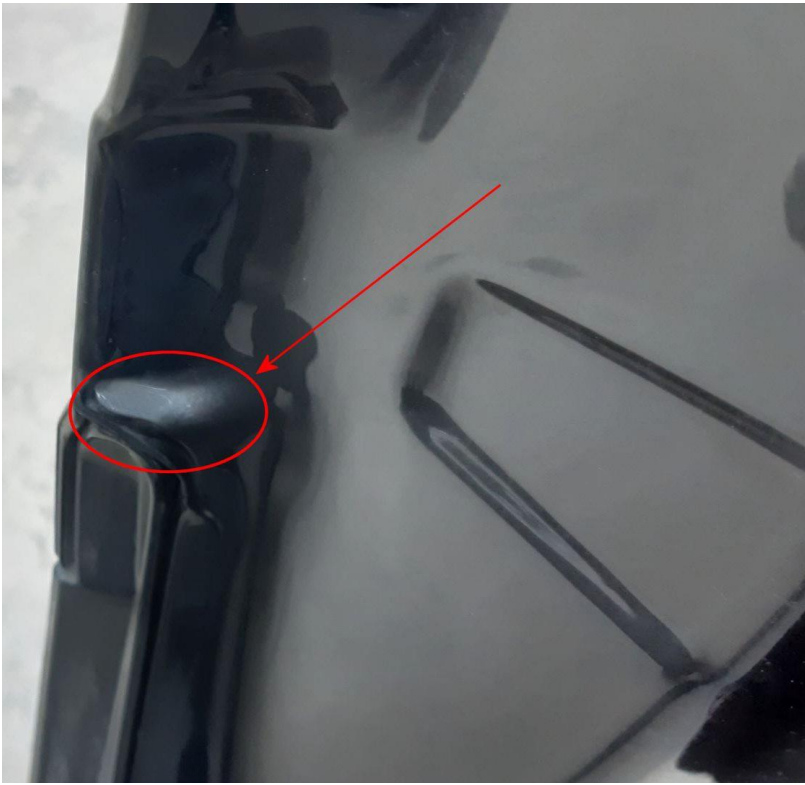
Figure 3

The issue is evident due to a clash condition between the front door inner panel hem (Figure 3) and the rear door lower brightware (Figure 4)
