Preview Solution CBR-2275-3

## **Volvo Chassis - Battery Electric Vehicle (BEV) Diagnostic Trouble Code (DTC) C10019E - Electric Vehicle Air Compressor 1, Stuck On**

Published 10 October 2024

VNRe chassis Model Year 2021 to present - Phase 1

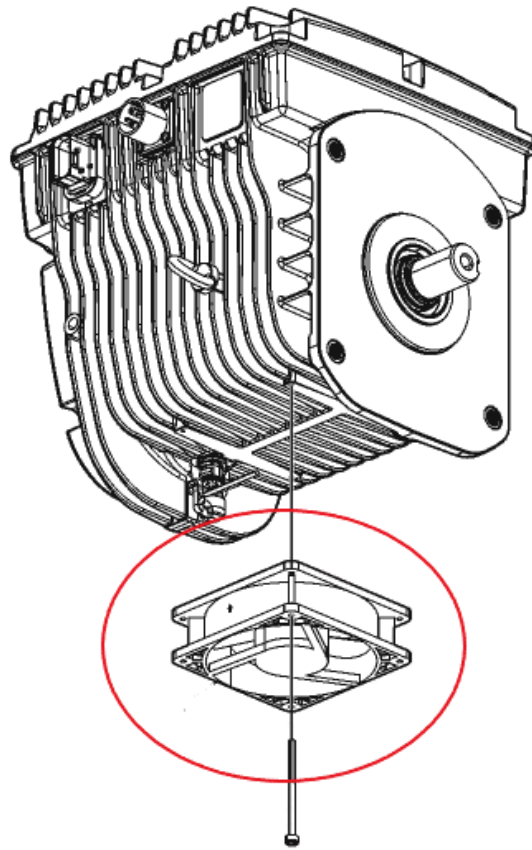
This fault is related to the Air Compressor Motor Cooling Fan. The cooling fan is mounted to the underside of the compressor motor and is powered from the motor.

1. No power or ground from the motor
2. Damaged wiring or connector
3. Damaged fan
4. Blocked fan
5. Bad fan motor

1. Visually inspect the fan and wiring
2. Check for power and ground when the compressor is engaged.

If all appears ok, and the fan is not working, replace the fan.
