Technical product information

Topic	Rear window glass - Water ingress - Left Or right hand side or water ingress from the top of the rear window glass
Market area	Bentley: worldwide (2WBE),China 796 VW Import Comp. Ltd (Vico), Beijing (6796)
Brand	Bentley
Transaction No.	2075642/1
Level	EH
Status	Approval
Release date

Continental GT and Flying Spur

Water ingress into the cabin (Rear window glass)

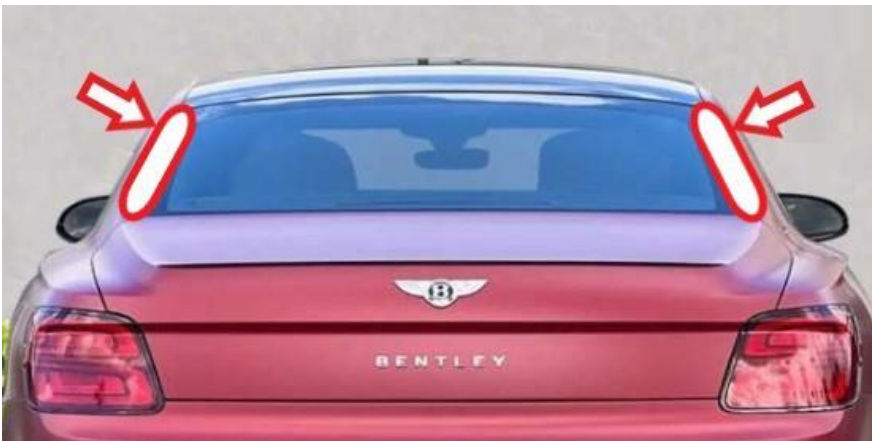
Water ingress into the cabin from the locations shown in Figure 1

Rear window glass water ingress (into cabin) - Left hand side

Rear window glass water ingress (into cabin) - Right hand side

In this scenario refer to Section 1

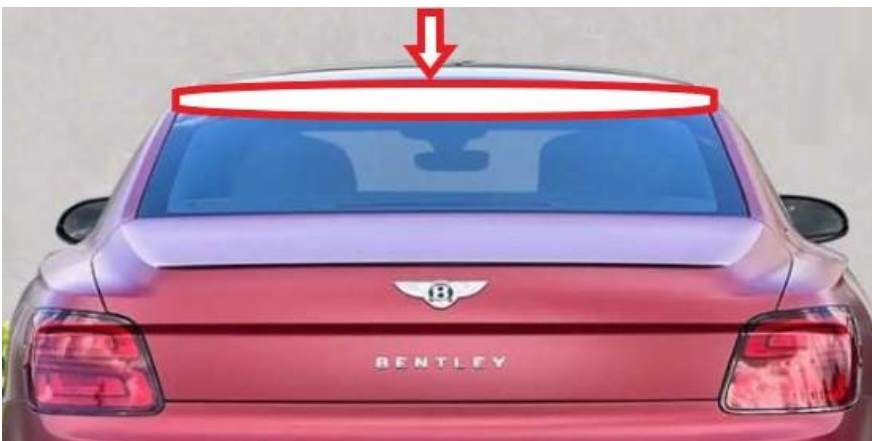
Referring to Figure 2 - Rear screen water ingress (into cabin) from the top of the rear window glass

In this scenario refer to Section 2
