Technical product information

Topic	Water evident on the A-Post pillar seam - Water dripping behind the door seal - Sunroof specified vehicles only
Market area	Australia E04 Bentley rest Asia and Australia (6E04),China 723 Volkswagen (Anhui) Automotive CO (6723),China 796 VW Import Comp. Ltd (Vico), Beijing (6796),Germany E02 Bentley rest Europe (6E02),Japan E03 Bentley Japan (6E03),Korea, (South) E08 Bentley South Korea (6E08),United Arab Emirates E06 Bentley Middle East and Africa (6E06),United Kingdom E01 Bentley UK (6E01),United States E05 Bentley USA and rest America (6E05)
Brand	Bentley
Transaction No.	2070638/2
Level	EH
Status	Approval
Release date

New Continental GT and New Flying Spur

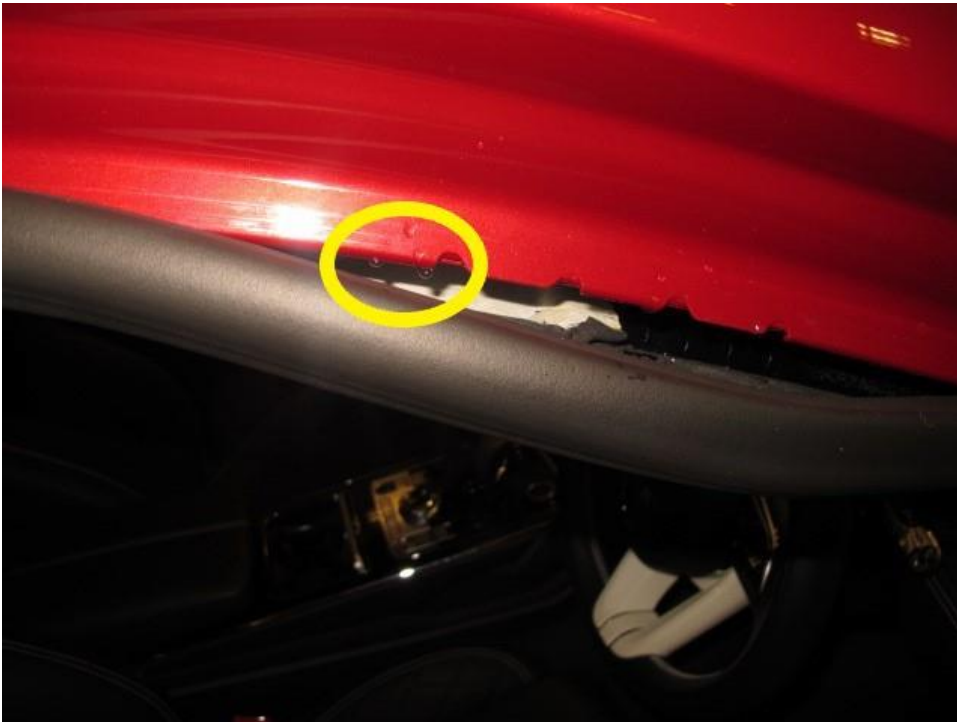
- Water evident on the A-Post pillar seam - Water dripping behind the door seal (Figure 1)

Hint: In some cases the footwell carpet may be wet

After conducting TPI 2062622/- water is found to be leaking from the location shown in Figure1

The issue described is only evident on vehicles with a sunroof, in the event the issue is evident and the vehicle is not specified with a sunroof please raise a DISS query and await feedback before conducting any further work

1) Has TPI 2075579/- been conducted?

No - Please conduct 2075579/- to completion

Yes - 2075579/- has been completed and the leak is still evident from the location shown in Figure 1 In the event the leak is still evident the operative should request assistance via a new or existing DISS query
