Technical Service Bulletin

GROUP BODY ELECTRICAL	NUMBER 24-BE-016G
DATE OCTOBER 2024	MODEL(S) GV70 (JK1A) GV70 ELECTRIFIED (JK1A EV)

COAXIAL CABLE SHIELD ADJUSTMENT FOR
DISPLAY SCREEN FLICKERING/BLANK

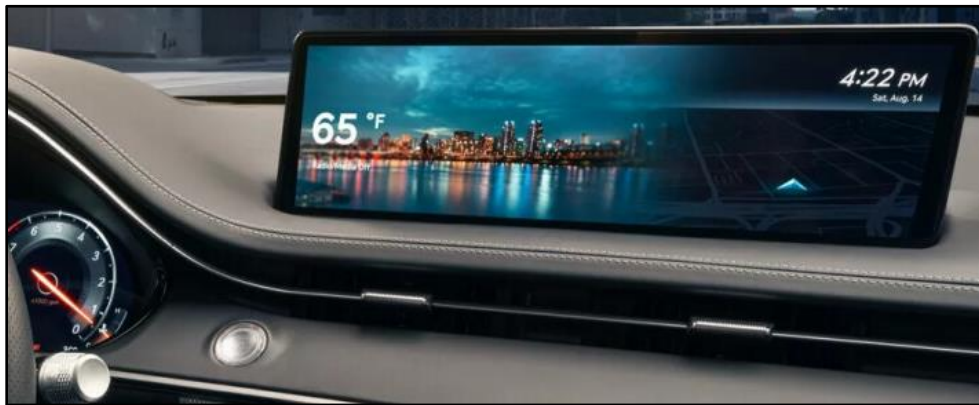
Description: Certain GV70 (JK1A) and GV70 Electrified (JK1A EV) vehicles may exhibit a display screen flickering or intermittently going blank. This may be due to the shield width of the coaxial cable being too wide, causing a loose connection. Follow the procedures in this bulletin to adjust the width of the shield using a supplied shield adjustment jig.

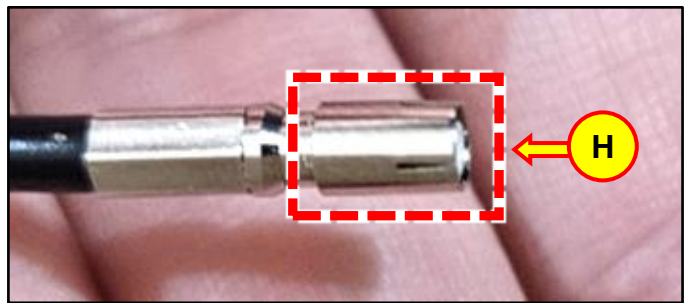
Shown at right is a coaxial cable shield (H) that is too wide and needs adjustment.

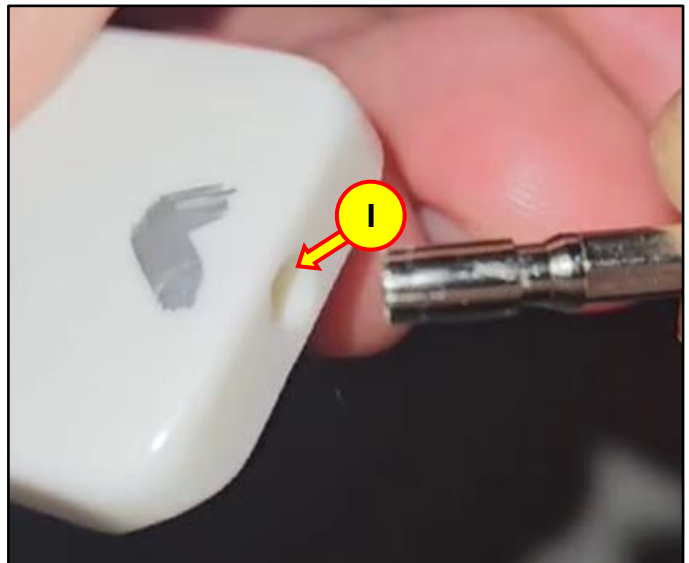
Notice that the coaxial cable shield is larger than the hole of the jig (I). Proceed to next step.

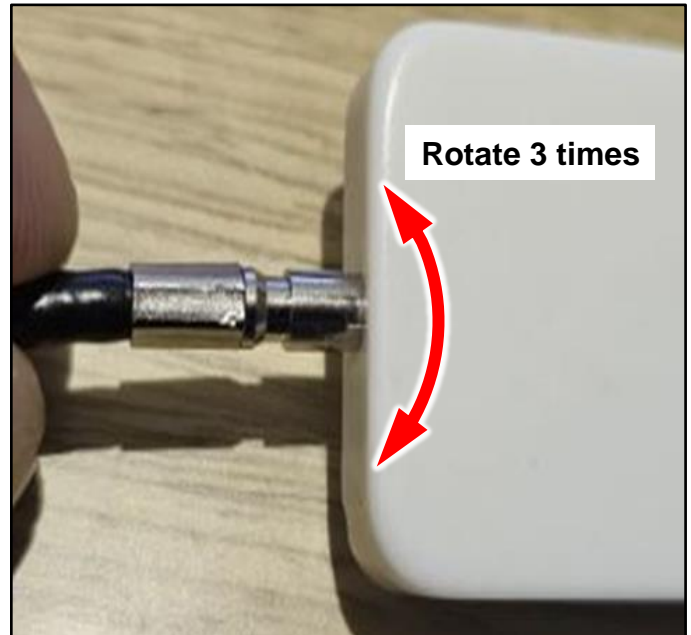
This will reduce the width of the shield to enable a better connection in the connector.

7. Once inserted, rotate the jig around the shield 3 times.
