| | | <b>Tesla, Inc.</b><br>Service Bulletin | | <i><b>Inspect Front Roof and Center Spine Appliques for Lack of Adhesion</b></i> | |
| SB-24-12-008<br>October 31, 2024 | | R1 | | | |

On some Model X vehicles, the front roof applique and/or center spine applique may have been applied to the roof without the use of primer, which could cause the applique(s) to separate from the roof. This bulletin employs an improved inspection process which replaces the one for SB-20-12-005.

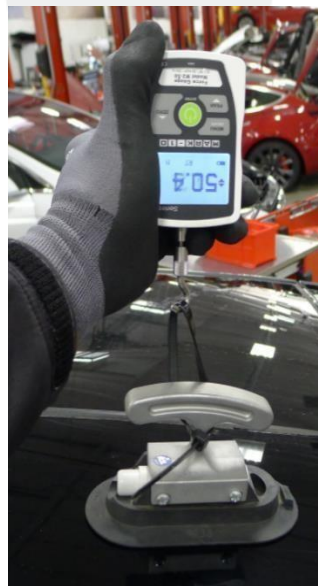
**Figure 3 – Force gauge reading**

3. Connect the vacuum cup to the force gauge and slowly pull the vacuum cup up with the force gauge (Figure 3) with at least 120 N of force for 10 seconds.

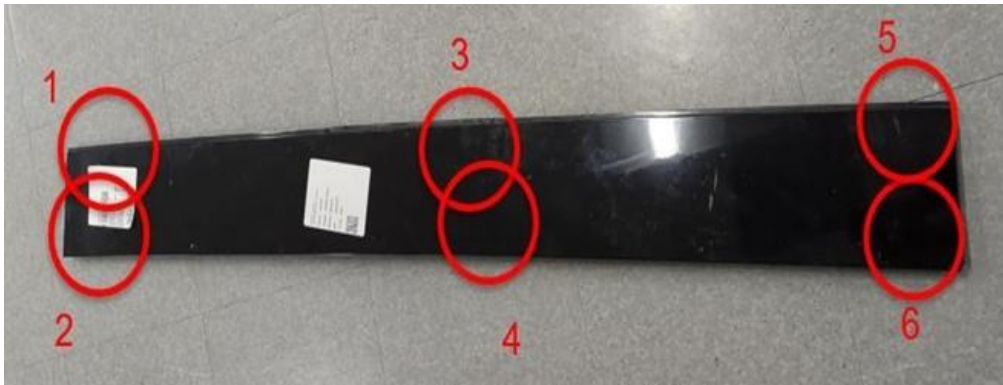
**Figure 4 – Front roof applique inspection positions**

4. Inspect the front roof applique for any signs of damage or looseness/separation from the roof and note down the force value applied.
  - If the front roof applique is in good condition and remains adhered, continue to the next step.
  - If the front roof applique is damaged, loose, or shows signs of separation, replace the front applique (refer to Service Manual procedure [12206002](#)) and proceed with step 7.
5. Carefully remove the vacuum cup from the front roof applique to prevent accidental damage to the applique and rear door roof glass seals.
6. Repeat steps 2 through 5 on the remaining front roof applique inspection positions (Figure 4). The circles indicate general locations, make sure that the actual suction cup does not overlap the edges.

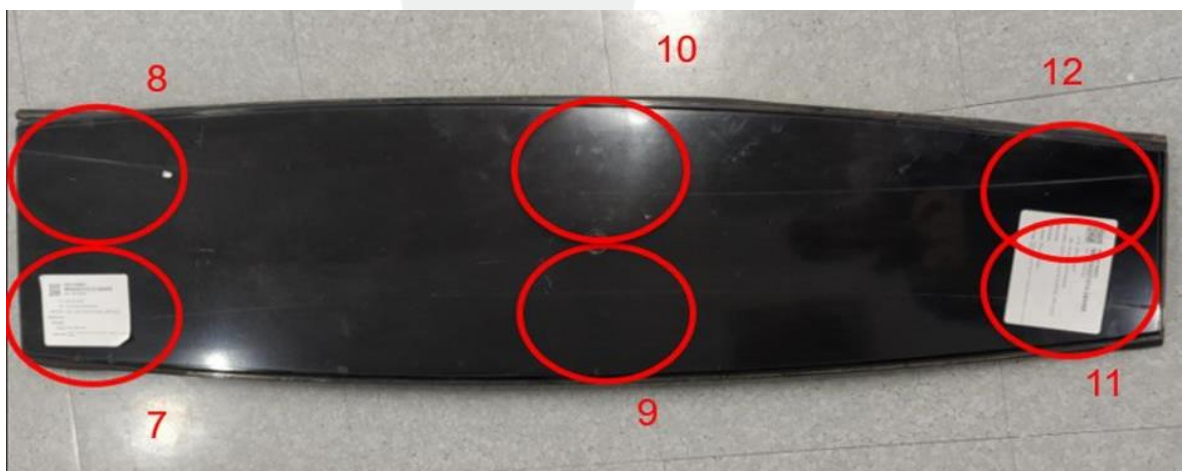
**Figure 5 – Center spine applique inspection positions**

9. Connect the vacuum cup to the force gauge and slowly pull the vacuum cup up with the force gauge with at least 120 N of force for 10 seconds.
10. Inspect the center spine applique for any signs of damage or looseness/separation from the roof and note down the force value applied.
  - If the center spine applique is in good condition and remains adhered, continue to the next step.
  - If the center spine applique is damaged, loose, or shows signs of separation, replace the center spine applique (refer to Service Manual procedure [10403002](#)) and proceed to step 11.

11. Carefully remove the vacuum cup from the center spine applique to prevent accidental damage to the applique and rear door roof glass seals.
12. Repeat steps 8 through 11 on the remaining center spine applique inspection positions (Figure 5). The circles indicate general locations, make sure that the actual suction cup does not overlap the edges.
13. Allow the adhesive on any replaced applique panel to dry for 1 hour before returning the vehicle to the customer.
