# Technical Journal

**Upper front suspension creaking/knocking noise**

| REF NO:<br><b>TJ 36527.7.0</b> | ISSUING DEPARTMENT:<br><b>Technical Service</b> | CAR MARKET:<br><b>United States and Canada</b> | |

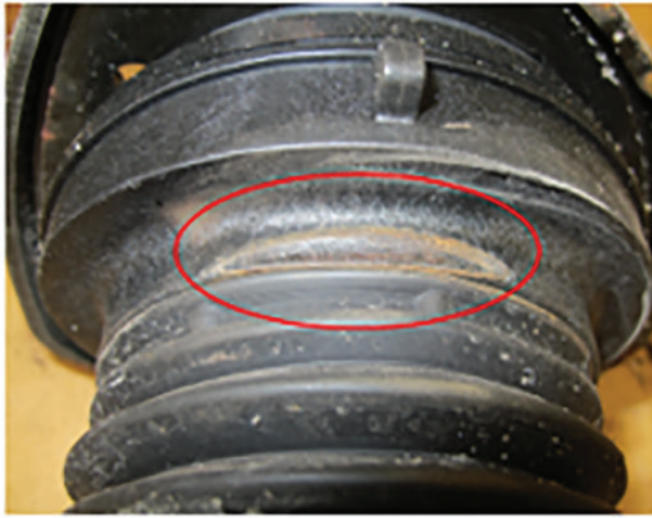
- During acceleration/braking (knocking noise.MOV and picture 1)
- During (slowly) driving over bumps and into turns (knocking noise.MOV and picture 1)
- During turning to left or right when standing still (Creaking noise.mp4 and picture 2)
- During parking manoeuvring (Creaking noise.mp4 and picture 2)

\*If there is a confirmed creaking/knocking noise from the upper front suspension.  
Please follow VIDA to replace the upper bearing.
