Technical Journal Title EX90 Software download issues - temporary solutions		Ref. No. TJ 37071.1.0	
Issuer (Dept.) Technical Service		Issue Date 10/3/24	Status Date 10/14/24
Car Market United States and Canada	Partner 3 US 7510 Volvo Car USA	Function Group 3018	
Function Description Software		Page Page 1 of 7

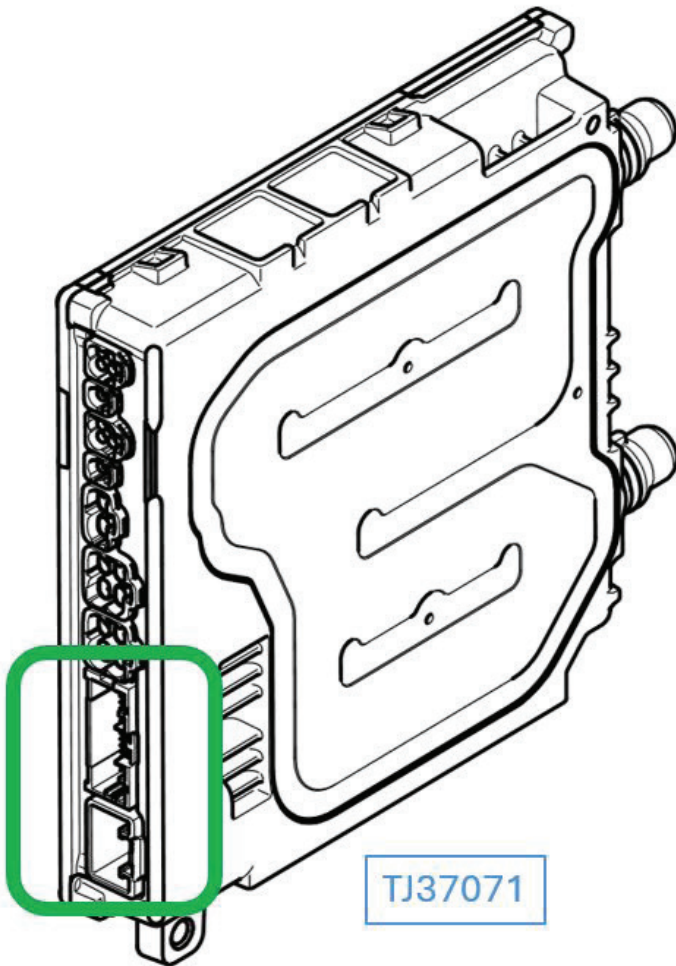
- a. If the VIUP/D is in Programming.
 - aa. Do a 12V reset with VIDA, 30 minutes.
 - ab. Reload VIUP/D.
 - b. If the VIUP/D is not responding.
 - ba. Perform a 12V reset with VIDA for 30 minutes. (try at least 3 times).
 - bb. If we get the VIUP/D in Programming, do a reload.
 - bc. If the VIUP/D is still in not responding, contact RTS.
- How to do a 12V hard reset if 12V reset with VIDA fails (step #2 & #3):
 - Alt a:
 - a1. Disconnect 12V batteries.
 - a2. VIDA => Software installation => Advanced test => Reset
 - a3. Connect 12V batteries after more than 10 minutes.
 - Alt b:
 - b1. Disconnect 12V batteries.
 - b2. Access the VCU in the front passenger compartment and disconnect connector (see picture VCU1) on the VCU for more than 10 seconds.
 - b3. Connect 12V batteries after more than 10 minutes.
