Technical Journal

Technical Journal Title White patch condition in paint from protection cover		Ref. No. TJ 36277.2.1	
Issuer (Dept.) Technical Service		Issue Date 10/22/24	Status Date 10/24/24
Car Market United States and Canada	Partner 3 US 7510 Volvo Car USA	Function Group 8000	
Function Description Body, cab and interior		Page Page 1 of 3

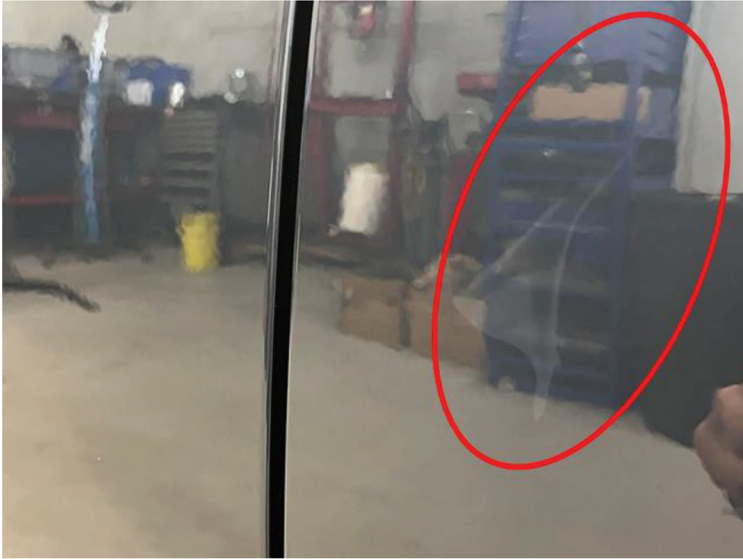
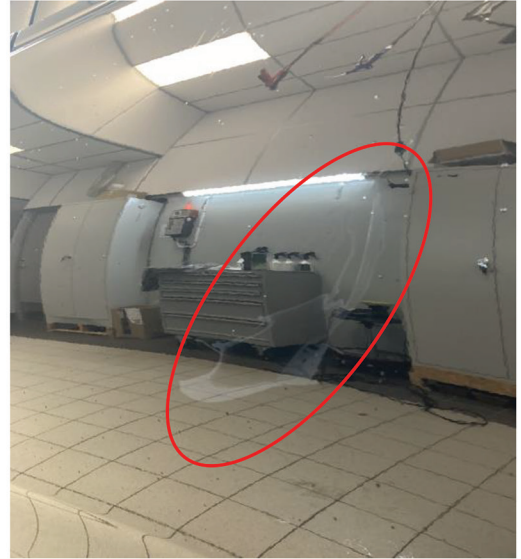
TJ-36277

* If experiencing milky stripes/white patch conditions in the paint when the raggard or vehicle cover is removed, please see advice under "Service".

* If milky stripes/white patch condition occur when the rapgard or vehicle cover is removed, do NOT polish, wax or repaint the area. The defect can be removed by exposure to outside daylight for 48hrs. Or an IR-radiator can be used, carefully heat up the area to a temperature of 50-70°C (122-158°F) for 30 minutes. Note! The temperature of paintwork must not exceed 100°C (212°F). For example pictures of the defect, see attachment TJ-36277.pdf.
