Check engine warning light active - Fault P300CA8 or P300CA9 "Hot film mass air flow sensor malfunction" present in engine control unit

Topic number	LI14.30-N-075882
Version	3
Function group	14.30 - Secondary air injection
Date	10/10/24
Validity	Model 907 with engine 654
Reason for change	Adjusting the remedy: requesting IFQ cases.

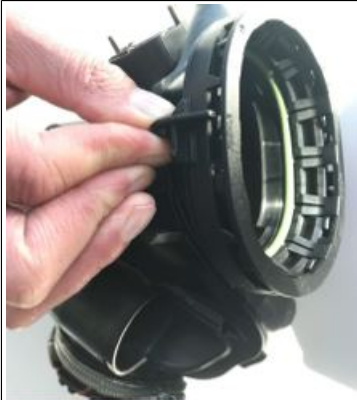
Attachments	
File	Description
2b.JPG

- Relevant area of right-hand clean air line to center clean airline (quick-release coupling - Picture 2a), Observe the following operation steps:
- Operate connector coupling as far as the end stop rib "open position" (Picture 2b).
- Hold connector coupling open until the left-hand clean airline is pushed into the connector coupling as far as the end stop and lies flush all around (Picture 2c).
- Release connector coupling and actively slide it back to the "closed position."
- Check correct seating of the clean air line using the lock position. If the lock position is not visibly reached (Picture 2d), the clean airline must be repositioned.
- Check the seal between the turbocharger and clean airline for damages. When disassembling that connection point, always replace the sealant ring.

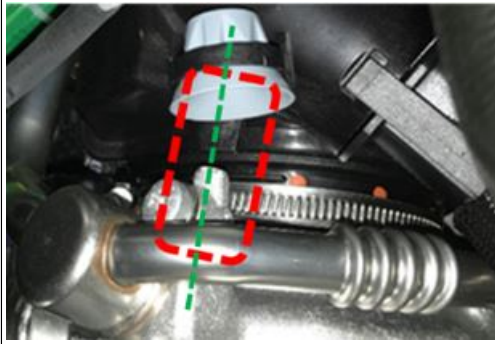
1c.JPG

- Check that the right-hand clean air line is aligned with the exhaust gas turbocharger. The cast lug must be cleanly aligned with the tab (Picture 1c).

Information: When conducting repairs and assembly work, ALWAYS replace the seal in this area.

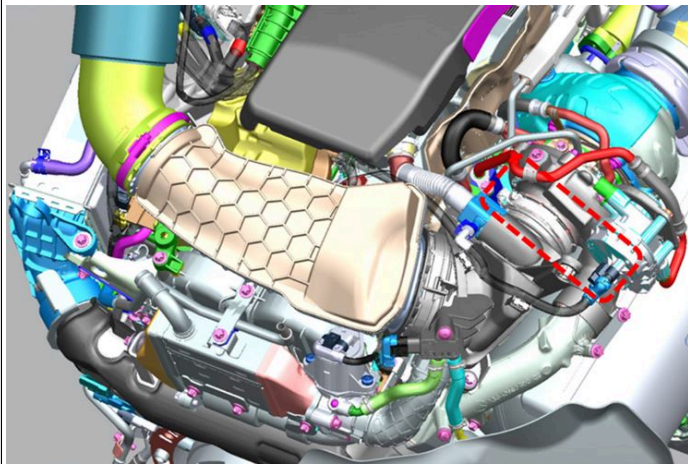
1a.JPG

- Relevant area of exhaust gas turbocharger to the right-hand clean airline (Picture 1a):

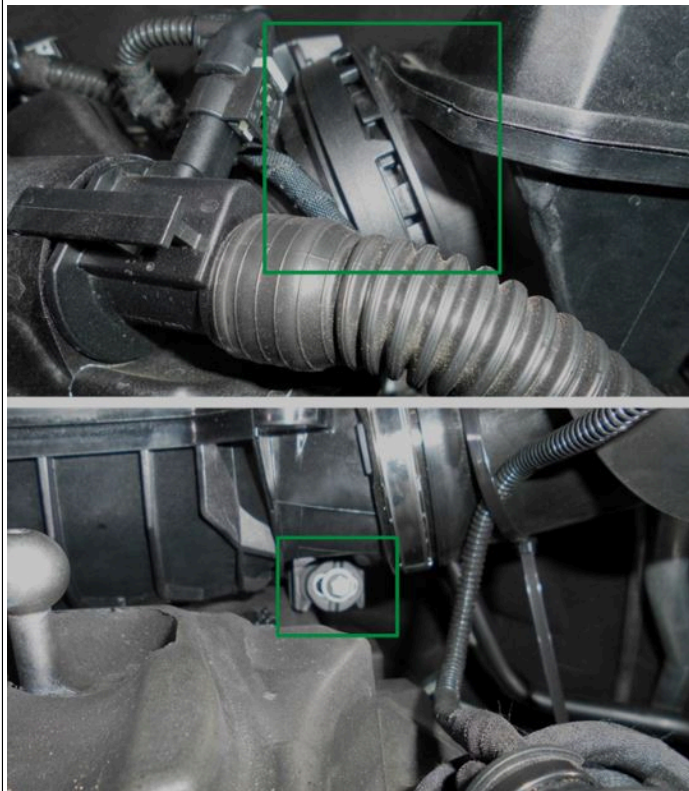
3.JPG

For example images of correct and incorrect installation, (Picture 3) and (Picture 4).
