XAB- A/C Inoperable or Blowing Warm Air

Models	Model Year	Model Type	VIN Range	Vehicle-Specific Equipment
Macan Electric	2024	XAB	N/A	N/A

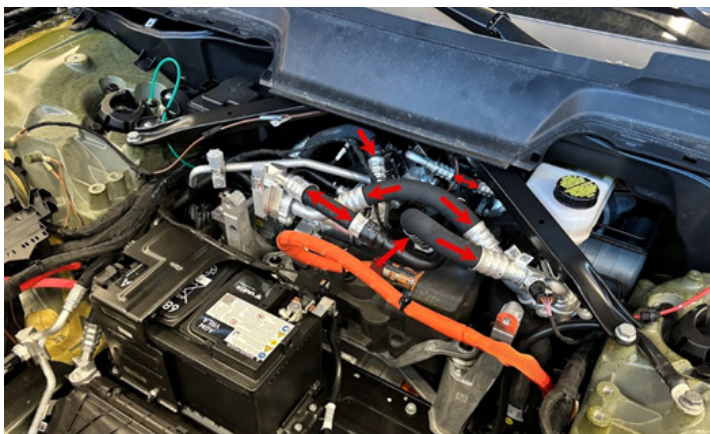
Figure 1

All vehicles are filled correctly with refrigerant from production. Refrigerant leaks may occur from crimps or connections of the A/C lines in the front trunk area (Figure 1).

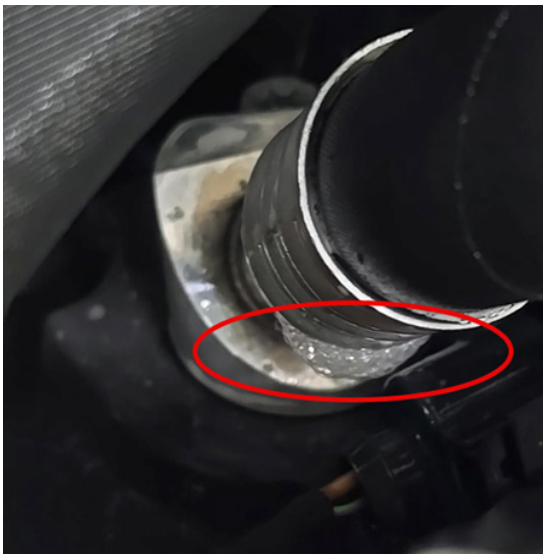
Figure 2

If pressure loss is detected, closely inspect the aforementioned lines for leaks with soapy water. If leaks are observed like in the photos below (Figure 2-4), replace the two A/C lines highlighted in red in Figure 5 with part numbers PAD816740A and PAD816743. Submit a Parts Support PRMS ticket to order these replacement parts.
