Motor Symptom - Cooling System cannot be Filled Correctly: Check and Replace High-Voltage System Coolant Distributor if Necessary (SY 149/24)

Model Line: Taycan (Y1A / Y1B / Y1C)

Model Year: 2025

Concerns: Coolant distributor for high-voltage system

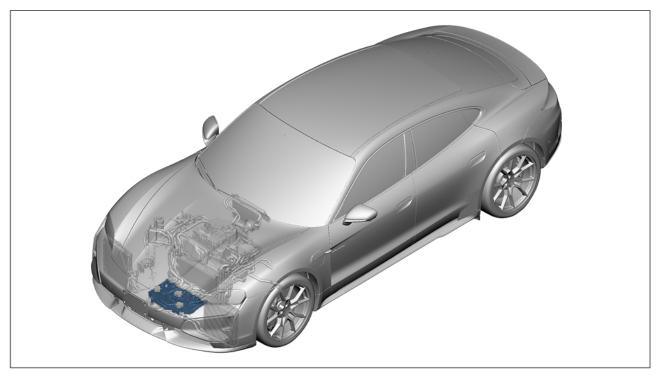
Symptom: After repairing the vehicle, the cooling system cannot be fully vented and refilled.

Cause: It is possible that a **high-voltage coolant system distributor** was installed in the vehicle that does not

reach the vacuum values for venting and filling the cooling system.

Installation position of coolant distributor for high-voltage system

Check and replace high-voltage coolant distributor if necessary.
