**External Body Symptom - Rear Spoiler (Wing) Jams / Fault Memory Entry in Rear Spoiler Control Unit: Reworking Spoiler Drive (SY 157 / 24)**

Model Line: **Panamera Sport Turismo (971)**

Model Year: **As of 2018 up to 2024**

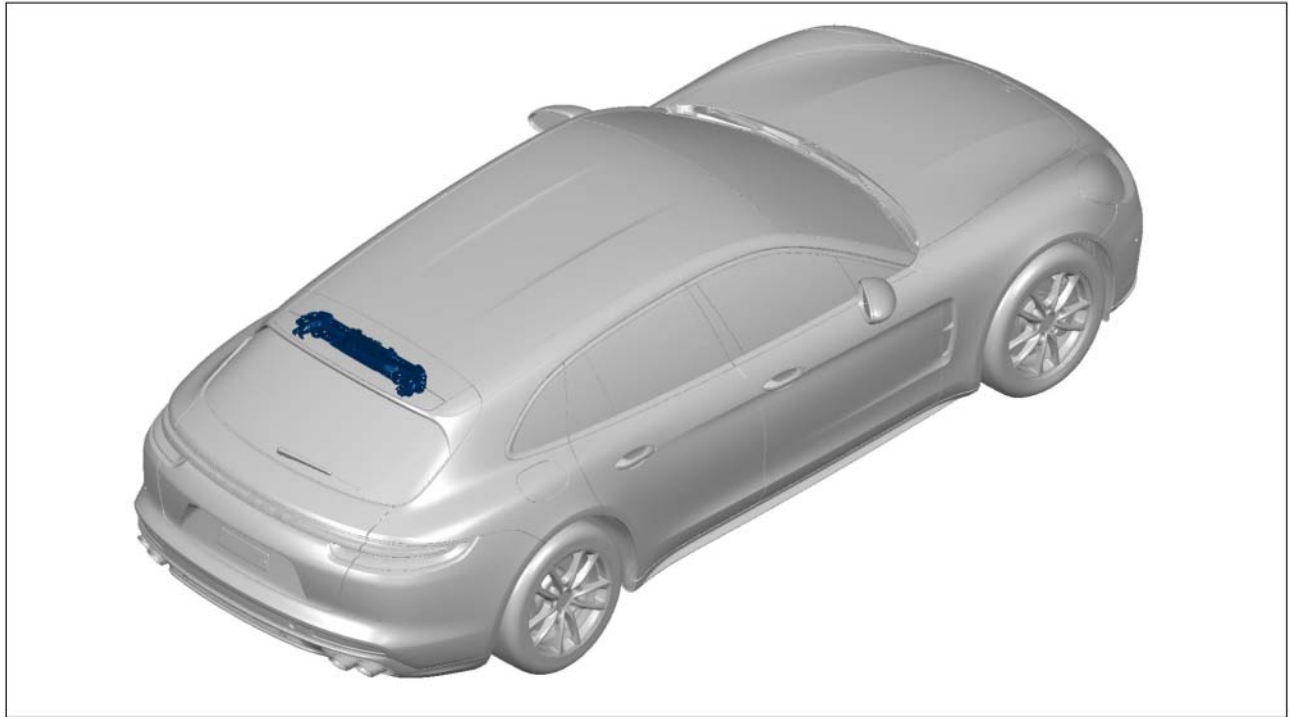
*Spoiler drive installation position***Required parts and materials**

Symptom: **The rear spoiler cannot be retracted and the white warning message "Spoiler fault" is displayed on the instrument cluster; in addition, the "Spoiler extended" function is not available or is greyed out on the central display.**

Cause: Dirt or tension on the spoiler drive can activate block detection in the rear spoiler control unit. As a result, the rear spoiler adjustment function is deactivated.

Remedial Action: In the event of a complaint, rework the spoiler drive.
